PV Connector Reliability: Initial Results from Field inspections Across the US

Bruce H. King¹, Laurie Burnham¹, Tap Lolla², Wayne Li², Vignesh Ramasamy³, Andy Walker³, Jal Desai³, Michael Woodhouse³

¹ Sandia National Laboratories, ² Electric Power Research Institute, ³ National Renewable Energy Laboratory

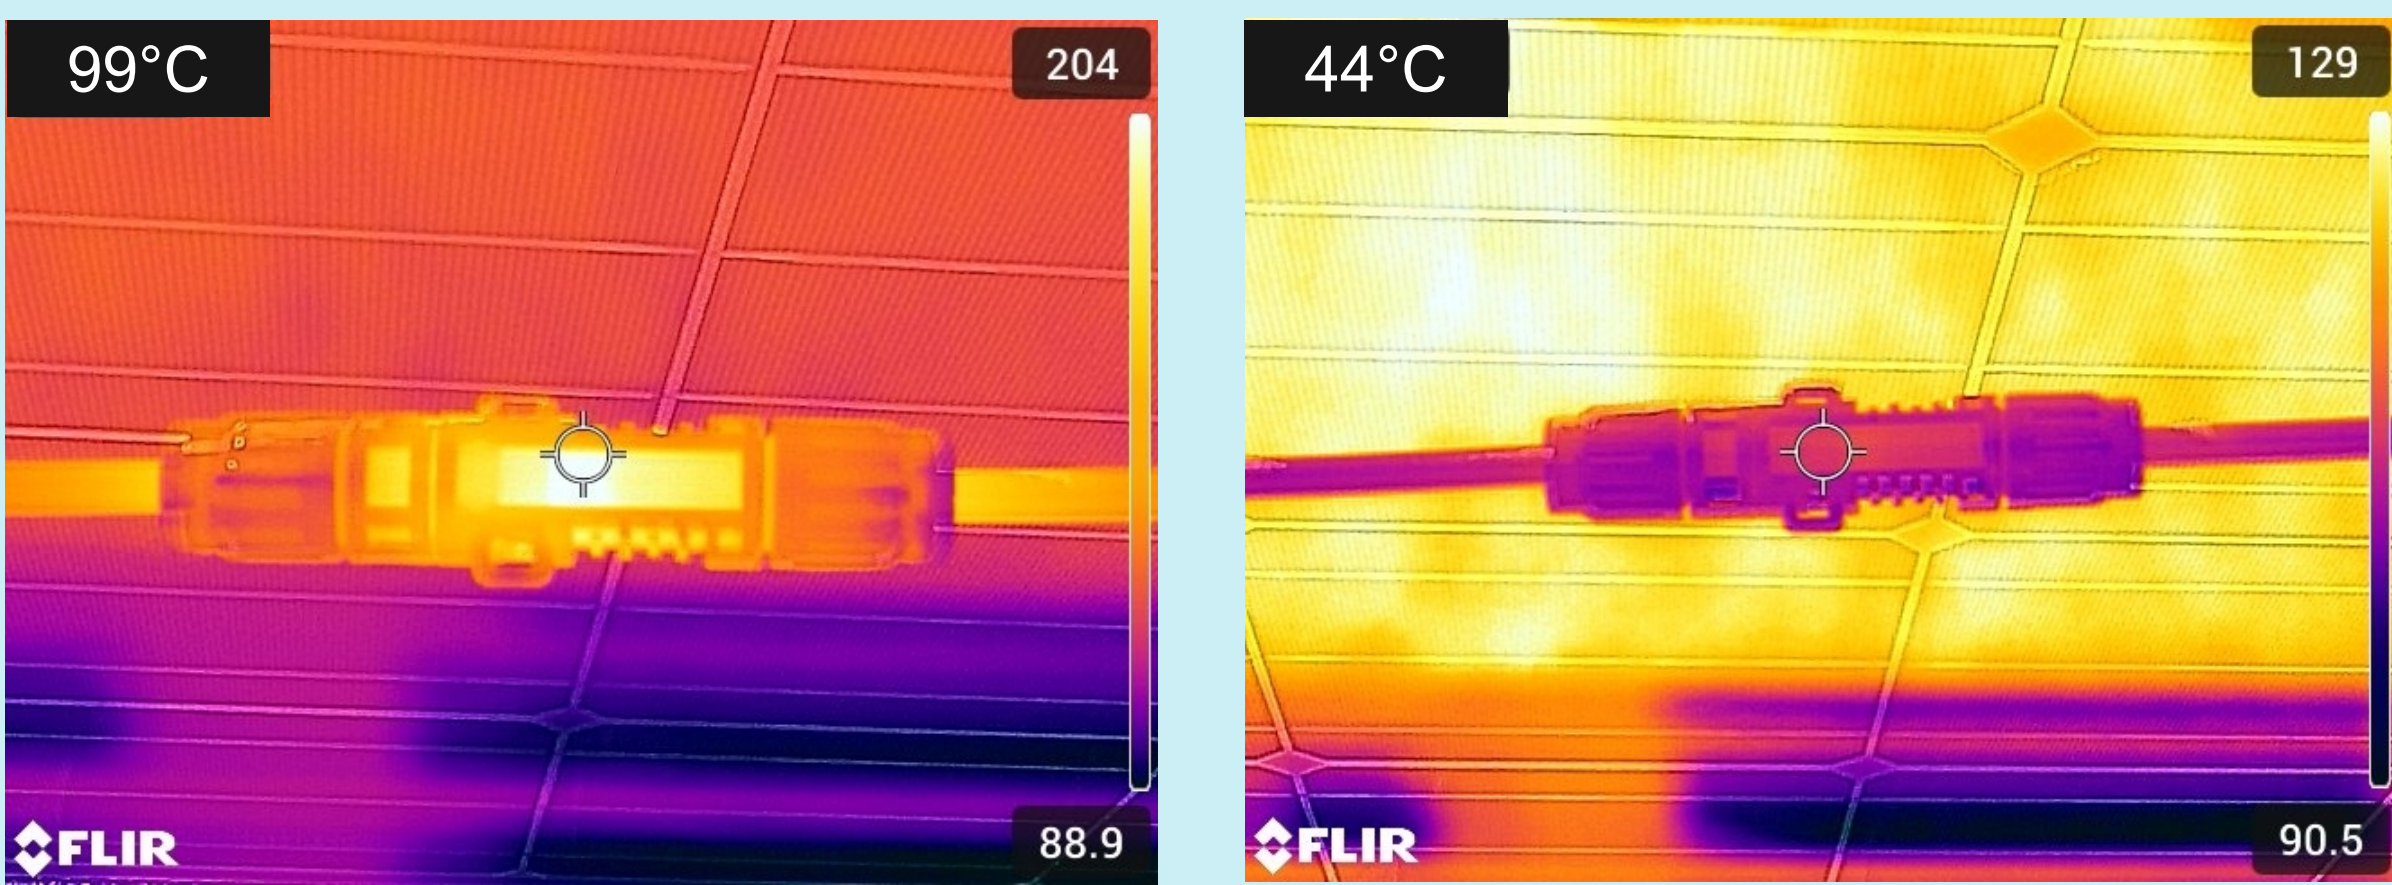
Ambient Temp: 36°C | GPOA: 1017 W/m² | Imp: 9.2A

1. Increased Contact Resistance
 - Expected $\Delta T < 30^\circ C$ (per UL/IEC ratings)
 - "Cool connectors" imply $\Delta T = 8^\circ C$
 - Many connectors exceed $\Delta T = 30^\circ C$ Observations:
 - All ferrules could be loosened by hand
 - Heat spread laterally into PV wire

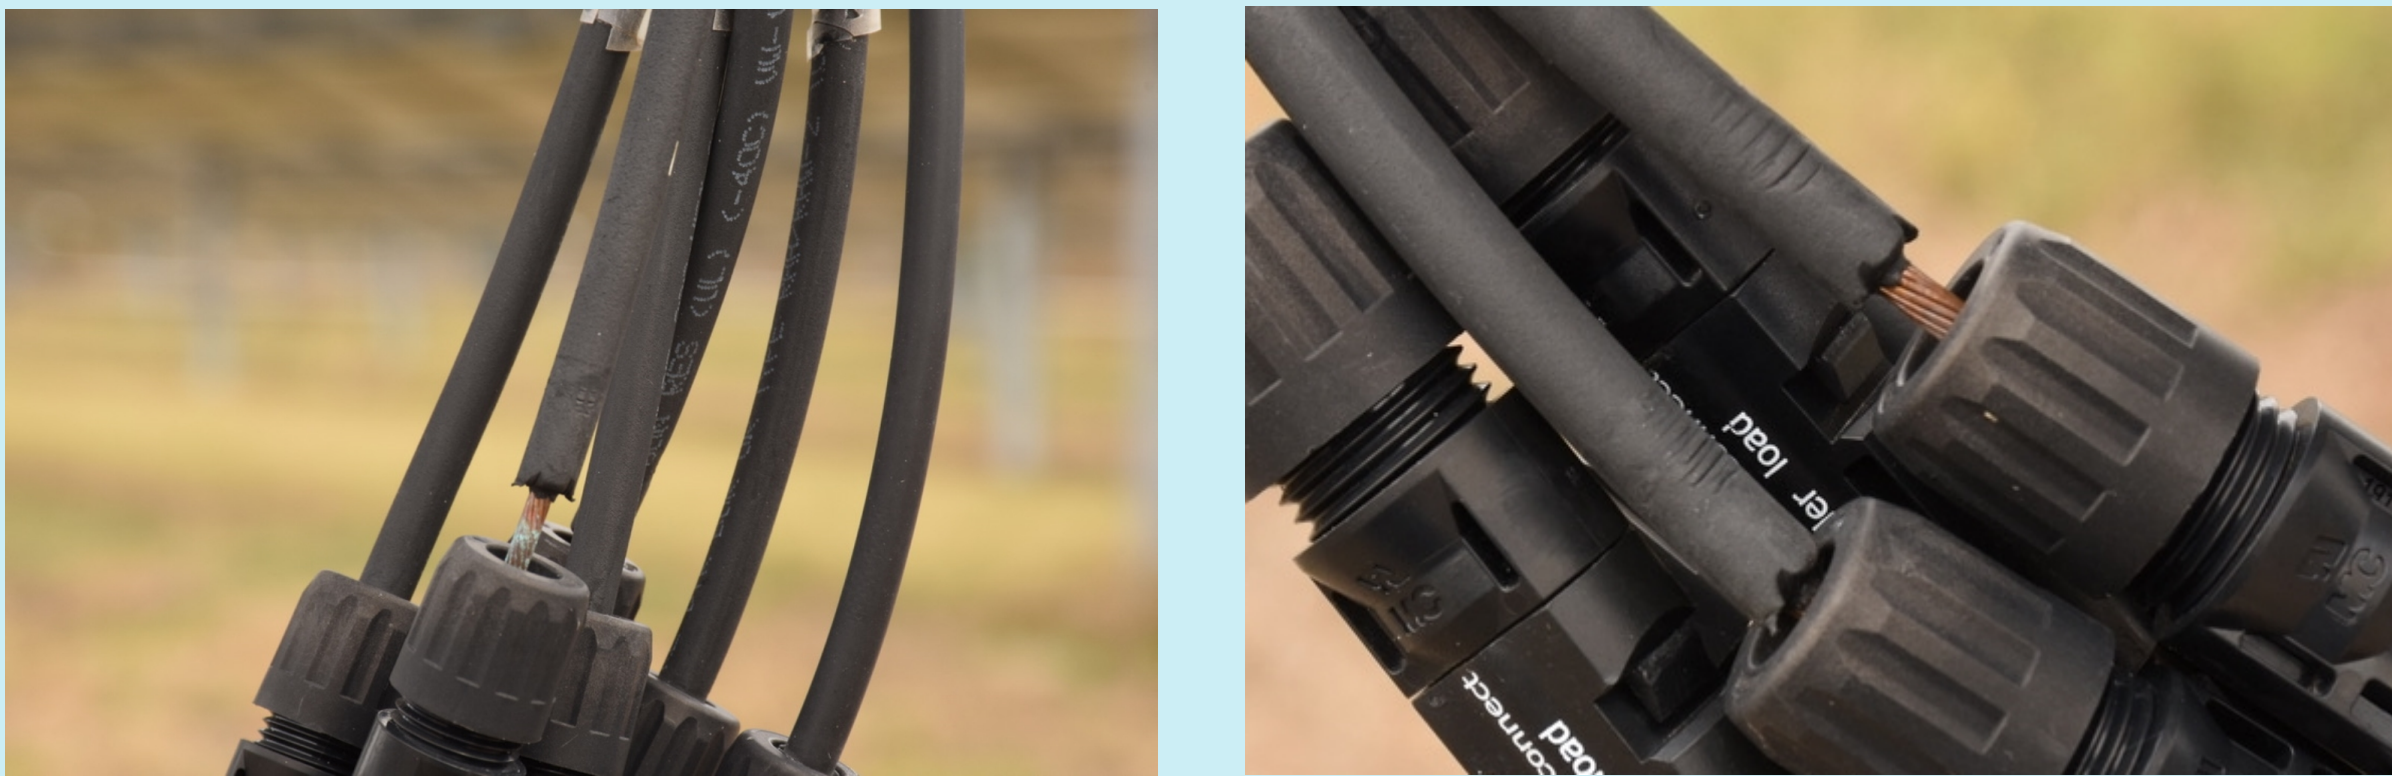
2. Seal failures at the ferrule
 - Over stripping or insulation "pullout"?
 - Incipient copper cable corrosion
 - Water ingress into housing is inevitable

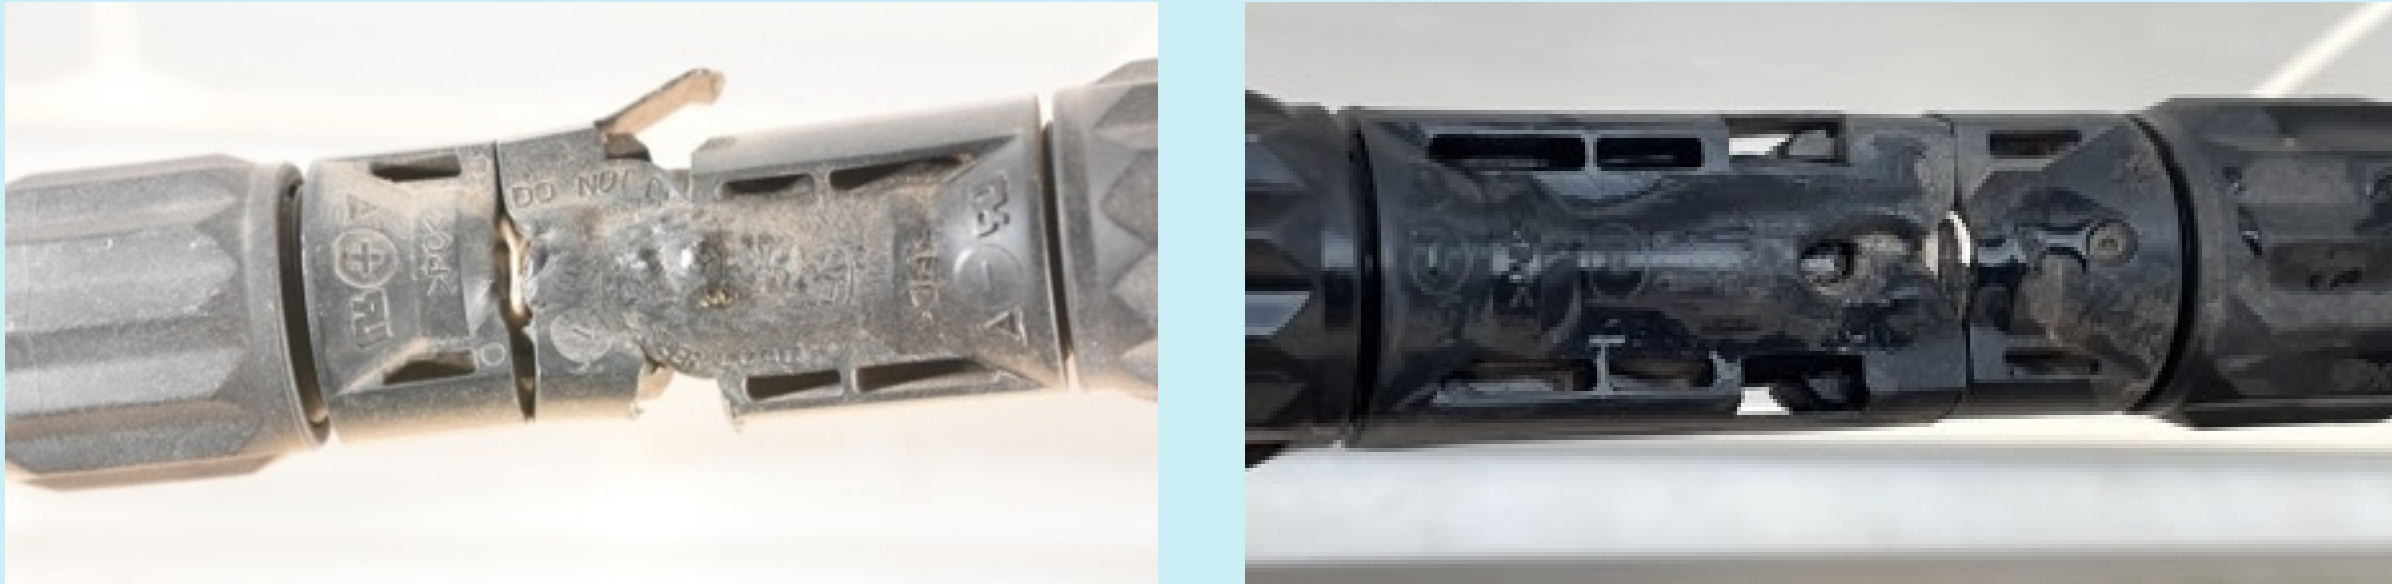
3. Housing failure
 - Melting of the housing due to increased contact resistance can directly expose energized contacts and compromise the o-ring seal.

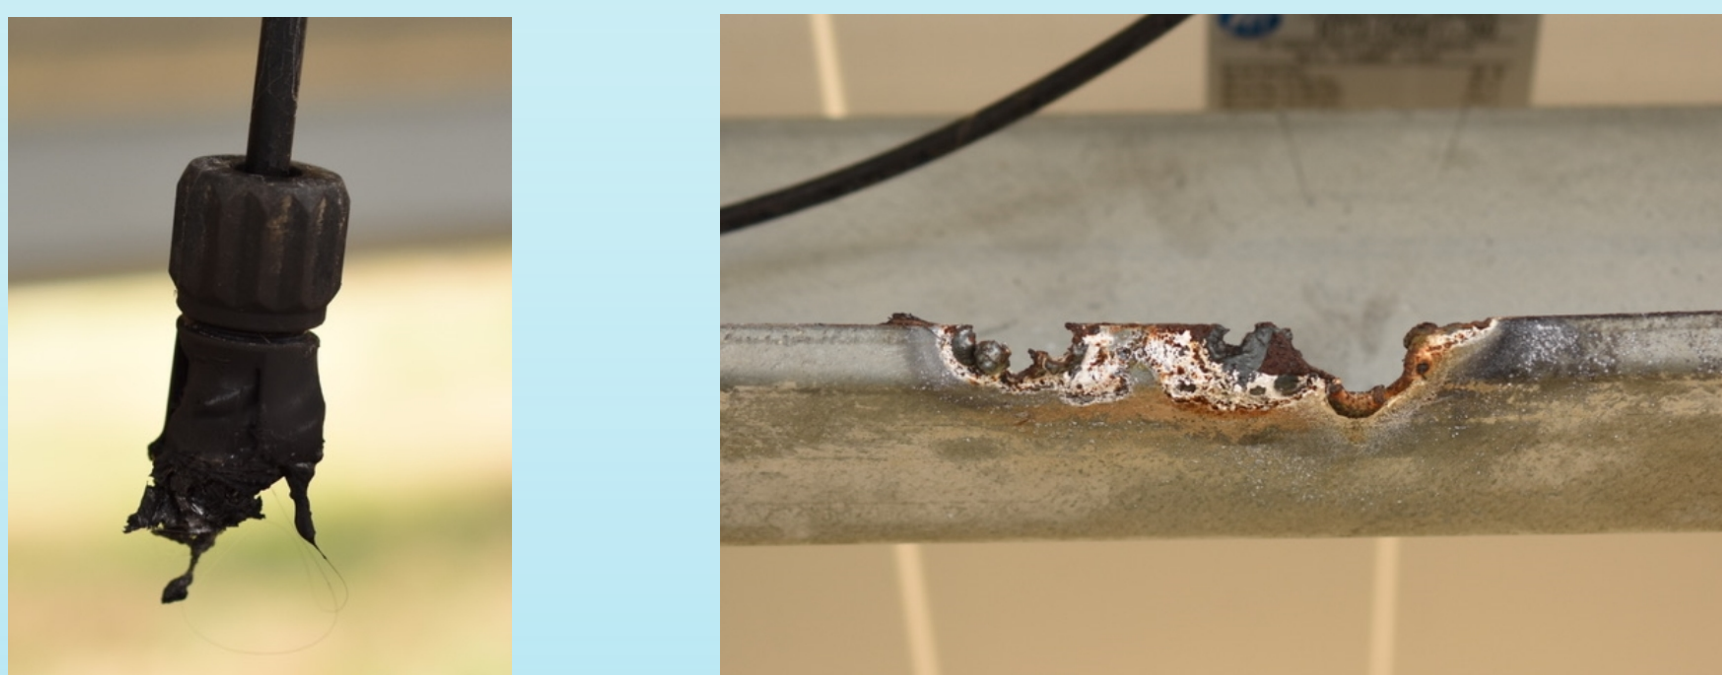
4. Catastrophic failure
 - Connector housing failure, whether from improper assembly and water ingress or plastic melting can cause catastrophic arcing to nearby metallic components
