PV Connector Reliability

Part II: Forensics Analysis of Failed Connectors

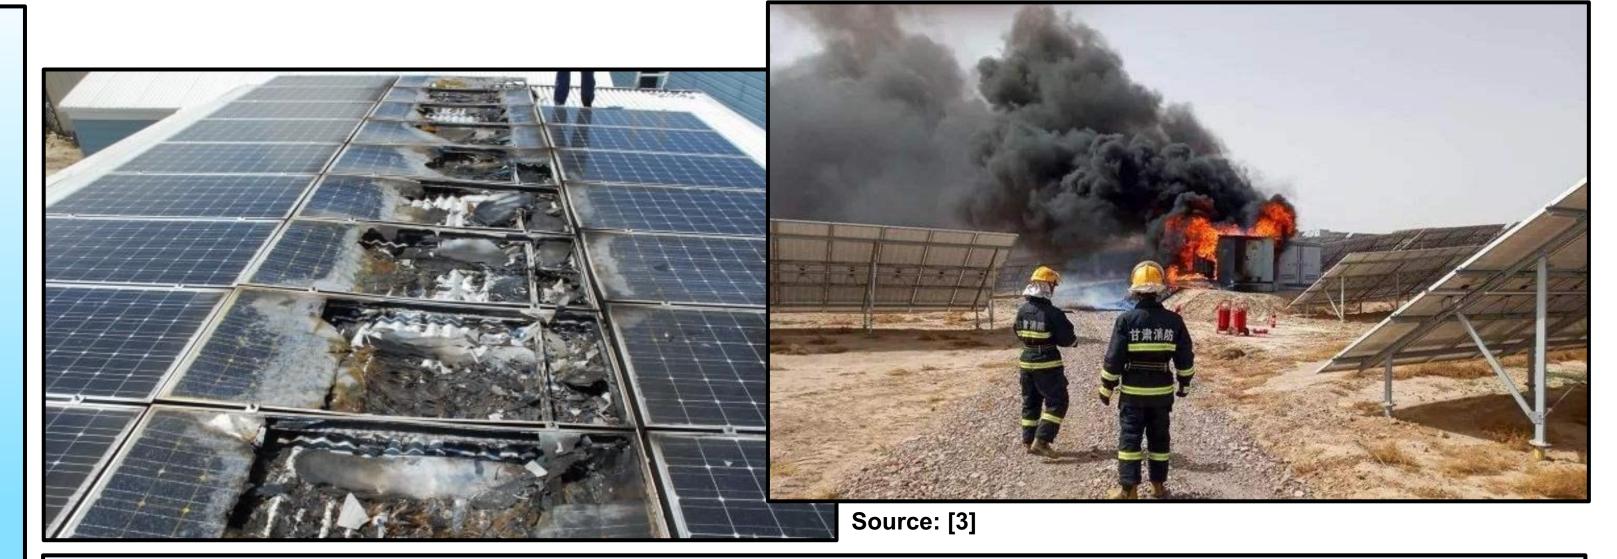
Fig. 1. Incidents showcasing examples of damage to solar PV modules and instance of fire in a solar station resulting from connector failures.

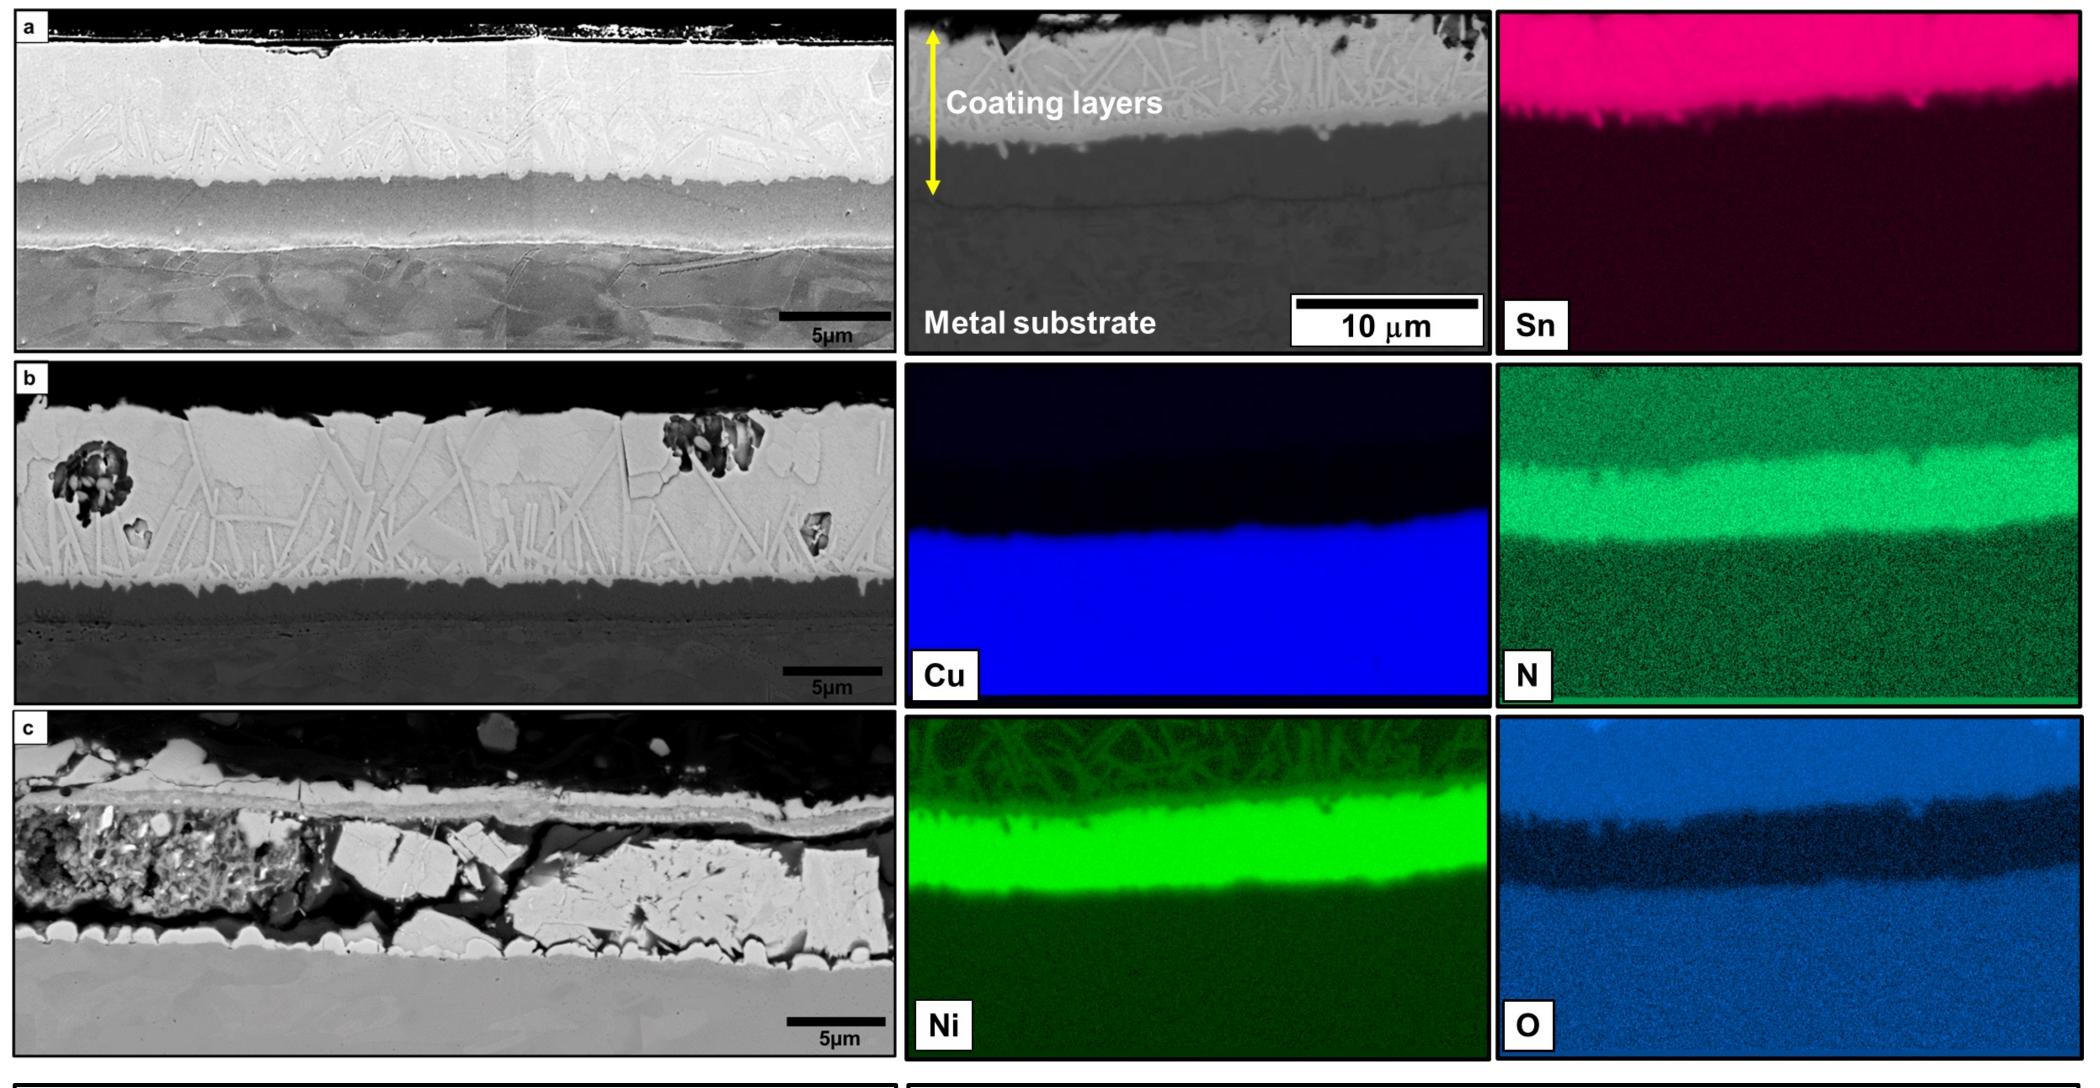
- Analysis of off-the-shelf connectors shows noticeable variations in connectors from different manufacturers.
- Fig. 3 compares the structural characteristics of the surface coatings on connectors from three different manufacturers. Some connectors show a multi-layered coating structure adherent to substrate (*Fig. 3* -

images a and b), others show a lack of coating structural integrity (*Fig. 3 – image c*). The coating layers may be necessary to protect the metal pin from environmental conditions that lead to corrosion so the diagnosis of variability and defects is important.

Differences in coating composition and deposition may cause differences in long-term performance of PV connectors in field

Fig.3 Surface coating characteristics of off-the-shelf connectors showing differences in structure of coatings

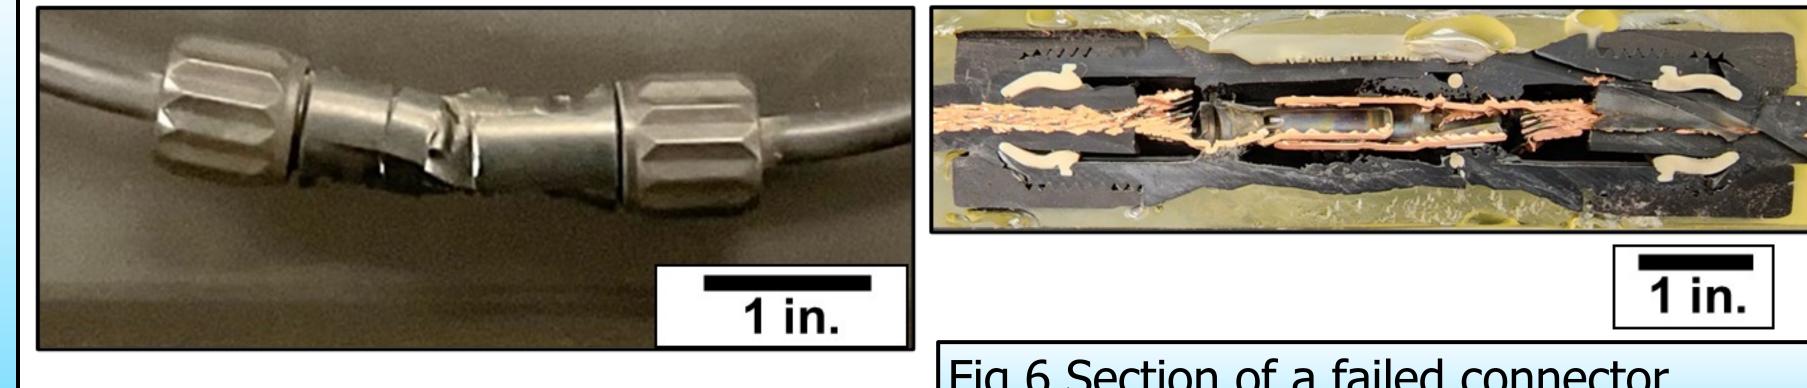
Fig.6 Section of a failed connector showing interior portions for forensic Fig.5 Example of a field-failed connector analysis.

collected for forensic analysis
