# Bladena

## Solutions for cracks.

Presenter: Andrei Buliga M.Sc. Structural Engineer

29.08.18

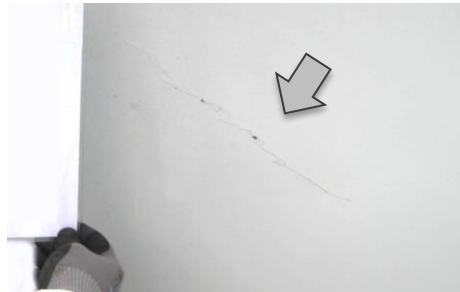
Transverse crack

Surface observation

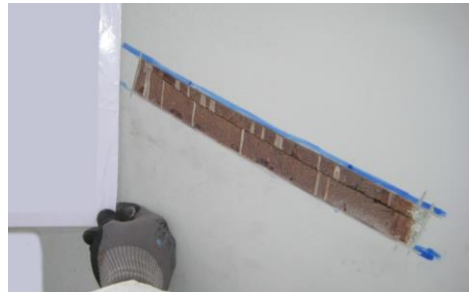
Under the skin observation

Rapid  
development

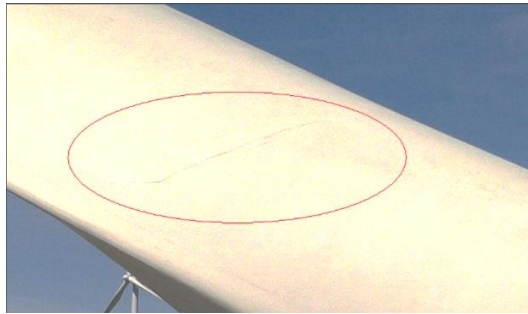
Transverse crack is found

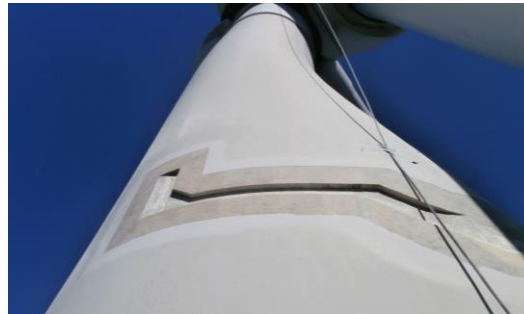
Extensive repair is made

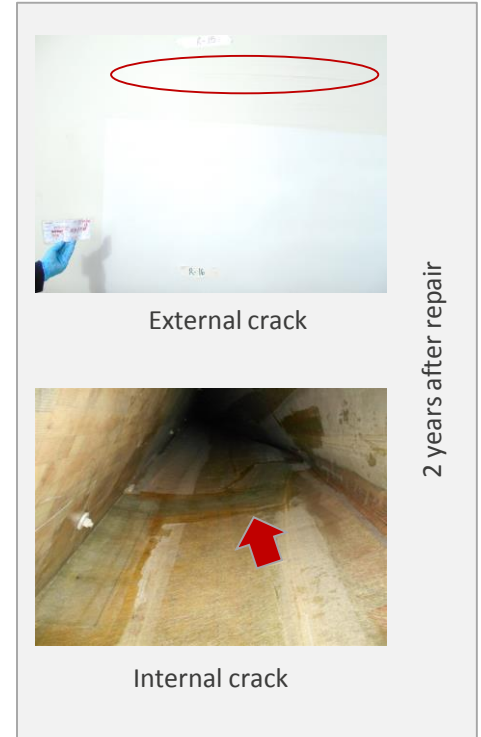
- In real life we have, regardless of today's testing standards plenty of structural blade damages that occur again and again.
- The reoccurrence happens because root cause is not removed.

- Cracks appear again in the same spot where repairs were previously made.

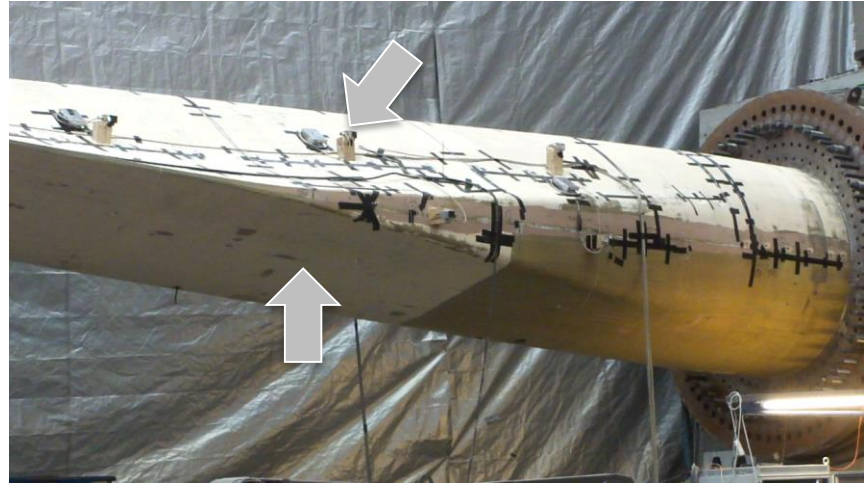
- Noises were heard during a full-scale fatigue test in an area where local bending of blade panels was observed.
- The blade was visually inspected, however no damages were found.
- The bending of the panels is not observed when the blade is stationary.

Out-of-plane bending of panels is observed during the blade fatigue test.

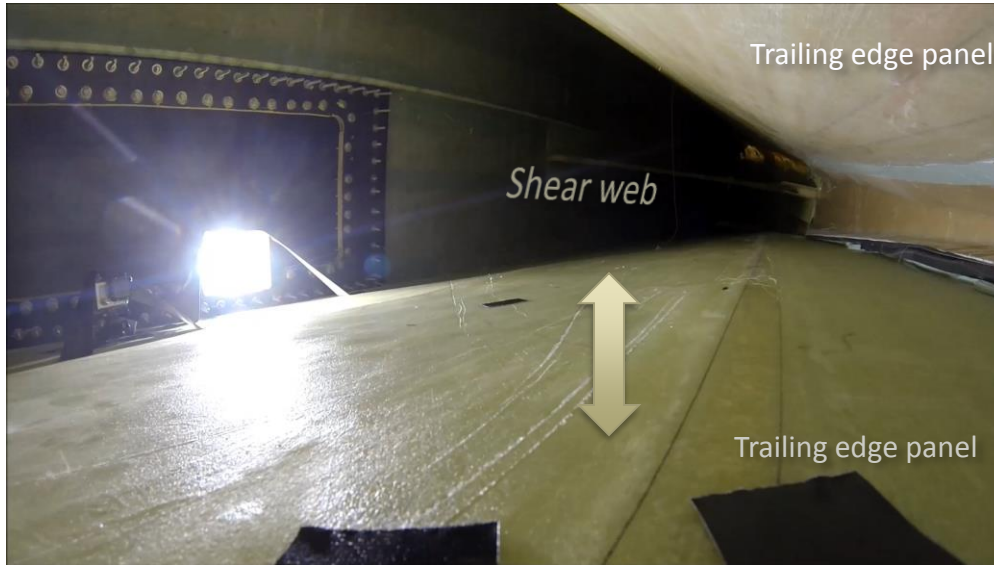
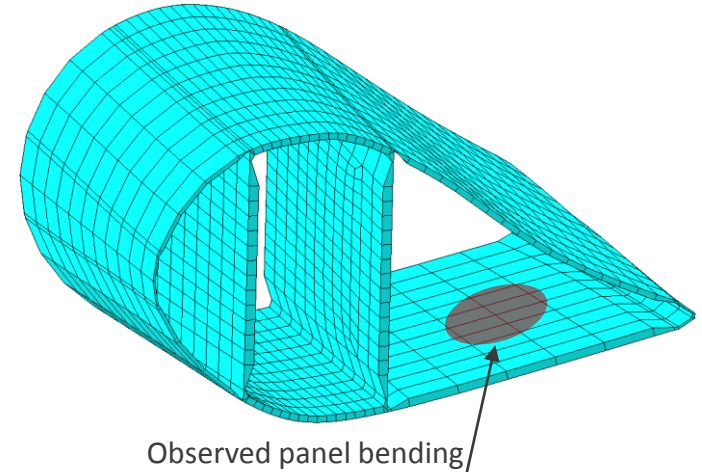
- Internal camera surveillance during the test pointed out local out-of-plane panel deformation.
- Similar to the exterior visual inspection, no damage or deformation was observed when the blade was stationary.

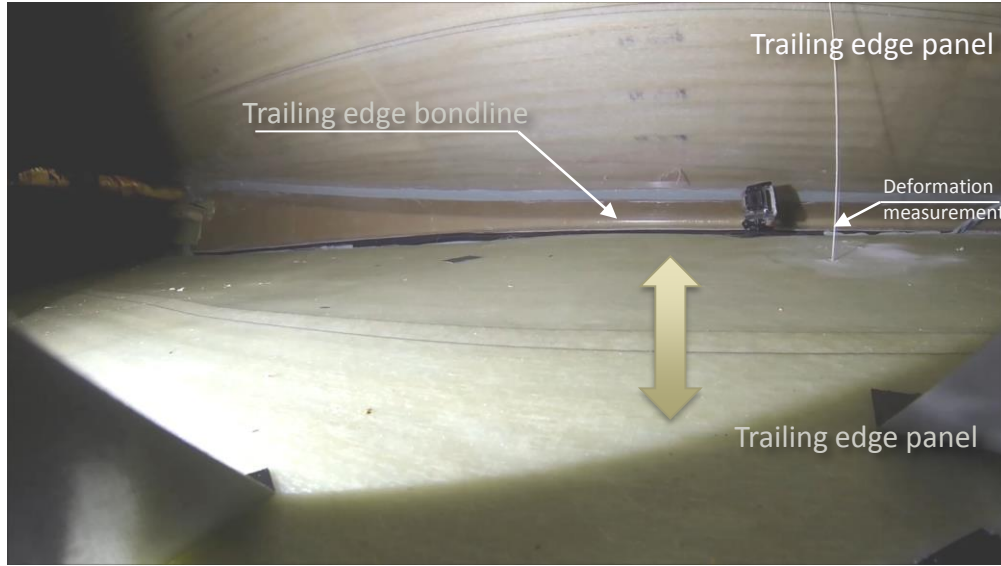
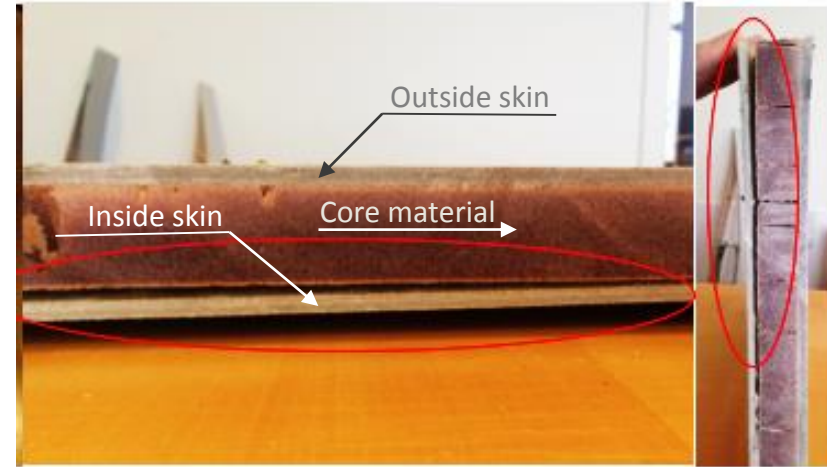
- The damage was confirmed when the blade was cut.
- A clear skin debonding from core in the inner skin was found.
