Blade Visual Inspection and Maintenance Quantification Study

Sandia Blade Workshop
October 19, 2022

Wind Turbine Blade Maintenance Quantification

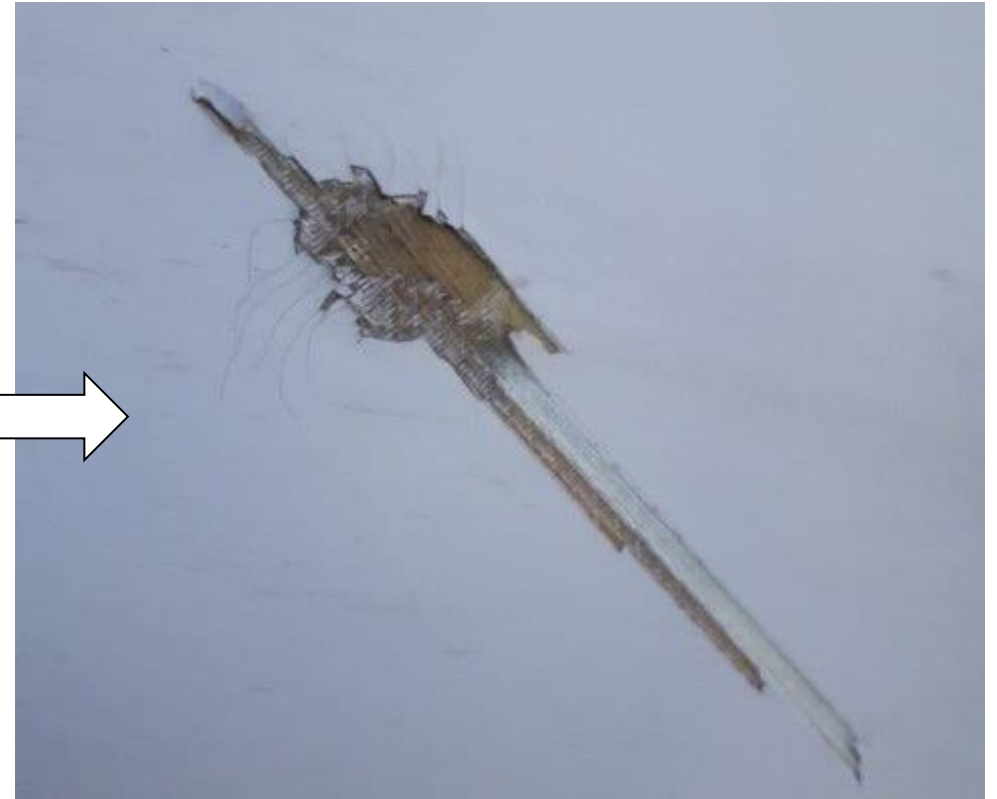
This damage is at 80% span on the suction side shell.
The damage measures approximately 10 cm x 3 cm.
This turbine has been running for approximately 30% of its design lifetime.

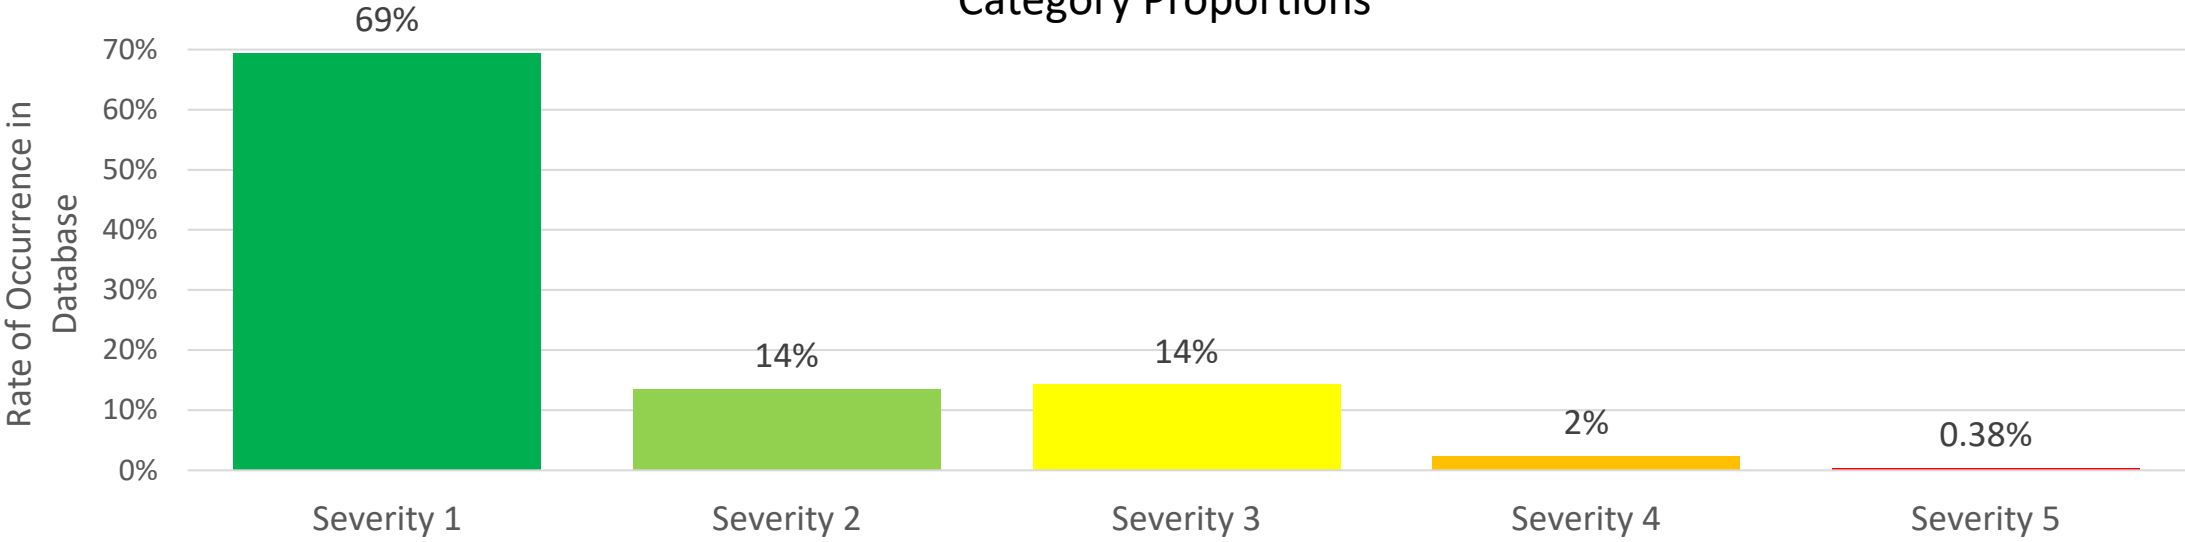
Category 1	Category 2	Category 3	Category 4	Category 5
<i>scratch in coating</i>	<i>small region of coating damage</i>	<i>crack in structure at leading edge</i>	<i>large area of leading-edge erosion with fiberglass exposed</i>	<i>significant length of open trailing edge</i>

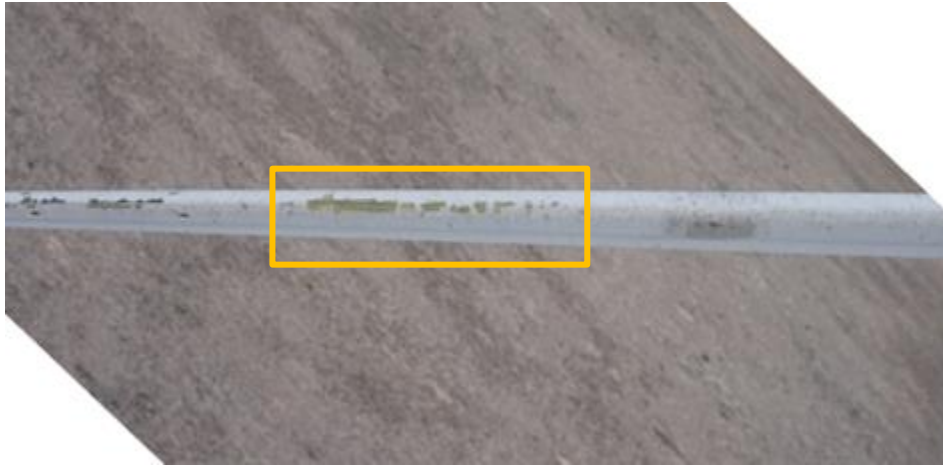
Inspection date: 1/19/2020
Severity category: **3**

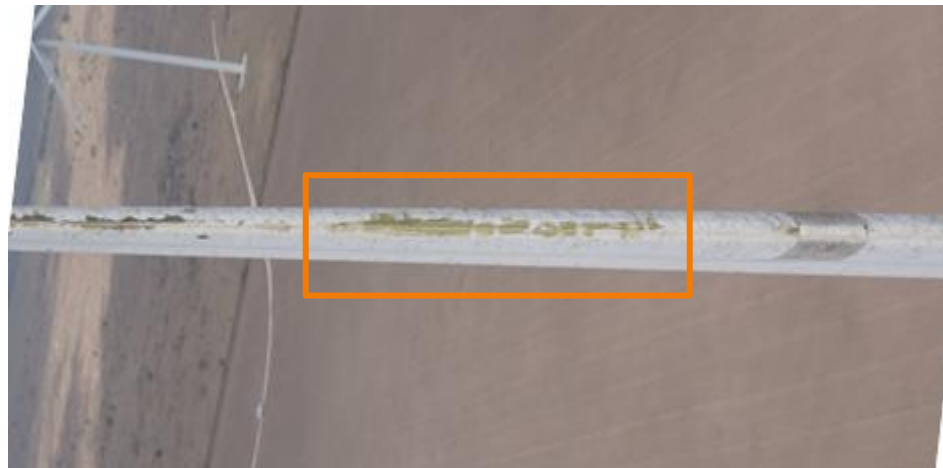
Inspection date: 2/8/2021
Severity category: **4**

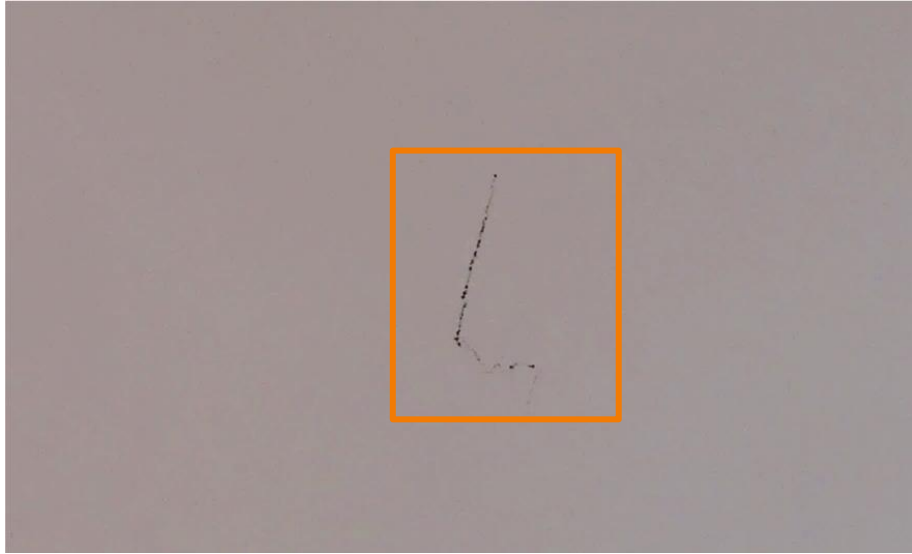
Inspection date: 2/15/2020

Severity category: **4**

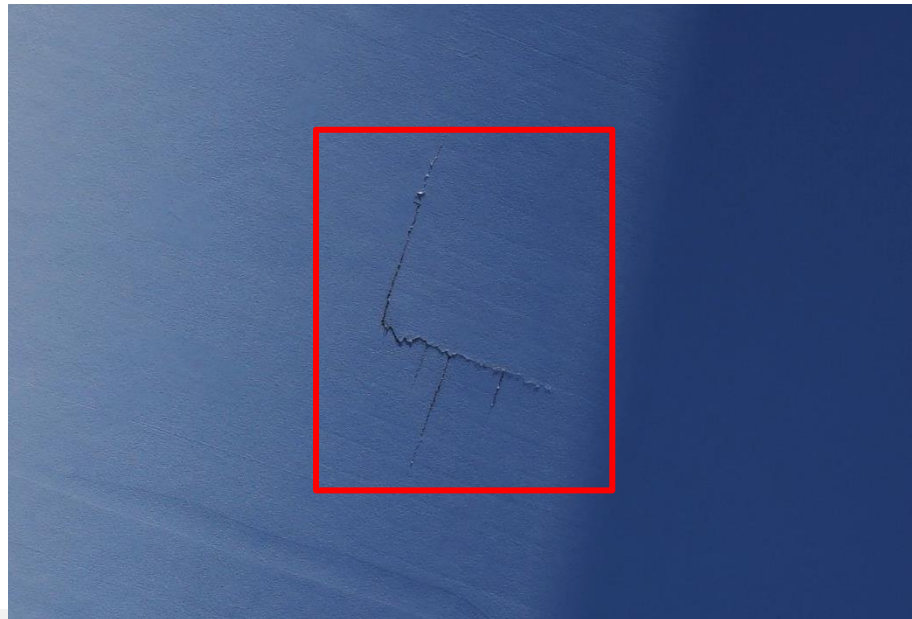
Inspection date: 3/11/2021

Severity category: **5**
