Investigation of Installation Practices: Field Observations

Sandia-EPRI Connector Reliability Workshop

Site Visits: Utility, Commercial, Small R&D

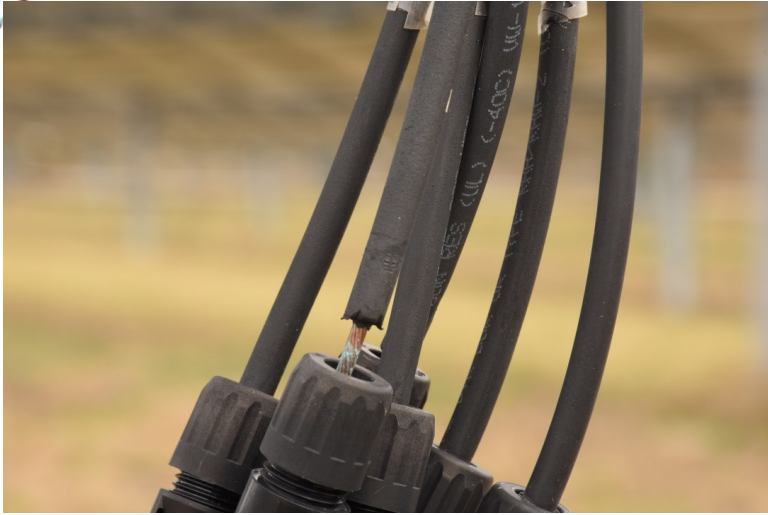
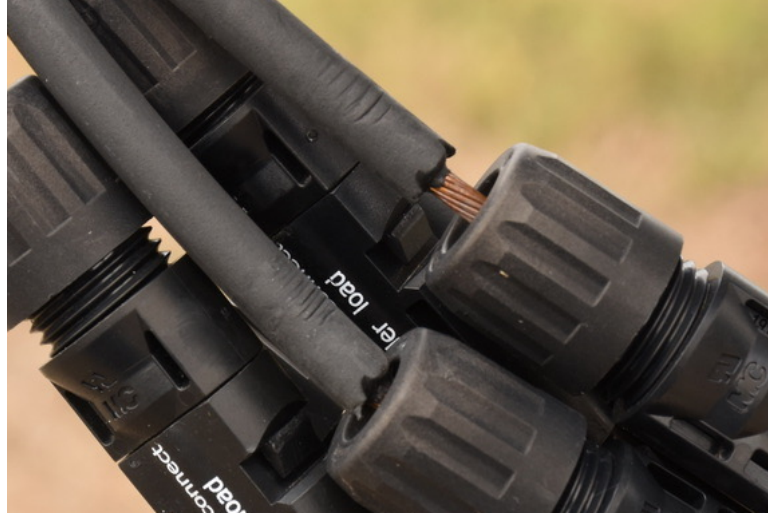
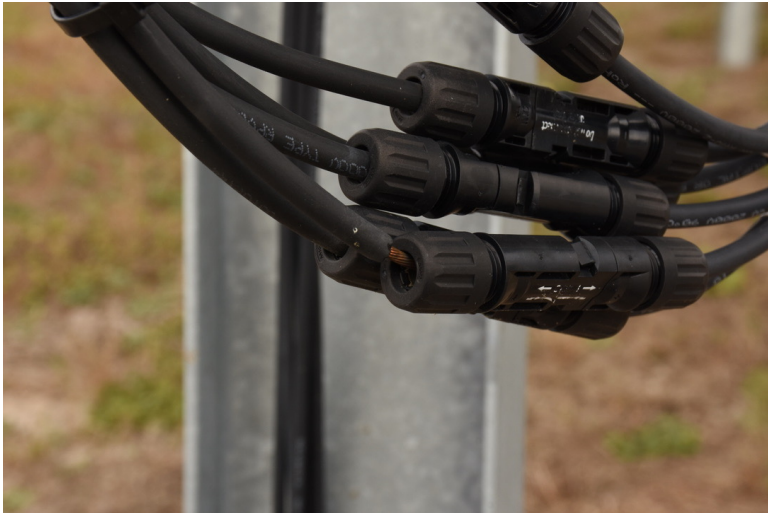
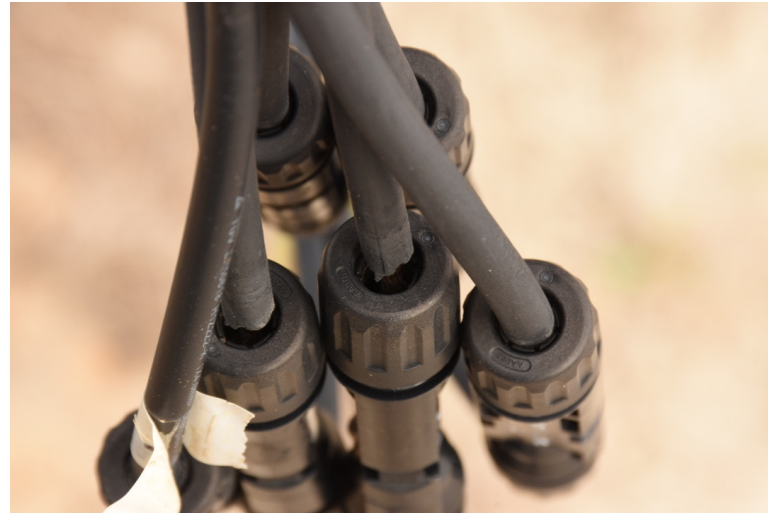
Home-runs: Ferrules, torque and cable insulation

- Numerous examples of seal failures at the ferrule
- Evidence of cable insulation “pullout”.....short stripping or shrinkage?
- Incipient cable corrosion in some cases
- Almost certainly accompanied by water ingress into housing
- Not a matter of “if”....a matter of “when”

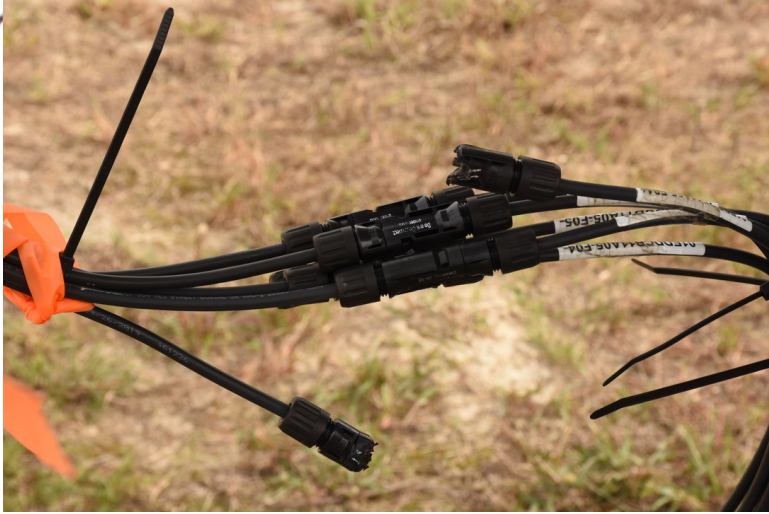
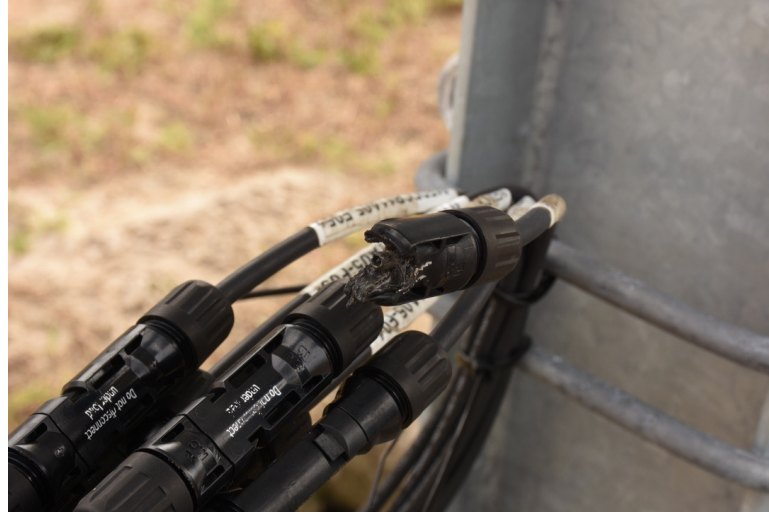
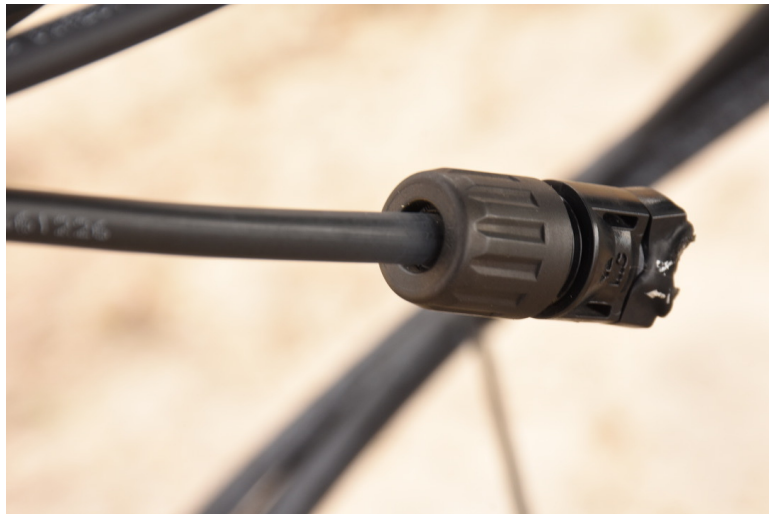
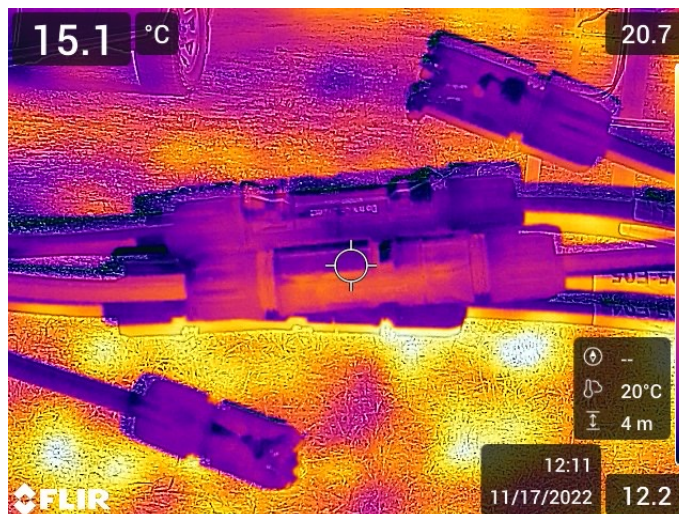
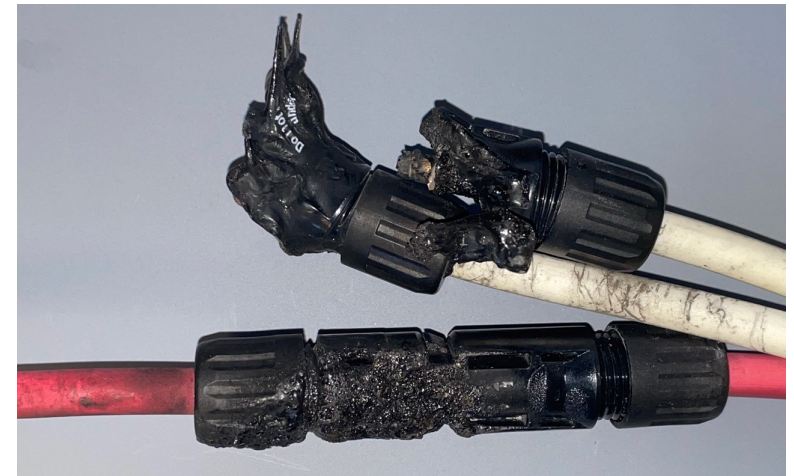
Home Run Bundles: Thermal Damage and inspection challenges

- Runaway resistive heating at pin-sleeve contact
- Bundled home run harnesses can put adjacent connectors at risk
- Emerging thermal damage may not be easy to identify
- Blocks with failed strings are offline...no current = no heat
- Identification by maintenance crews often most reliable

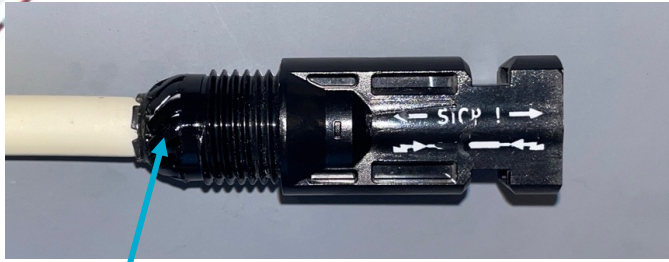
Proper torque
Collapsed strain relief
Pin secure

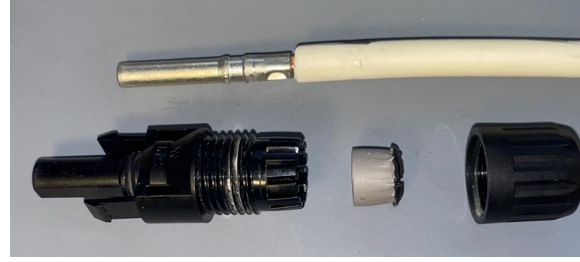
Improper torque, poor insertion

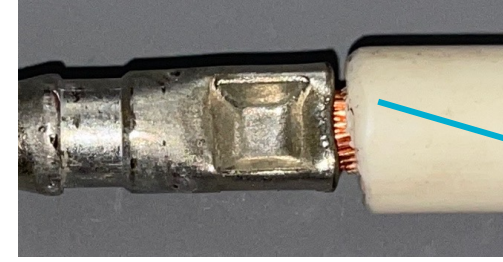
Wrong Crimp Tool

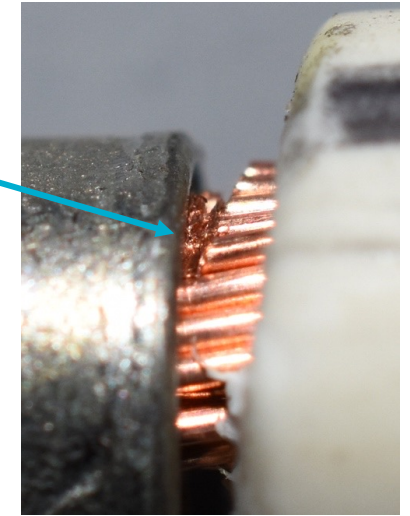
Cut Strands
Wrong strip tool?

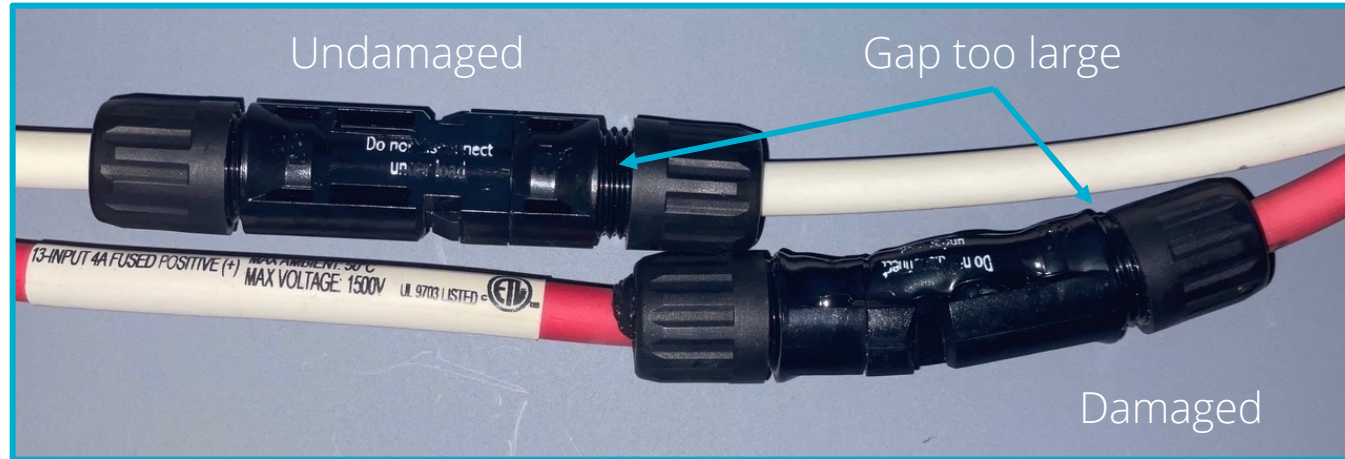
Bad crimp

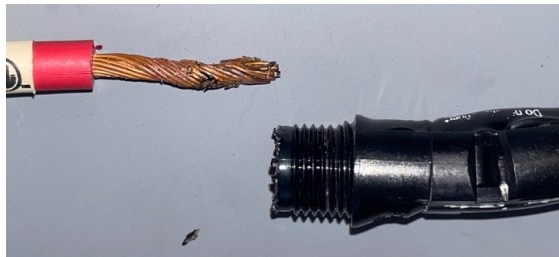
Proper torque

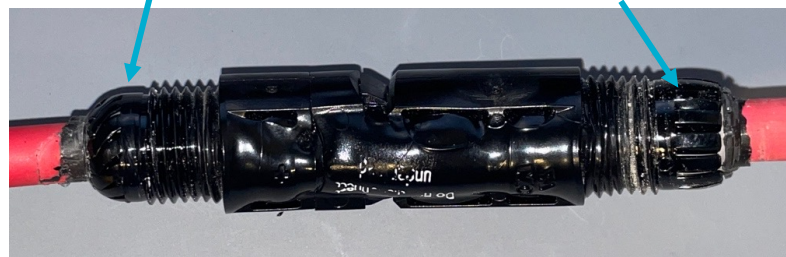
Improper torque

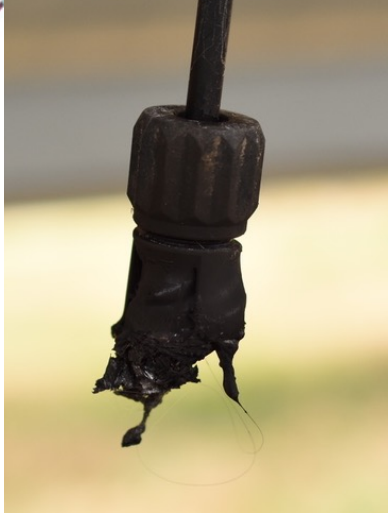
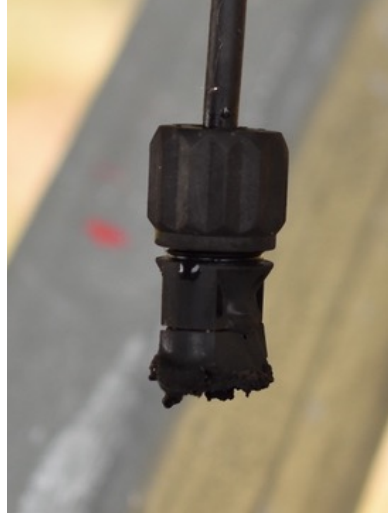
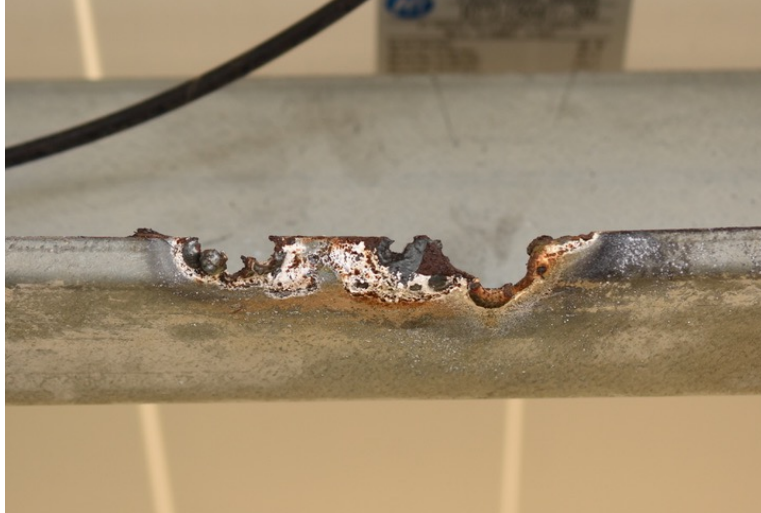
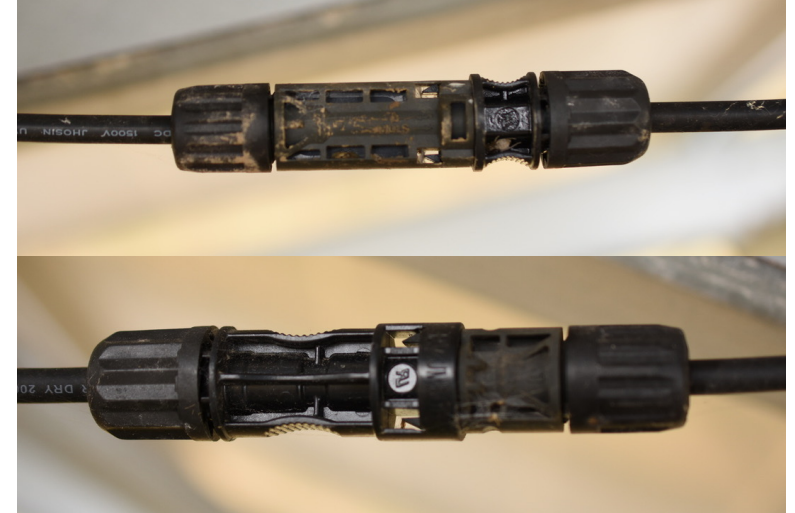
- Field-made jumper to accommodate a module replacement
- Cable routing left connectors laying in trays where they could be submerged
 - connectors are IP68, but....only if they're assembled correctly
- Electrical arc to racking

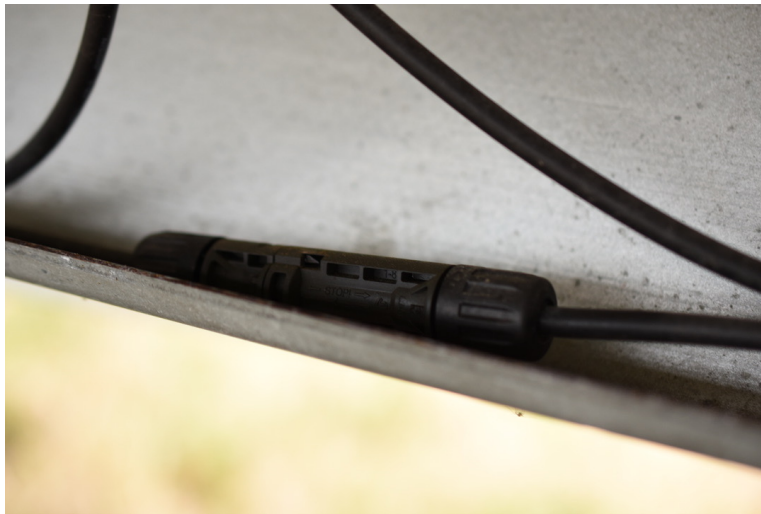
- Cross-mating between replacement modules
- Single module model, two j-box & connector assemblies
- In total, four different connectors observed on site
 - Original module – high #'s
 - Replacement module – low #'s
 - Home runs & harnesses – med #'s
 - Field repair – very low #'s
