# Connector Failures: Field and Lab Findings

**Connector Reliability Across the US Solar Sector**

**SETO CPS Agreement # Sandia 38531 and NREL 39035**

07/17/2024

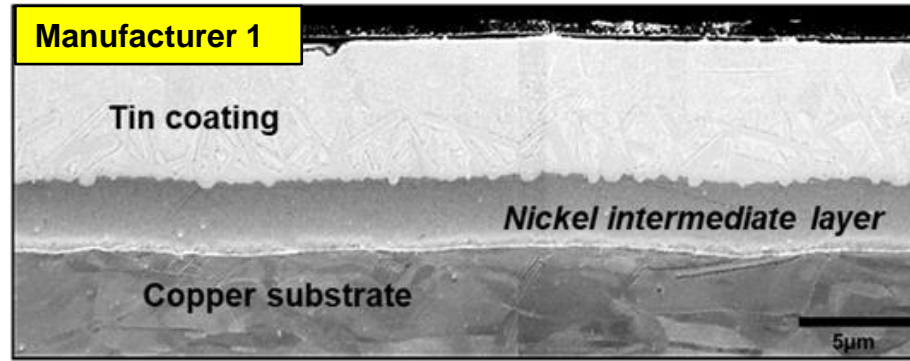
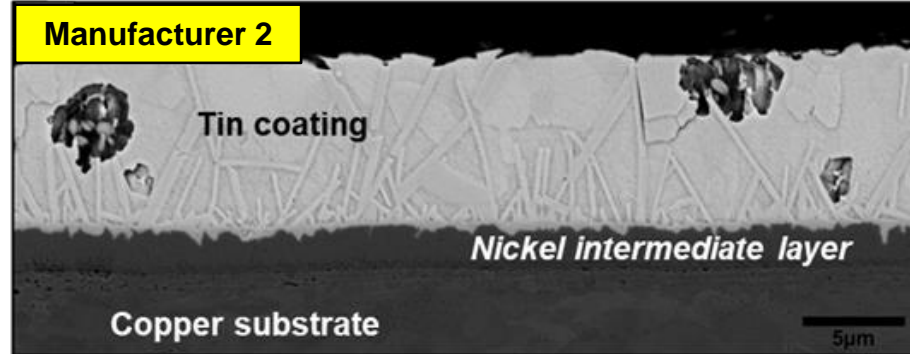
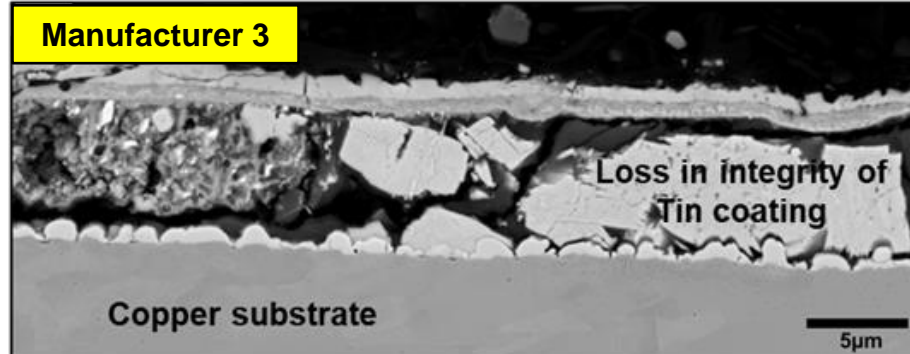
Findings from this study have shown evident variability in structure and integrity of coating layers in commercially available connectors

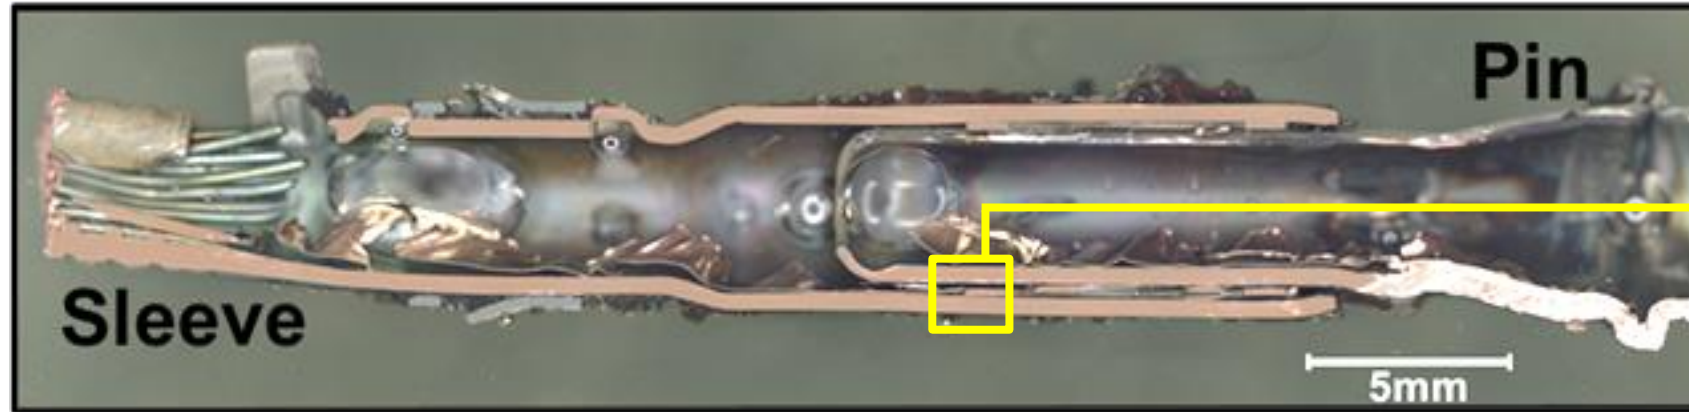
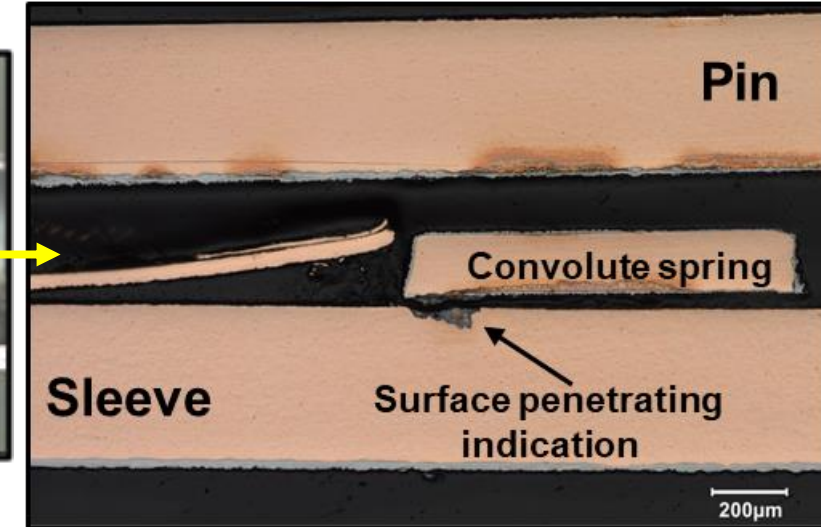
Mounted and polished cross section of connector from field

Contacting surfaces of failing connectors show signs of oxidation and local melting at contacting surfaces

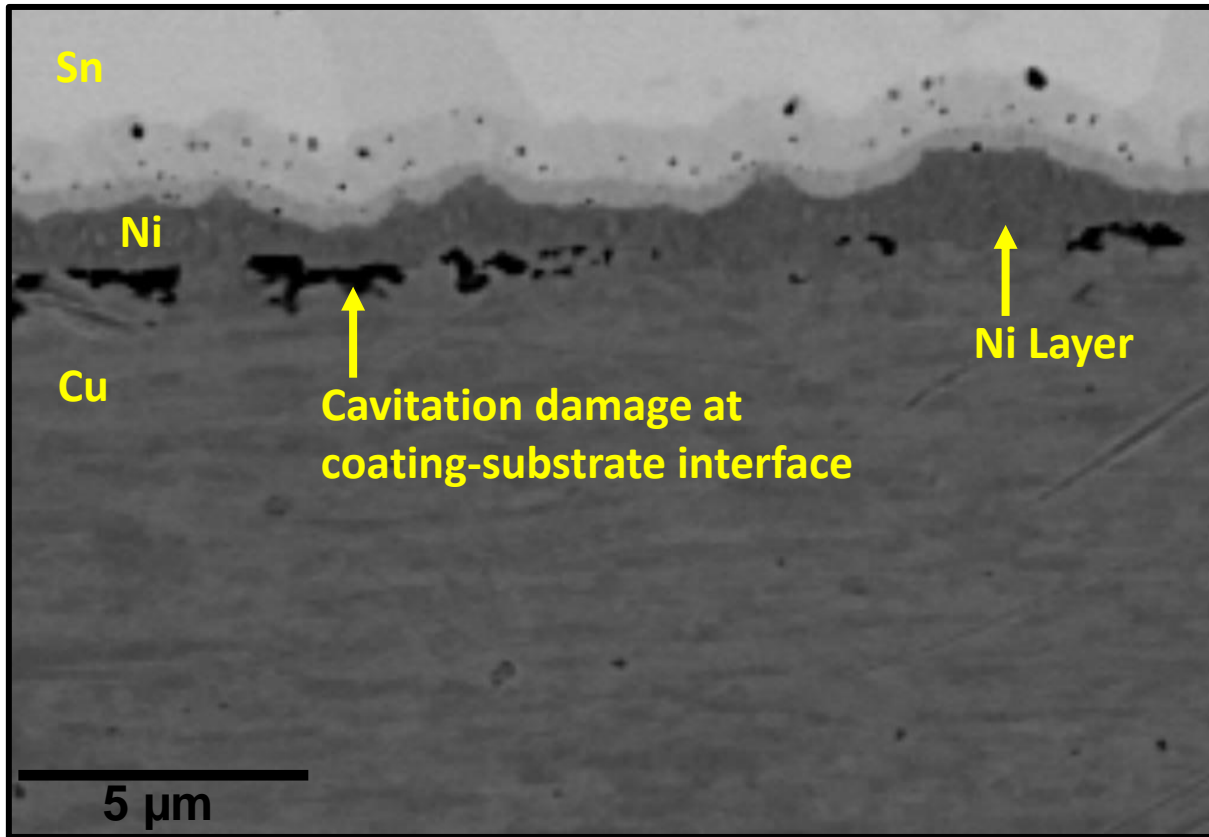
Sub surface void formation

Evidence of coating degradation during service observed at contacting surfaces. Such degradation mechanism may be a precursor to sub-surface oxidation and higher resistance at contacting surfaces, leading to eventual failure

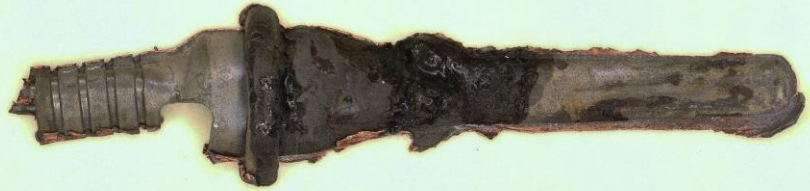
Pin- outer surface

Contact surfaces of failing connectors are dull and inner surface of sleeve show presence of surface features

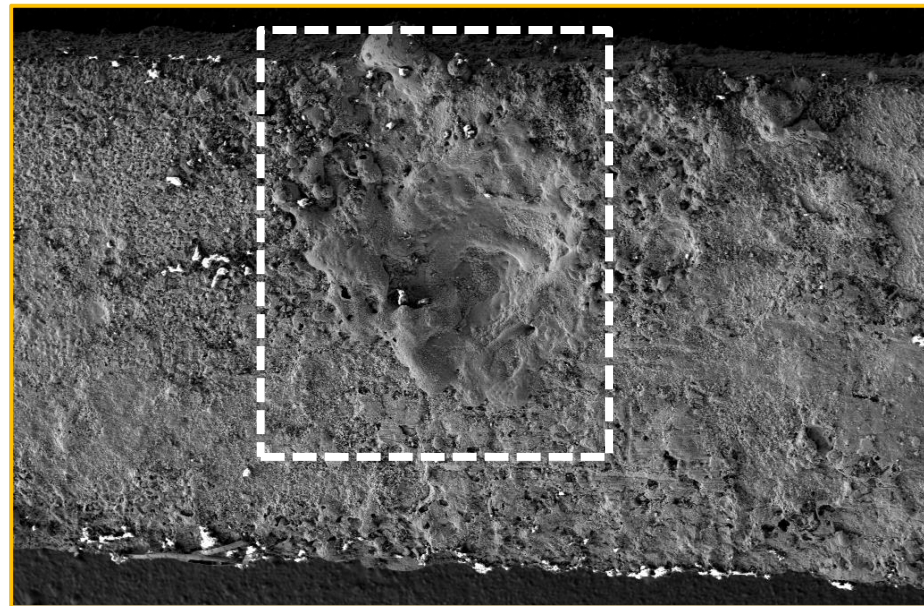
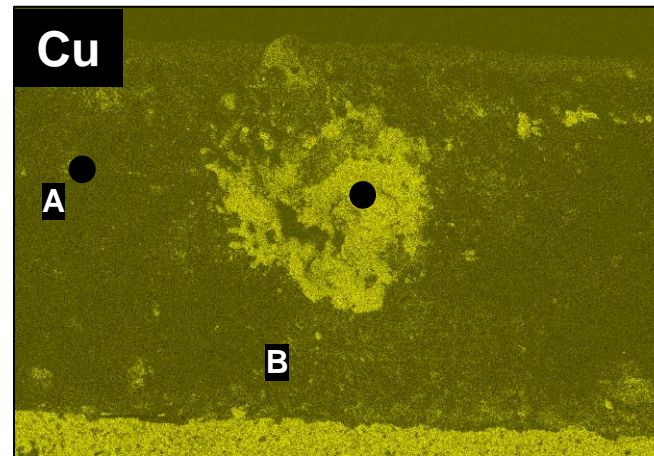
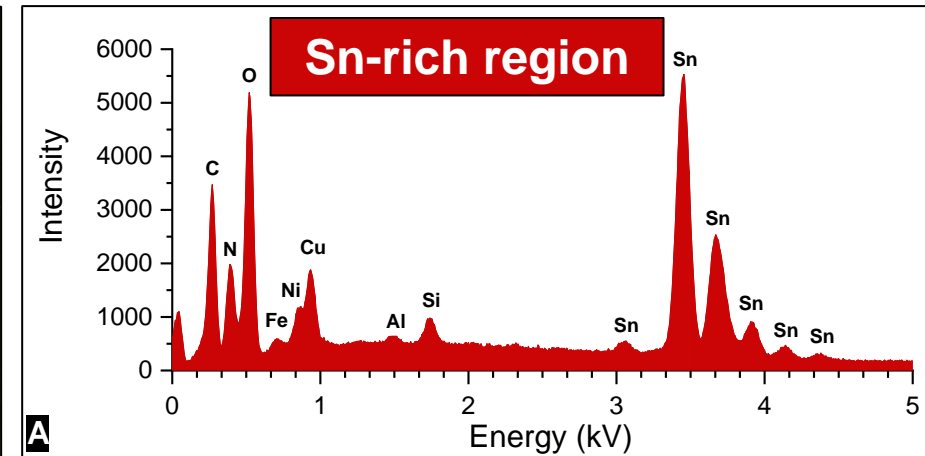
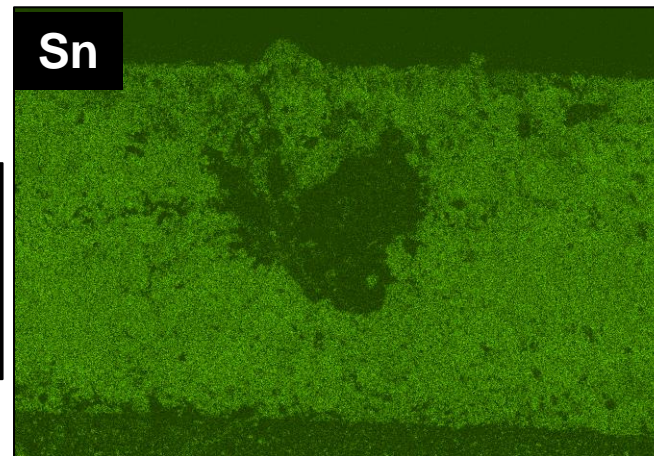
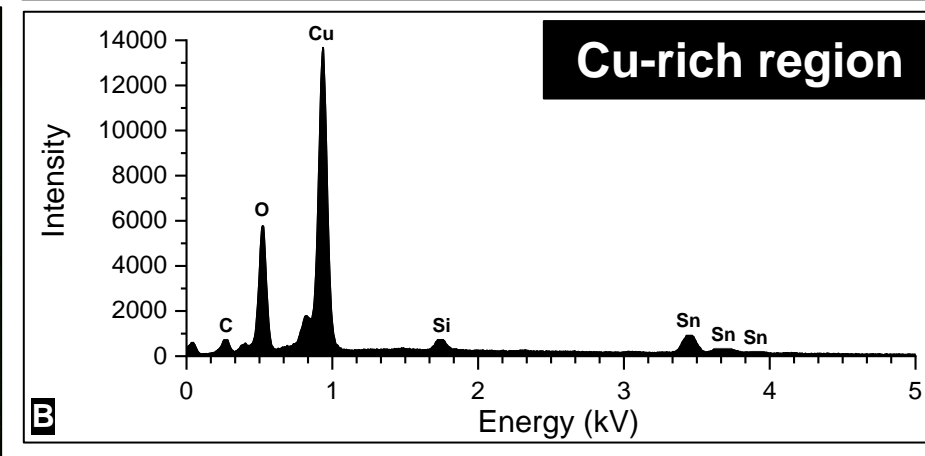
Sites with loss of Sn surface coating and local melting

EDS analysis clearly shows loss of Sn surface and melting of Cu (melting point 1,984°F or 1,085°C) suggesting a significant spike in local temperature
