# SANDIA REPORT

SAND2014-0602C

## Corrosion and Erosion Behavior in Supercritical CO<sub>2</sub> Power Cycles

Darryn D. Fleming, James J. Pasch, Thomas M. Conboy, Matt D. Carlson, Alan M. Kruizenga

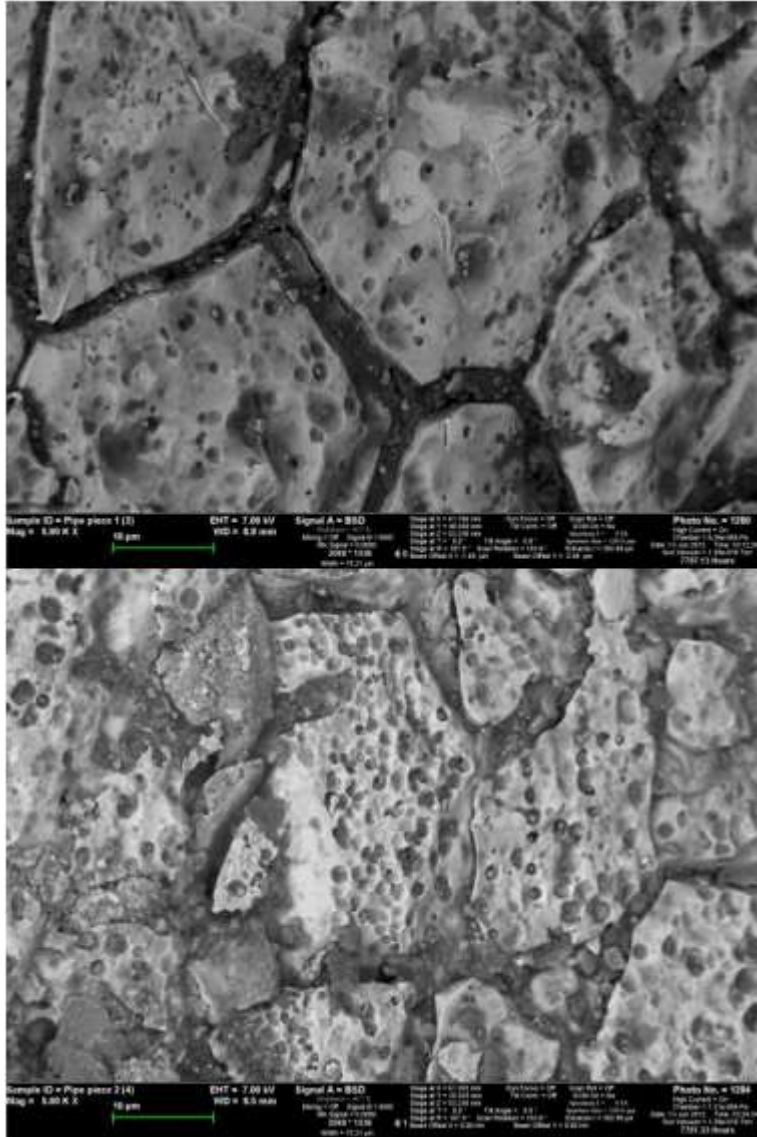
This analysis showed that the in-service pipe contained evidence of intergranular attack along the grain boundaries and pitting on the grain surfaces, as shown in Figure 2-1. These conditions were identified using a low-energy Backscatter electron imaging (BEI) SEM. There was a noticeable deposit in the intergranular trenches. Upon further analysis with EDS, the material was concluded to be carbonaceous. These results raised concerns that S-CO<sub>2</sub> may be influencing the apparent materials degradation observed. Additional preventative maintenance pipe sampling were planned to gain further insight into these data.

Figure 2-1: Two SEM images of the in-service SS 316L piping showing significant intergranular corrosion and pitting.

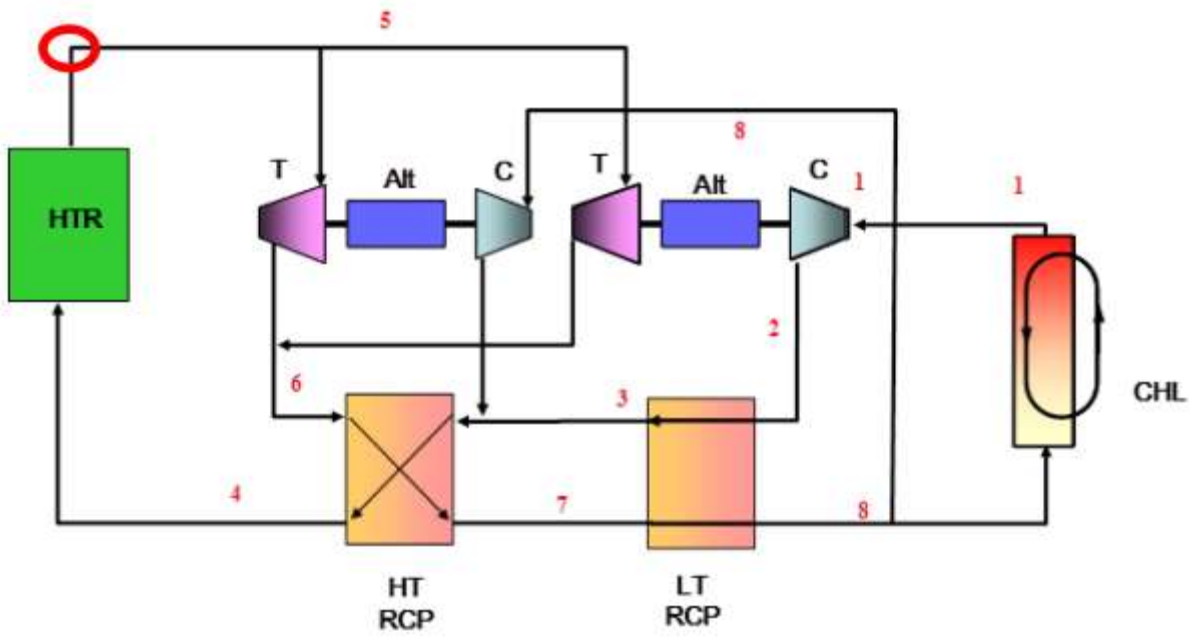
(2a)

In early May 2013, the Brayton team decided to obtain a sample from the GEN IV S-CO<sub>2</sub> RCBC loop. It was determined that the leg that had the highest temperature should represent conditions where corrosion would be the most severe in the loop. The sample was taken from the heater outlet indicated by the red circle in Figure 2-2 (a). The sample was cut using a low-speed reciprocating saw to avoid sample contamination from cutting oils. Cross-sectional microscopy was used to gauge the depth of the affected base material to quantify the depth of the intergranular attack initially found in fresh pipe Figure 2-2 (b) shows the physical location of the sample taken from the loop and the actual sample is shown in Figure 2-2 (c).

Figure 2-2: Sample location in schematic view (a) Sample location in physical view (b), corrosion sample removed (c).

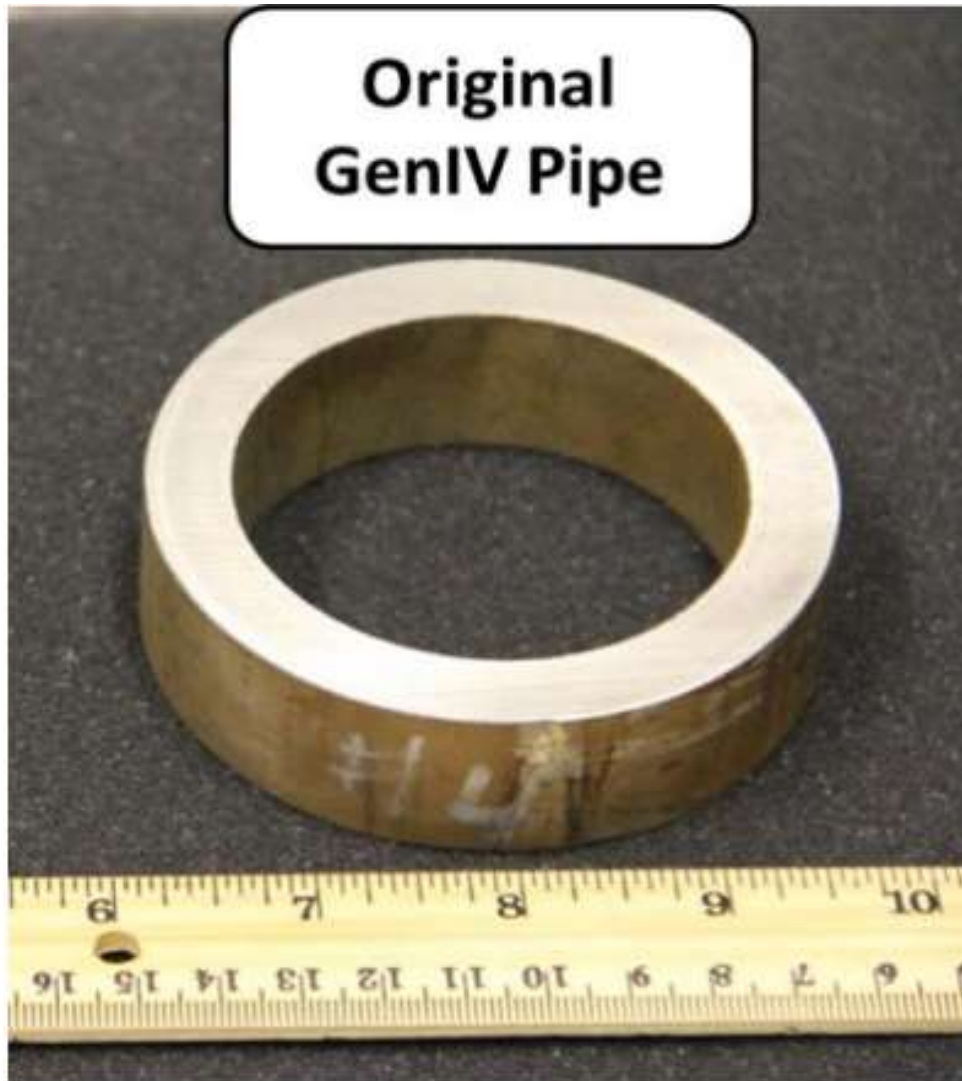
(2c)

It was apparent that the inside diameter of the pipe exhibited uniform intergranular attack to a depth of  $15\mu\text{m} \pm 4\mu\text{m}$ . When analyzing the sample at 500x, small amount of surface scale on the inside diameters (IDs) of the pipe were noticeable. Scale was not uniform, and only presented itself in small amounts on the IDs of the pipe, which indicated that corrosion was insignificant over the range of conditions and durations that the 316L were exposed to during system operation. Furthermore, the scale was not found in the intergranular trenches, but rather only on the surface, as shown in Figure 2-3.

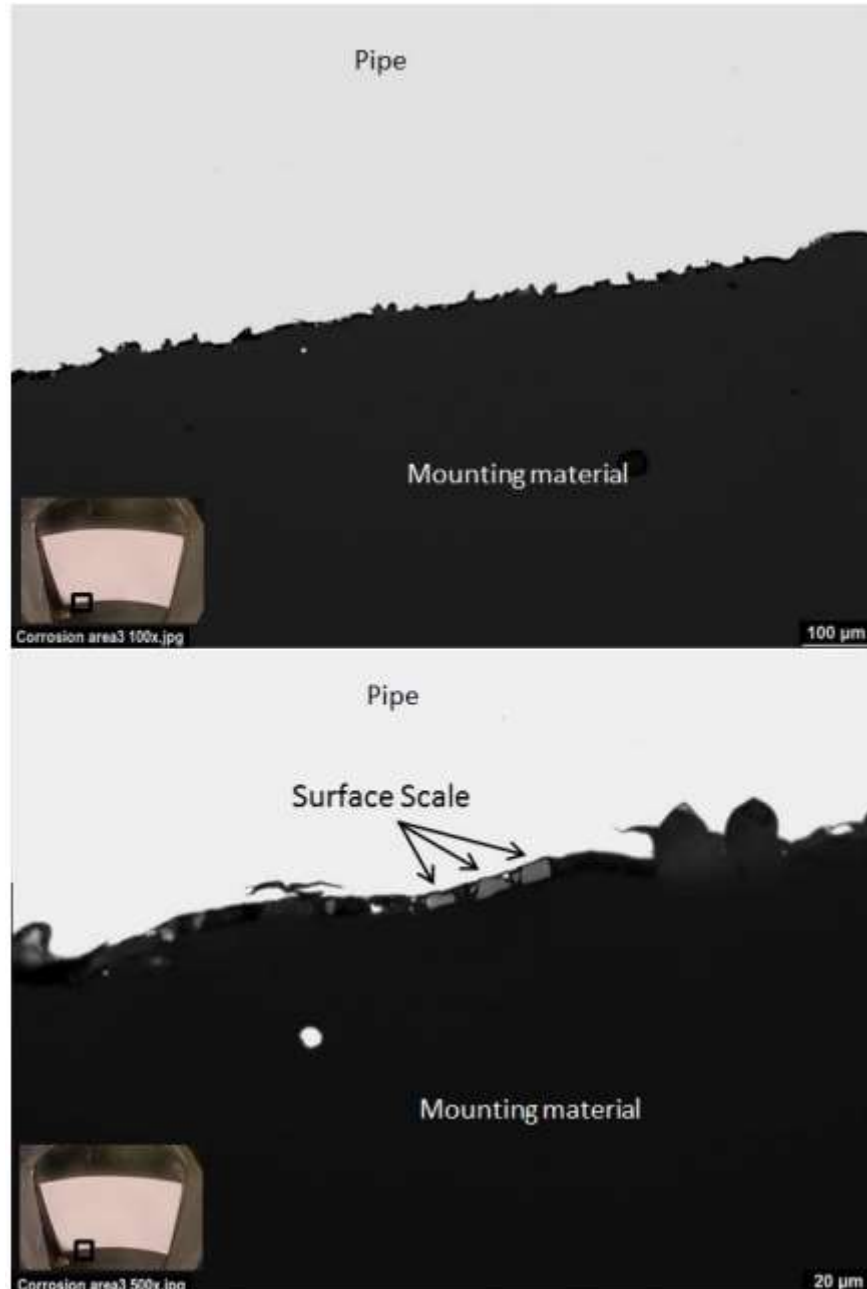
Figure 2-3: 100x (upper) and 500x (lower) images indicate surface features indicative of intergranular attack. Some surface scale was observed and will be identified using electron spectroscopy techniques.

Observations during the piping analysis raised questions regarding the as-received material quality and specifications obtained on the 316L piping. The original GEN IV piping is thought to be of lesser quality than domestic US piping material and possibly a counterfeit material. Details about the source of the piping and the level of manufacturing quality control are still uncertain. A pre-exposed material sample to establish a baseline was not secured, despite repeated requests of the manufacturer. In spite of this lack of baseline data it is thought that the

pickling process, used in removing surface scales during manufacturing, resulted in the grain boundary trenching.

In view of this information, SNL has currently benchmarked all newly installed SS 316L pipes in the RCBC loop to keep track of the number of hours in service and will continue periodic materials sampling. It will provide information for material requirements and pipe quality standards related to S-CO<sub>2</sub> systems. A mass spectrometer (Pfeiffer Vacuum Omni-Star) was installed downstream of the heater discharge and the turbine inlet to actively monitor the relative elemental compositions of materials being transported throughout the loop. These tests were initially benchmarked, and the details of these tests will be presented.

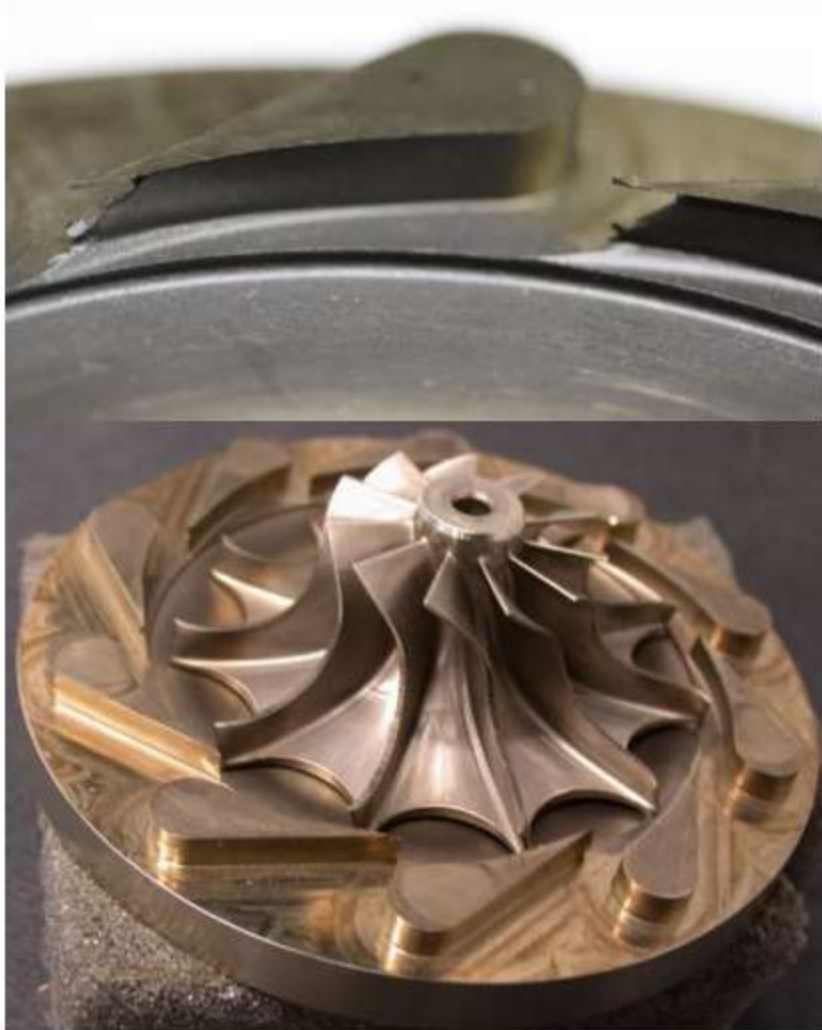
During the rebuild of the turbomachinery, it was noticed that the turbine wheel and nozzles showed significant erosion, which was thought to be due to particulate matter in the flow stream. The turbomachinery continued operation for five months until it was removed to undergo analyses that included microscopy, SEM, and EDS. Figure 3-1 shows the substantial amount of erosion on the turbine nozzle and turbine. Another area of high velocity flow and erosion is the compressor discharge. Inspection of these components revealed an absence of erosion as shown in Figure 3-2. It is very important to note that were two-phase flow conditions exist such as the compressor inlet there has been no visible signs of erosion.

Figure 3-1: Turbine nozzle with substantial amount of erosion, and turbine wheel with placement inside turbine nozzle.

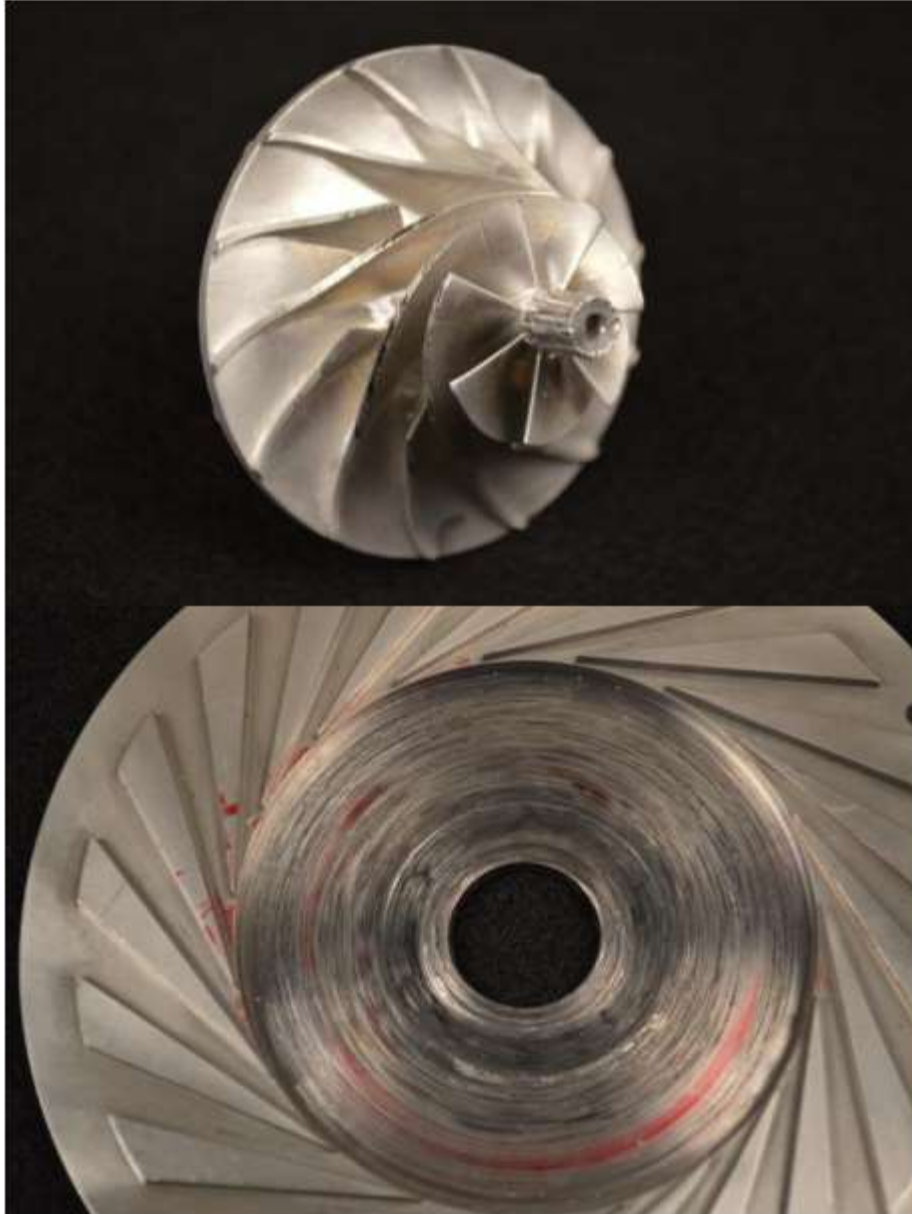
Figure 3-2: Compressor and compressor diffuser showing signs of no erosion or liquid impingent.

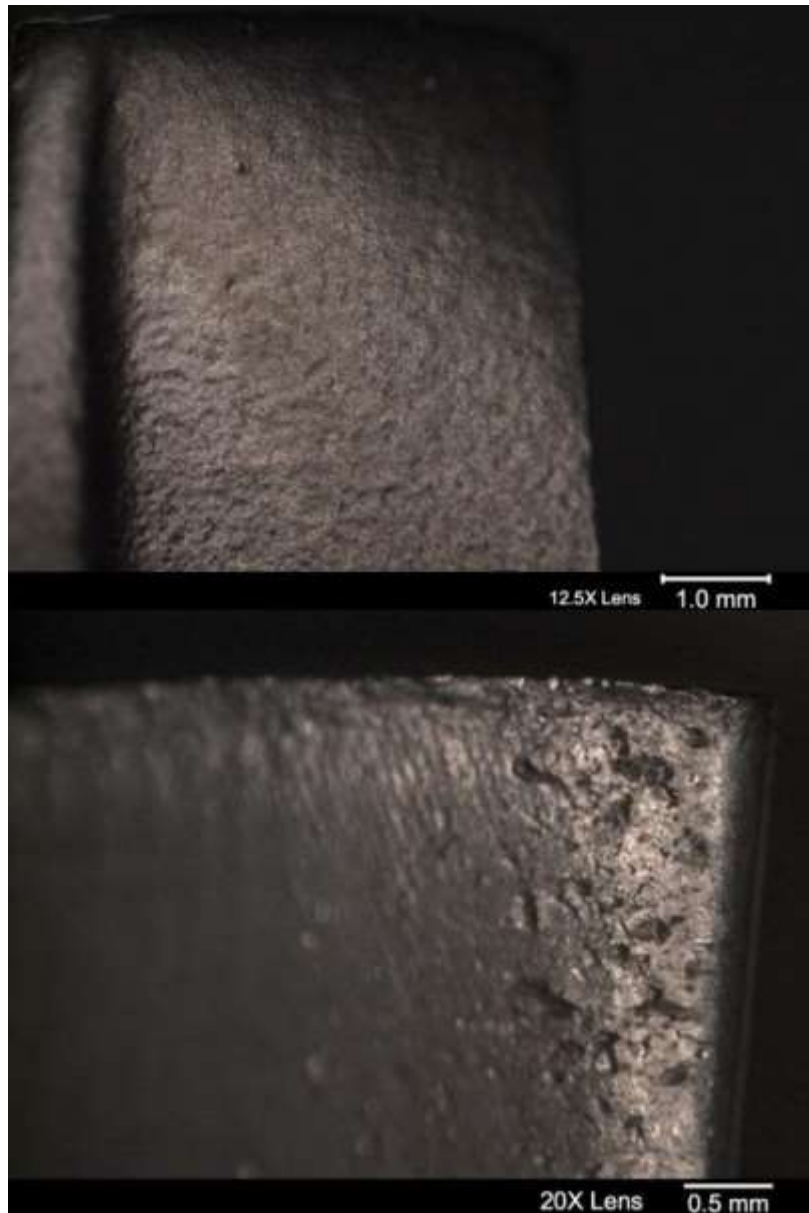
Turbine analysis was accomplished using microscopy and SEM/EDS. The results from microscopy showed substantial amounts of erosion. In addition, the inlet of the turbine wheel showed erosion that was apparently purely mechanical, resulting from particulate erosion, as seen in Figure 3-3. The reasoning behind the assumption of mechanical caused erosion is the fact that we operate with high temperatures that are far in excess of the critical temperature precluding the possibility of two-phase conditions that might lead to liquid impingement. Furthermore, erosion occurred primarily on the suction side of the blade.

Figure 3-3: Erosion on the Turbine, particulate erosion on turbine blade

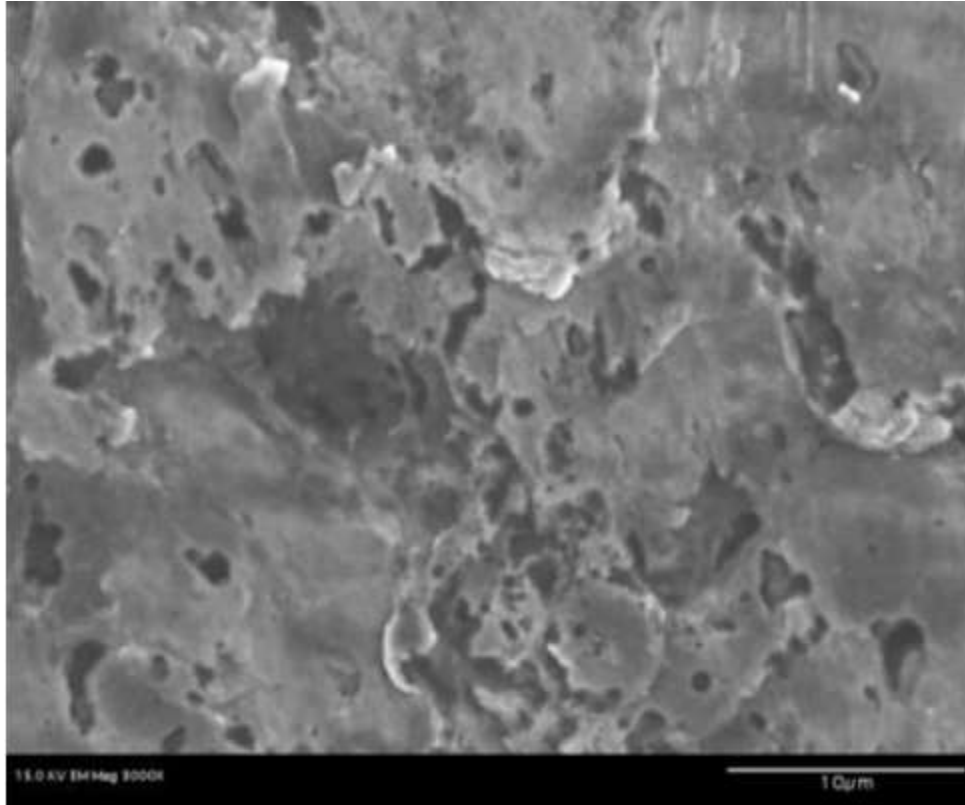
Results from the SEM, displayed in Figure 3-4, showed a different microstructure than what had been expected. There are indications of plastic deformation from abrasion, potentially due to a plastically deformed layer of some metal. To accurately identify the material causing abrasion, the material composition of C-22 (the material from which the turbine was constructed) was researched and compared it to the EDS measurement, as shown in Table 3-1. There was a high amount of Fe present on the surface of the turbine. The current best hypothesis is that small shavings of Ferritic steel may be the cause of the erosion.

Figure 3-4: SEM showing different microstructure

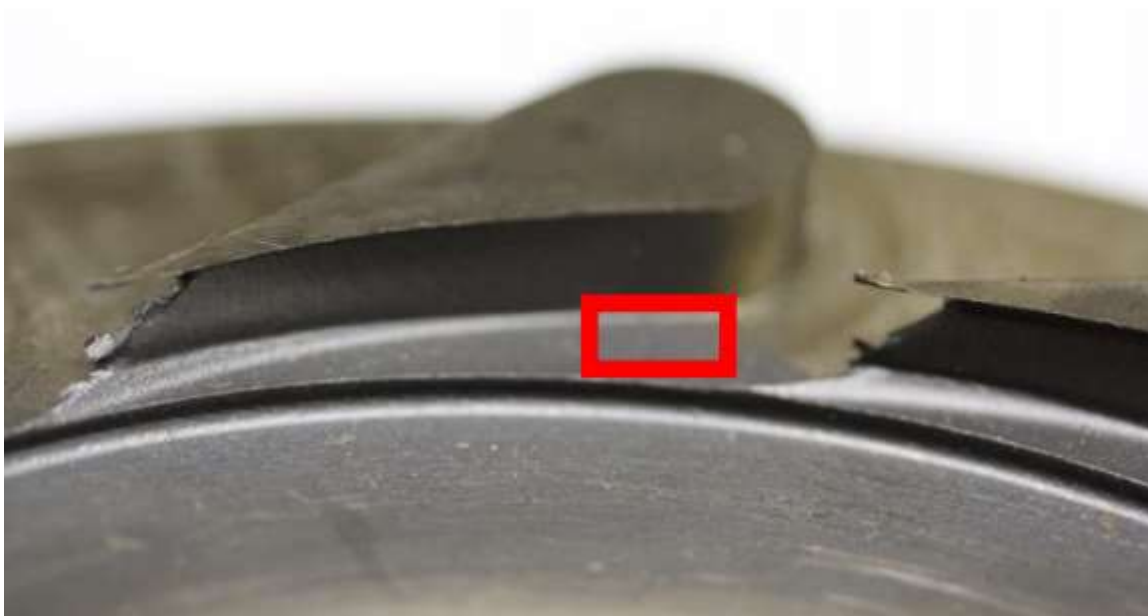
Visual inspection of the sample showed extreme wastage. Figure 4-1 shows a channel eroded out of the nozzle the height of the inlet of the turbine vane.

Figure 4-1: Turbine Nozzle with undercut and the EDS sample location represented by red square

Following these initial observations, the nozzle underwent analysis using EDS on the undercut of the nozzle. Because time would not permit sectioning the nozzle with a cutting technique, a similar location was chosen for analysis (See Figure 4-1). The EDS analysis showed that there was significant iron enrichment present on the surface, as well as a decrease in Ni. As shown in Table 4-1, the iron content was 40.7 by percent, which was significantly higher than the expected 23.8 percent.

Several general strategies are being employed to respond to erosion in S-CO<sub>2</sub> power cycles. This includes installation of an in-situ Thermostar mass spectrometer to identify loop contaminants. Also, erosion-resistant materials and coatings for use on the turbines and turbine nozzles associated with these prototype systems are being investigated.
