Exploring Diagnostic Capabilities for Application to New Photovoltaic Technologies

Enrico C. Quintana¹, Michael A. Quintana¹,
Kevin D. Rolfe¹, Kyle R. Thompson¹, Peter Hacke²

34th IEEE Photovoltaics Specialists Conference
June 12, 2009

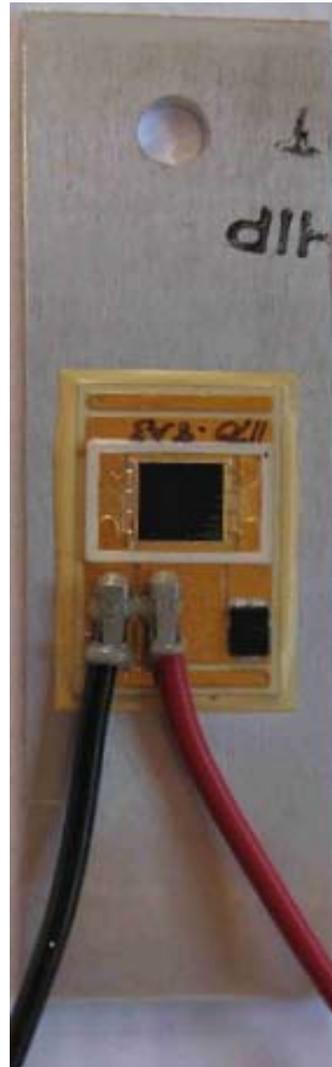
- Thermal management is critical for high concentration CPV
- Cell-to-substrate interface quality is key
- CT provided high resolution inspection of:
 - wire bonds
 - interfaces
- Cell-substrate interface study showed
 - slight geometry variation at perimeter
 - small voids in interface material

Optical image

CT scan video

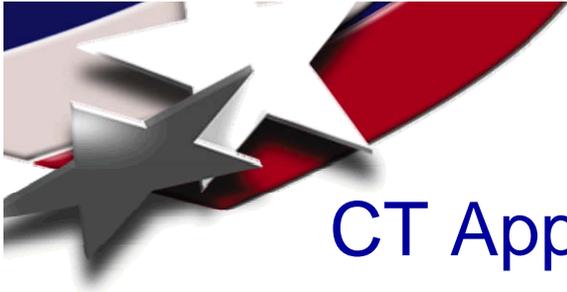
CT Application – Assessing Bond Integrity

Multiple bonds from sample

- Scanned with Phoenix Micro-Focus at 160 keV and 110 μ A
- Varian 2520 panel with lanex regular screen
- Cone beam reconstruction
- ~4.3x magnification, 30 μ m resolution
- Results fed back into R&D process

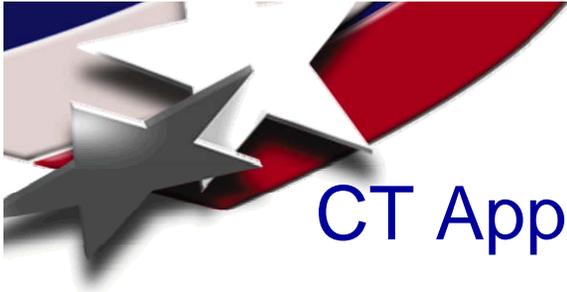
CT Application – PV Electronic Assemblies

- Capacitors in a potted electronic assembly
- Note the void between leads
- Moisture penetration into void will decrease distance between capacitor leads by 50%
- Vulnerability to failure increased

- 3D rendering of μ PV array
- CT allowed us to check for any gross defects in the PV assembly
- Integrity of the adhesive bond between the cells and the substrate

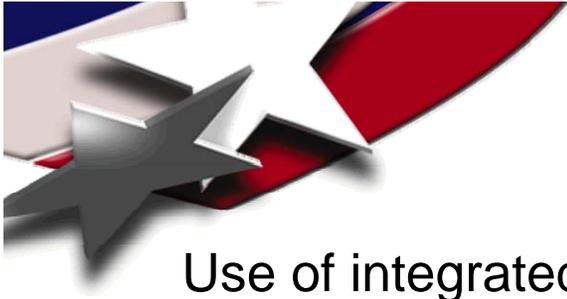
Innovative Module Assembly

Use of integrated backsheet layers

- Integrated foil conductor forms circuit
- Integrated dielectric layer
- PET/PVF backsheet

Integrated layer bonds directly to cell metallization on cells

- Cell-to-circuit bonding using solder or electrical conductive adhesive
- May eliminate cell stringing process

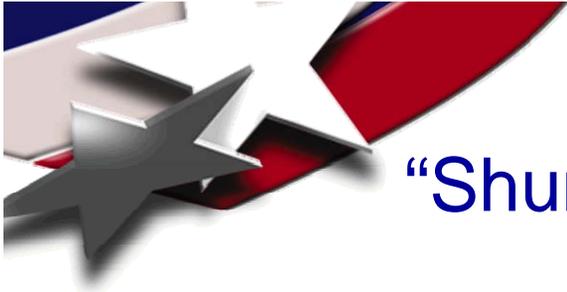
“Shunt-like” Behavior Seen in IR images

- Hotspots seen in forward bias, but not in reverse bias
- Same hotspots show up in reverse bias when a single cell is isolated with leads
- Destructive failure analysis revealed no apparent explanation for the shunts
- Significant effort without conclusive results can hamper development costs!

Shunts showed up after damp heat testing

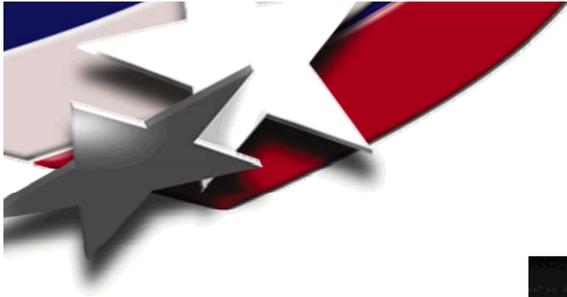
CT Identified Problem; Cross-sectioning Confirmed

- CT detected a pattern: single cell mini-modules shunting in the region where the n-busbar crosses the Cu etch line
- CT detected irregularities with copper foil-to-cell spacing throughout
- Cross-section revealed the Cu foil very close the top of the N-busbar on the edge of the cell
- Contact between the n-busbar on the cell and the P-polarity of the Cu foil would cause shunting--an edge pinch-off phenomena is confirmed

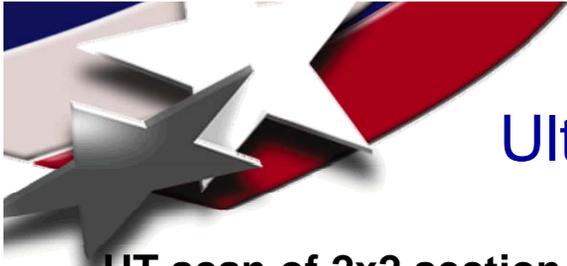
UT scan of 2x2 section of test sample

Ultrasound and Electroluminescence Results

- EL indicated inactive regions (possibly high resistance) around cell perimeter
- Ultrasound applied to examine bonds within the laminate
 - through transmission technique
 - low acoustic transmission indicates unbonded regions
- UT clearly identifies electrical bonds/disbonds (including kissing disbonds)

- EL image of single cell from above sample
- Dark blue areas indicate inactive regions

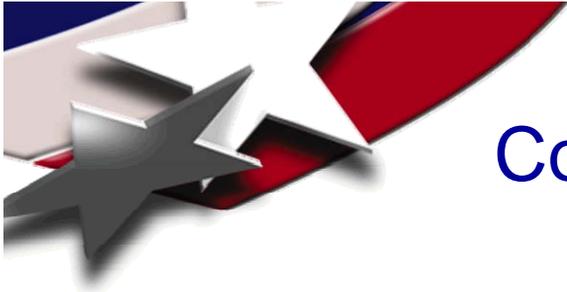
Correlation of UT and EL Images

- X-ray confirmed that bonds and bond locations were in place
- Disbonds in UT images correlated well with inactive regions on the perimeter on the EL image
- Good bonds in UT images correlated with active regions on EL
