# LONG-TERM PERFORMANCE AND RELIABILITY ASSESSMENT OF 8 PV ARRAYS AT SANDIA NATIONAL LABORATORIES

Jennifer E Granata, William E Boyson, Jay A Kratochvil,  
and Michael A Quintana

Sandia National Laboratories

Presented at the 34<sup>th</sup> IEEE PVSC

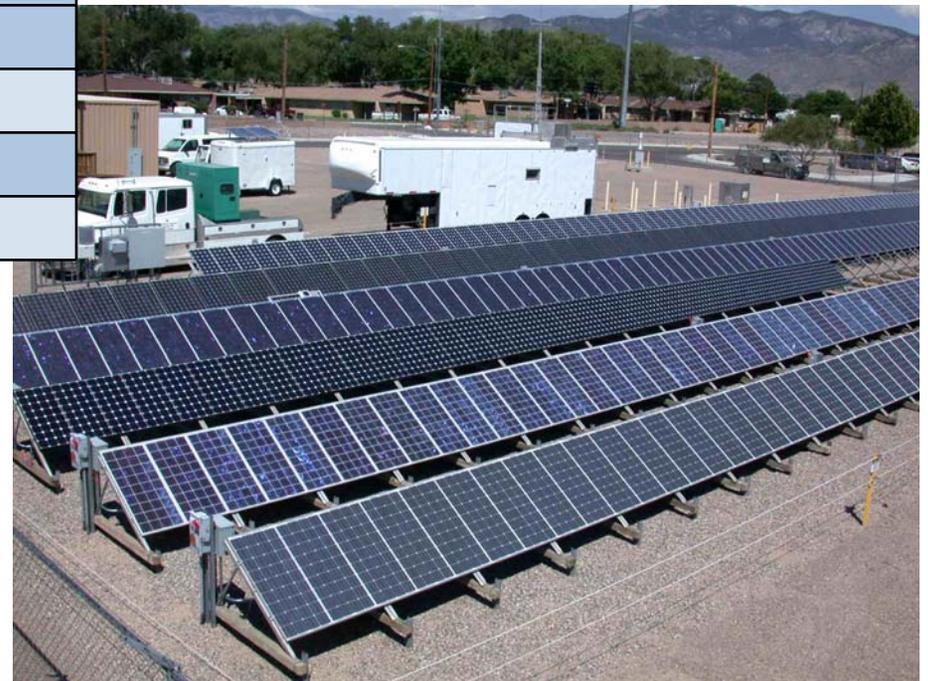
Array #	Tech	Strings	Modules /String	Instl. Date	Name Plate Rating (kW)
1	a-Si	70	1	2002	3.06
2	c-Si	4	20	2004	6.00
3	mc-Si	4	22	2005	7.04
4	mc-Si	4	22	2005	7.04
5	c-Si	6	7	2005	9.31
6	c-Si	3	28	2005	7.04
7	a-Si	3	2	2006	3.26
8	c-Si	3	21	2006	7.92
9	c-Si	24	12	2008	50.50

***Primary focus of this presentation:***  
**Six silicon-based PV arrays at Sandia's DETL**
