ES2010-90040**FREEZE-THAW TESTS OF TROUGH RECEIVERS EMPLOYING A MOLTEN SALT WORKING FLUID****Gregory Kolb**Sandia National Laboratories
Albuquerque, NM, USA**Clifford Ho**Sandia National Laboratories
Albuquerque, NM, USA**Brian Iverson**Sandia National Laboratories
Albuquerque, NM, USA**Timothy Moss**Sandia National Laboratories
Albuquerque, NM, USA**Nathan Siegel**Sandia National Laboratories
Albuquerque, NM, USA**ABSTRACT**

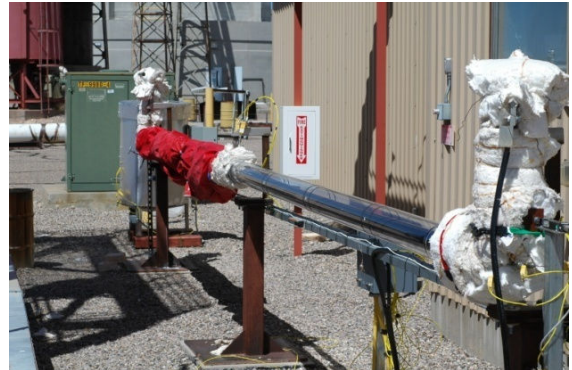
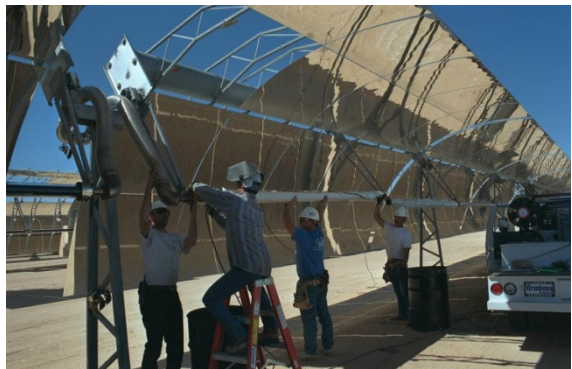
Figure 2 HCE freeze/thaw test rig in a 2-HCE configuration (top). The impedance heater electric connection can be seen at the top of the insulated standpipe. The standpipes approximate the expected orientation of the flex hoses during shutdown of a commercial plant (bottom), the time at which a freeze event is most likely. The HCEs are usually covered to prevent heatup due to one-sun exposure prior to first use (red cover on top, white cover on bottom).

The test rig consisted of one or two HCEs and two standpipes. The HCEs we tested are used in current oil-based trough plants (4 m long, 70 mm diameter cermet-coated absorber tube with a 2 mm wall, enclosed in a vacuum maintained by a 125 mm glass envelope). The standpipes at each end were made of the same material as the absorber tube. Their function was to maintain the HCEs full of salt as the salt shrank during solidification. They also mimic the orientation of the flex hoses at the ends of the solar collector assembly when the plant is shutdown (see Figure 2).

Electrical connections were placed at the top of each standpipe. When activated, a voltage was applied across the connections (6.7 V_{AC} RMS for the 2-tube configuration) to flow current through the standpipes and the HCEs and achieve the approximately 1kW of heating per tube defined by Kelly. Three thermocouples sensed salt temperature inside each 4-m HCE; one in the center, one located 15 cm inside from the left end and one located 15 cm inside from the right end, as shown in Figure 3. The inside thermocouples were not attached to the tube wall. Rather, they were loosely positioned inside the tube. Additional exterior thermocouples were spot welded to each end of the HCE (outside the glass envelope), and one of these was used to maintain a setpoint temperature using an on/off controller.¹ The bare standpipes were covered with several inches of fibrous insulation to reduce heat loss. The HCEs were supported by hanger bars, one attached at each end. When an HCE is heated from ambient to the typical trough operating temperature of 300 °C, the length of the stainless steel tube will increase approximately 1.2 cm and this

growth was verified by a potentiometer device mounted coaxially at each end. The hanger system was designed to allow the tubes to freely expand. If a hanger impedes growth, the tube could bend due to restrictive clamping forces. Since we wanted to understand whether salt-freezing alone could lead to tube bending, it was imperative for the expansion system to not cause significant bending over the temperature range for the tests. Successful operation of the expansion system was verified by heating the empty tubes to nearly 300 °C with no perceptible tube deformation.
