Critical, Cost-Effective Wind Blade Inspections Using Autonomous Inspection Systems

Dennis Roach, Ray Ely, Tom Rice, Josh Paquette
Wind Blade Reliability Center
Sandia National Labs

SAND2018-9339 C

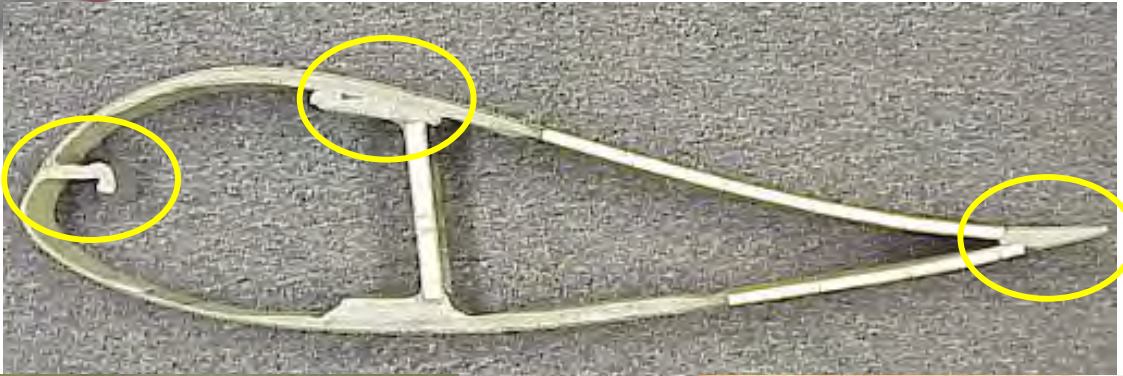
Inspection Areas and Flaw Types of Interest

Flaws include: Ply Waves
Delaminations, Adhesive
Voids, Joint Disbonds,
Snowflaking and Porosity

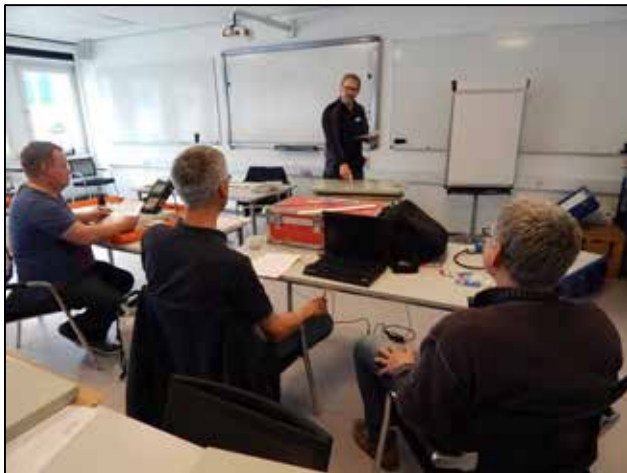
- 11 POD specimens with spar cap and shear web geometry
- Thickness ranges from 0.45" to 2.20" thick (with adhesive bond line)
- Blind experiment: type, location and size of flaws are not known by inspector
- All panels painted with wind turbine blade paint (match inspection surface)
- Performance of NDI – hits, misses, false-calls, flaw sizing, human factors, procedures

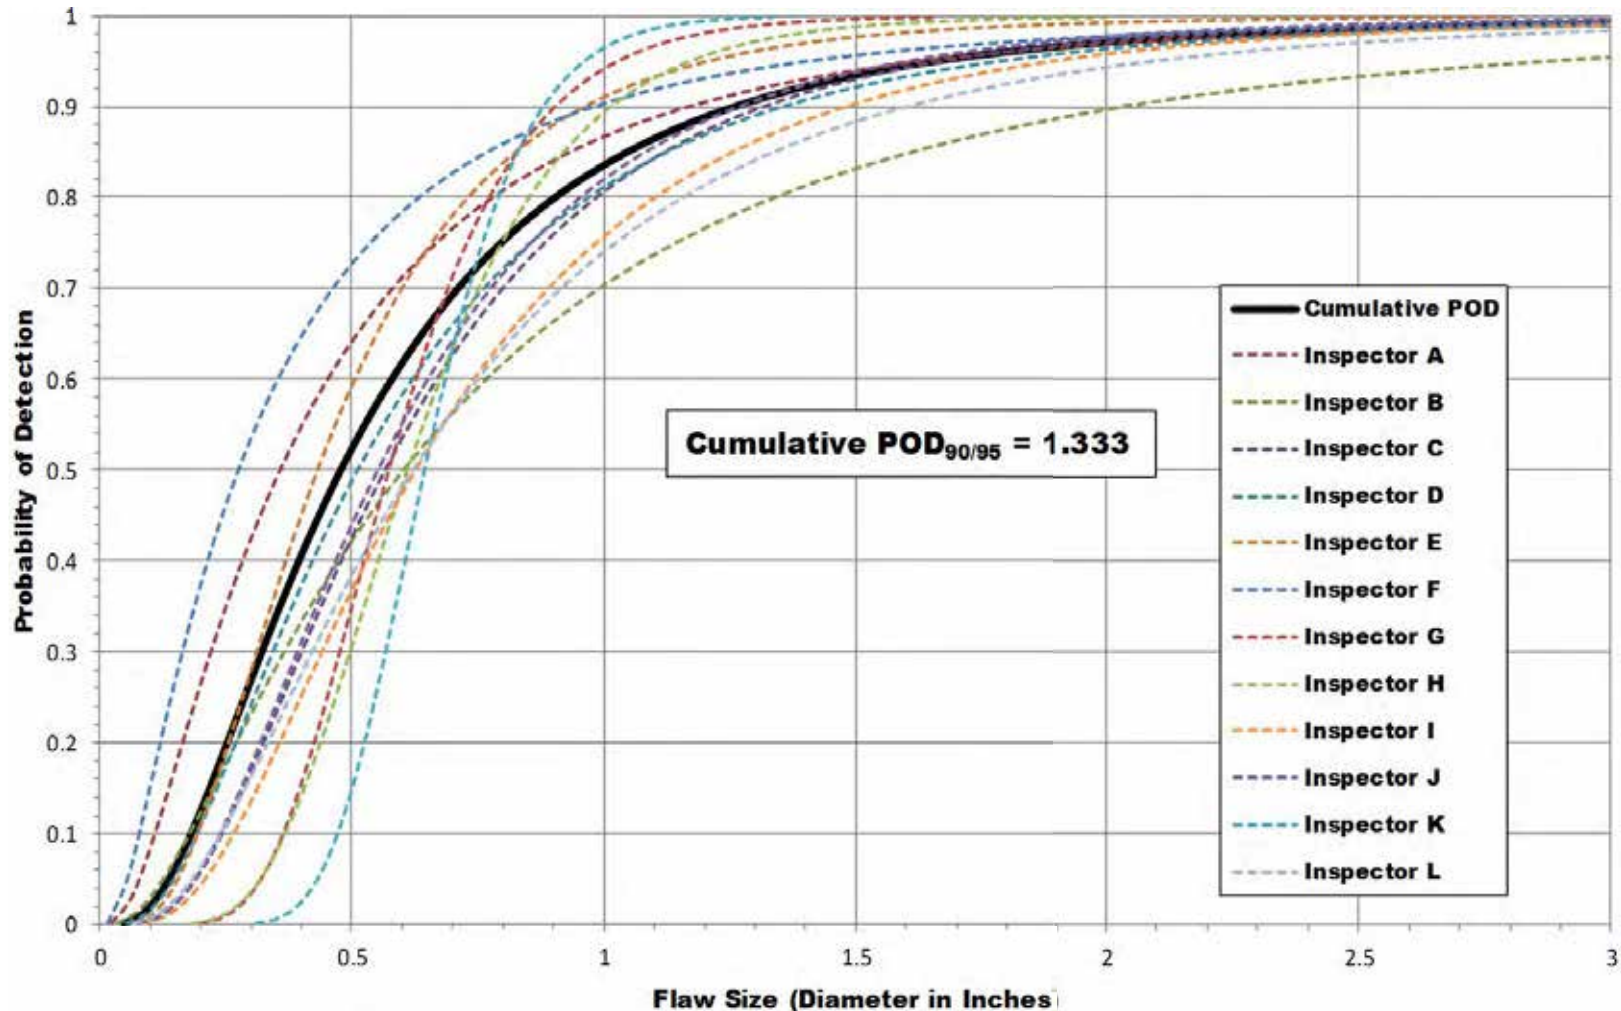
Wind Blade Flaw Detection Experiment – Individual Inspector and Cumulative POD Comparison

All Panels - Spar Cap with Shear Web and Box Spar Construction Types

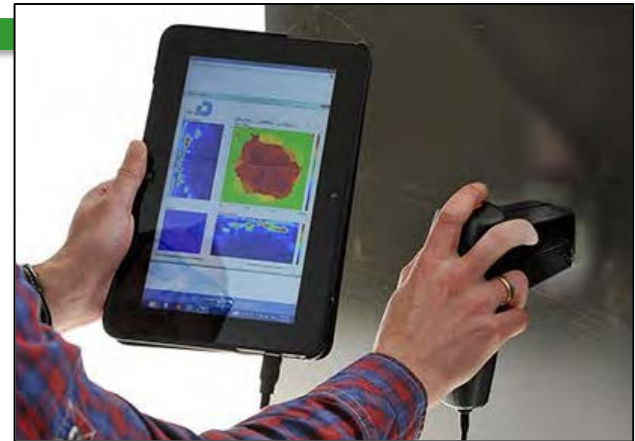
Robot with On-Board NDI System and Camera(s) for Real-Time Assessments

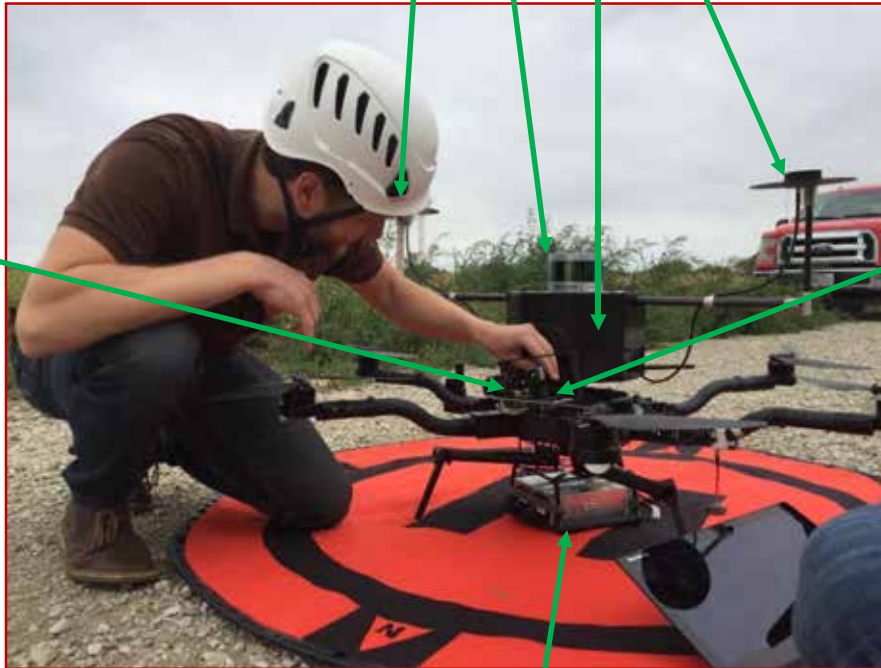
Thermography Inspection of Subsurface Flaws

Flir IR Camera

(320 X 256 pixels)

LiDAR and GPS Sensors &
Computer for Automated
Drone Controls

LiPo Batteries

Visual Inspection of Surface Flaws

Digital Camera

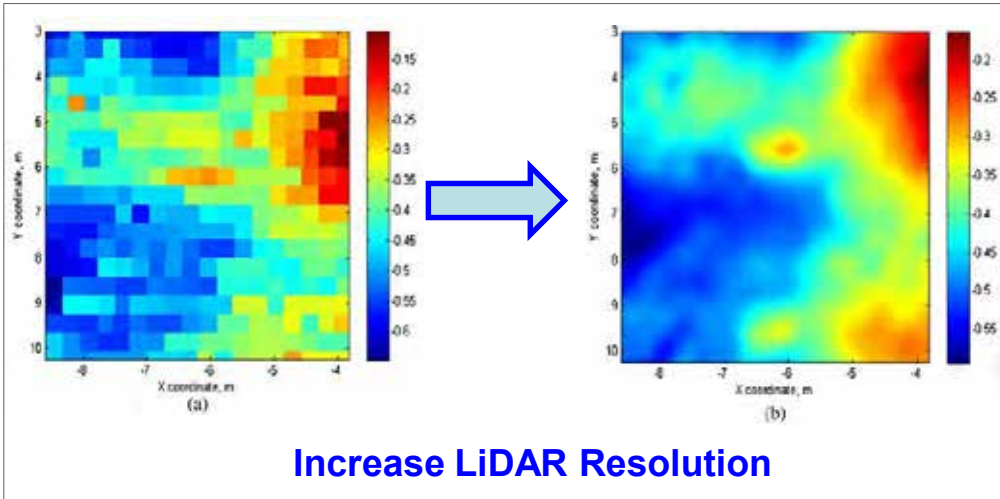
Use NASA's SuperResolution Algorithm to Process Data

Thermal Wave Imaging

Enables the drone to track relative position and orientation changes in order to measure IR data at an area of interest over time

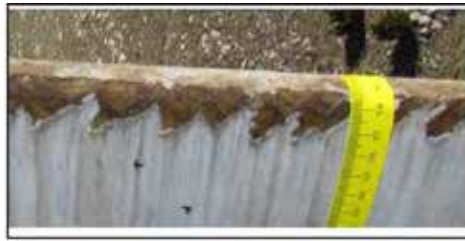
Establish Damage Severity Levels

High
LE erosion has penetrated into the blade structure exposing the underlying laminate of the leading edge.

Medium
LE erosion has removed the protective gelcoat and begun to penetrate into the bond and had exposed the underlying laminate of the leading edge.

Low
LE erosion has removed the protective gelcoat and begun to minimally penetrate into the bond.

Minimal
LE erosion has begun and appears to be superficially limited to the outer protective gelcoat.

Minimal
The leading edge shows beginning signs of LE erosion and is limited to the outermost, superficial layers of protective gelcoat.

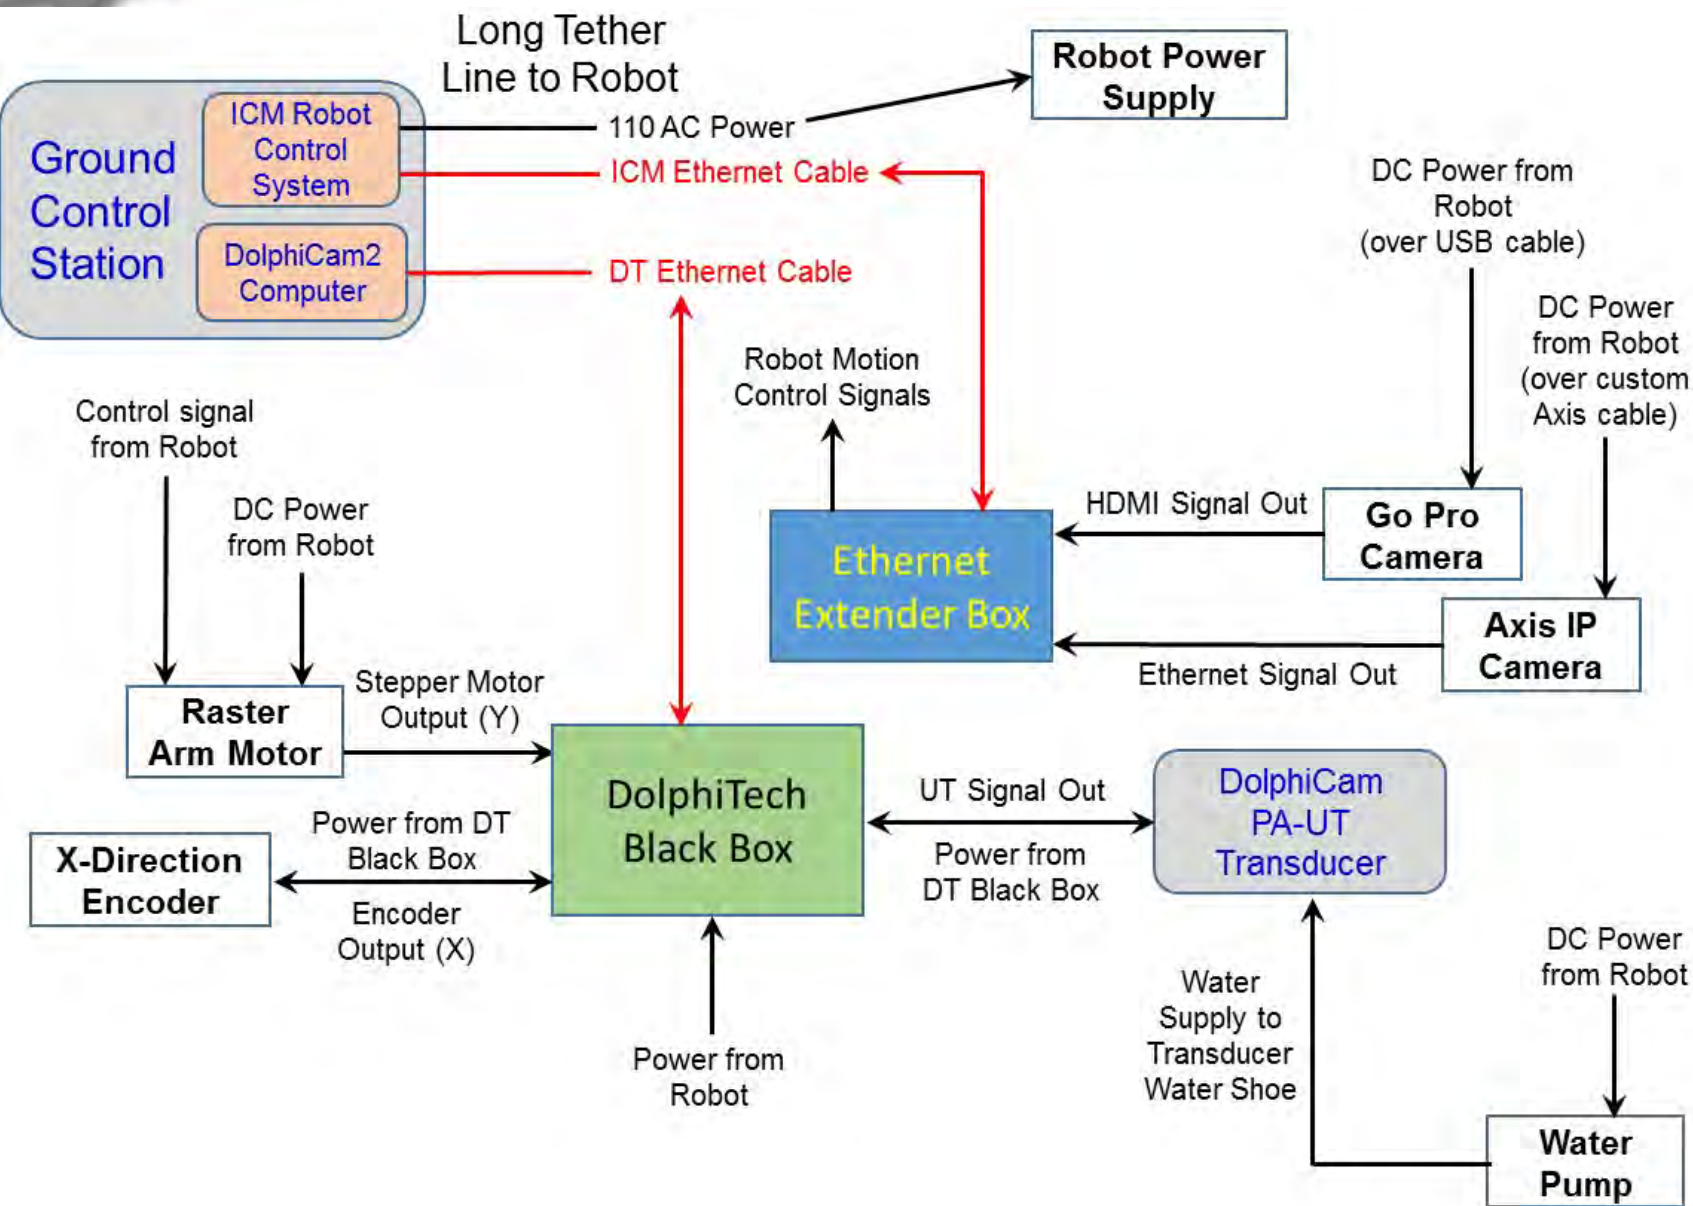
Robot-Deployed NDI System – Schematic of Power, Controls and Data Transfer
