# ***FY23 Status: Corrosion-Resistant Coatings on Spent Nuclear Fuel Canisters to Mitigate and Repair Potential Stress Corrosion Cracking***

## **Spent Fuel and Waste Disposition**

*August 10, 2023  
M3SF-23SN010207052  
SAND2023-09205R*

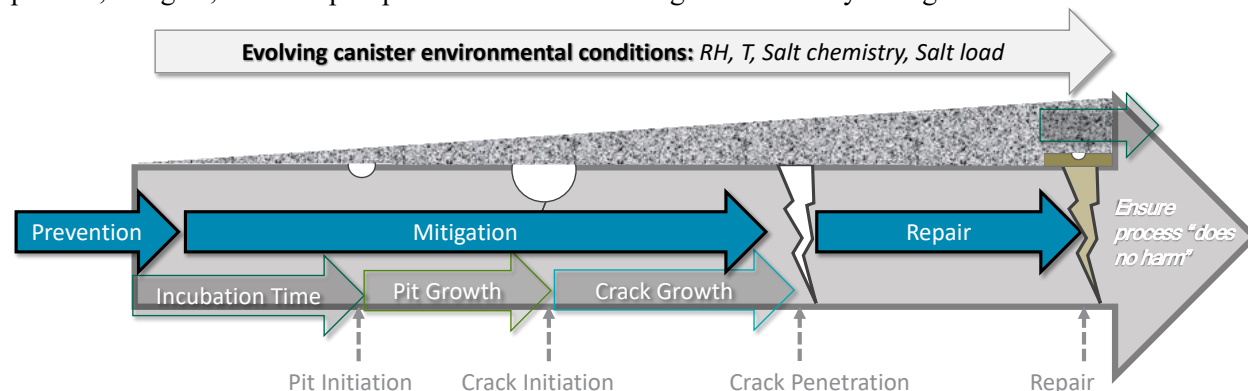
**Figure 1. Schematic showing where the mitigation/repair work fits in to the overall SNF dry storage canister SCC research at SNL as well as how prevention, mitigation and repair differentiate.**

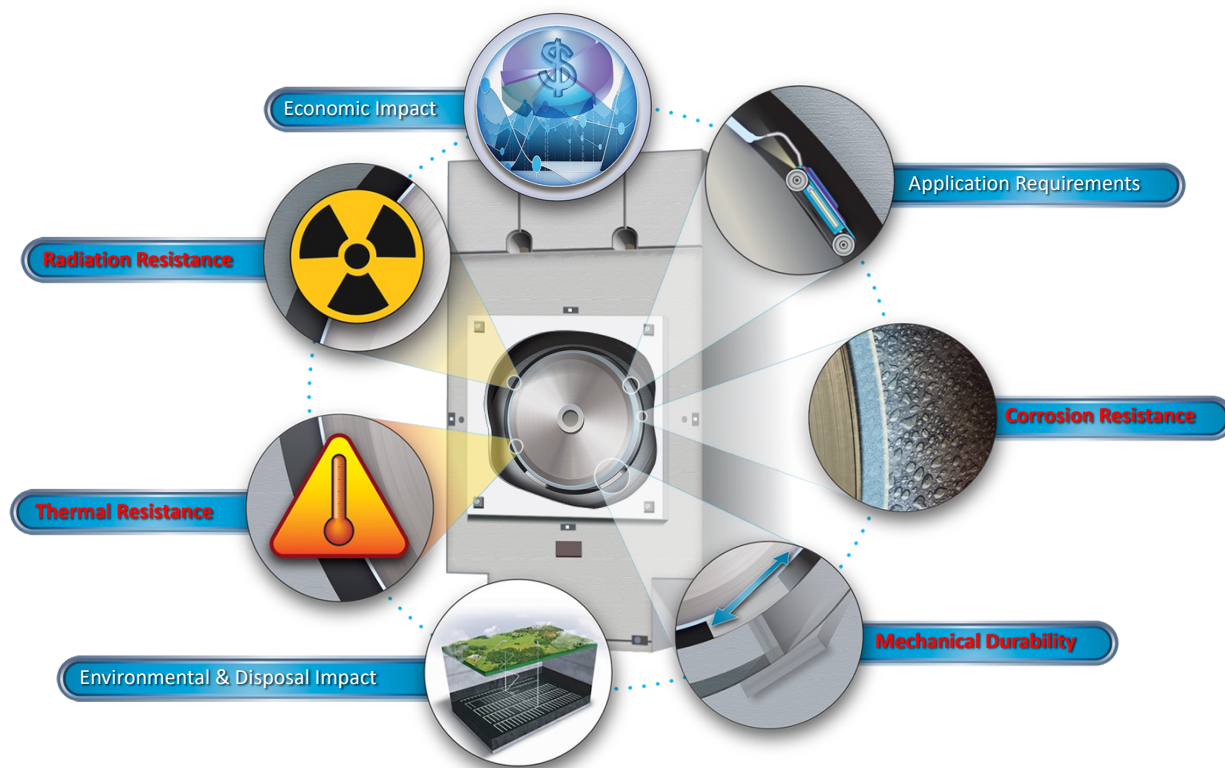
Figure 2. Image showing important considerations to determining if a coating could be effective for this application.

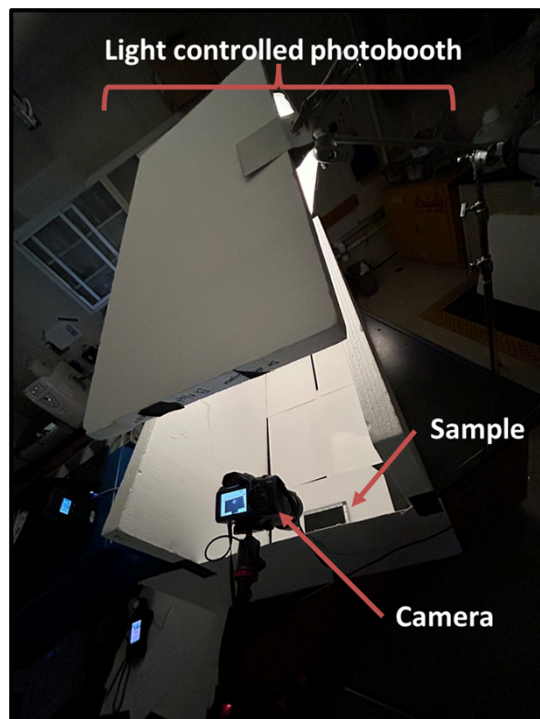
**Figure 3. Photobooth used to photograph the samples in a controlled light environment.**

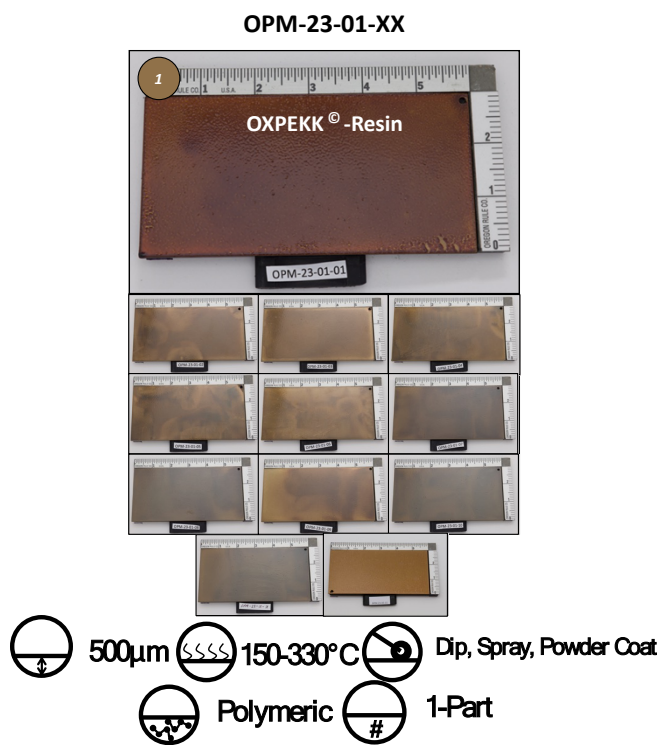
**Figure 5. Intake photos of OX-PEKK® coating samples OPM-23-01-01 provided by OPM. Also shown are basic attributes (approximate thickness, cure temperature, application methods, coating type, and number of components). *\*Note: OPM-23-01-01 was not used as it appears to have cured at a higher temperature, therefore OPM sent OPM-23-01-11. Because there was delay in the receipt of the coatings, OPM-21-01-15 was used in the radiation studies.***

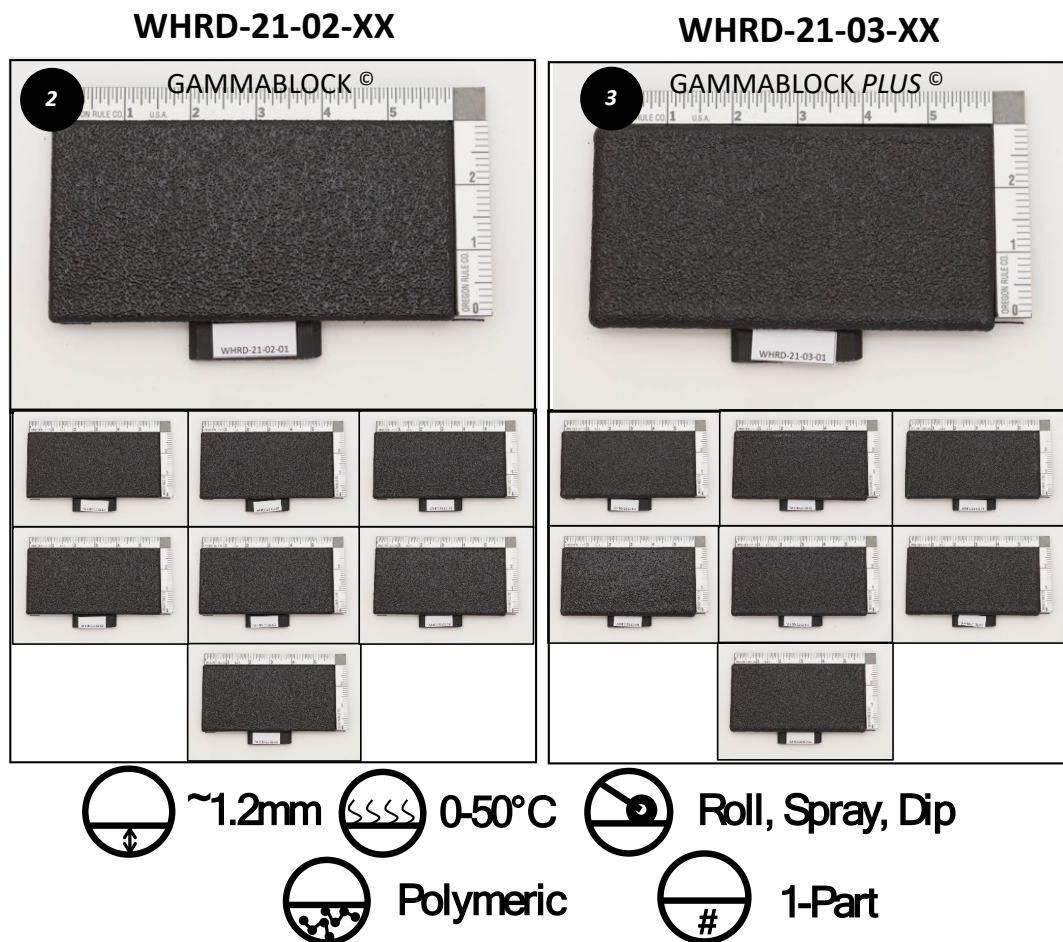
Figure 6. Intake photos of modified polyimide-polyurea-phenolic resin coating samples WHRD-21-02-XX and WHRD-21-03-XX provided by WHRD in FY21. Also shown are basic attributes (approximate thickness, cure temperature, application methods, coating type, and number of components). \*Note: No new samples were provided by WHRD in FY23, therefore untested samples from FY21 were used for radiation testing.

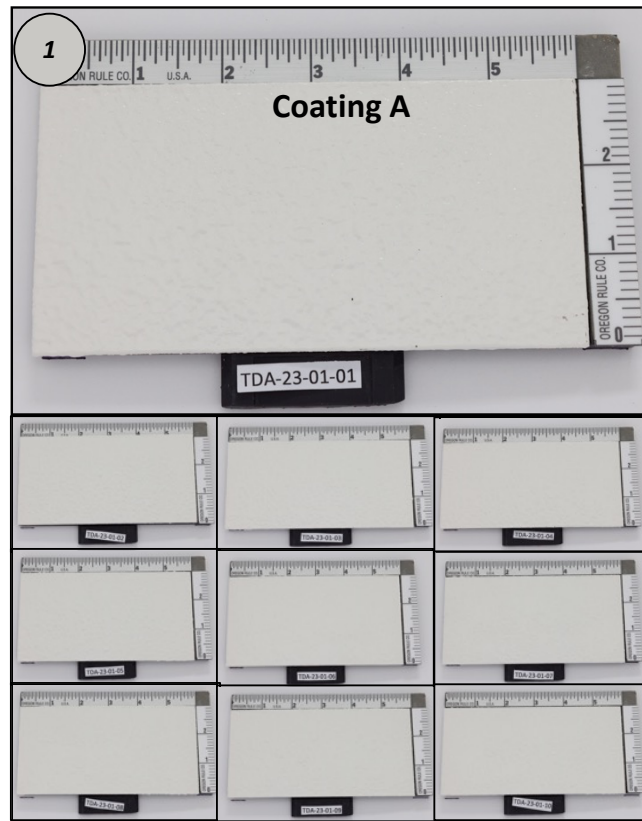
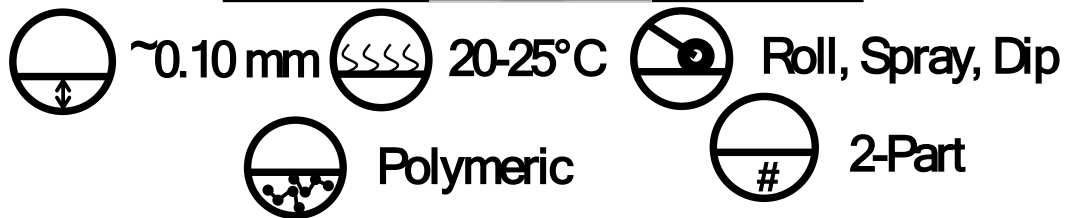
**TDA-23-01-XX**

**Figure 7. Intake photos of modified Sherwin-Williams Macropoxy 646N with TDA corrosion inhibitor package, TDA-23-01-XX, provided by TDA in FY23. Also shown are basic attributes (approximate thickness, cure temperature, application methods, coating type, and number of components).**

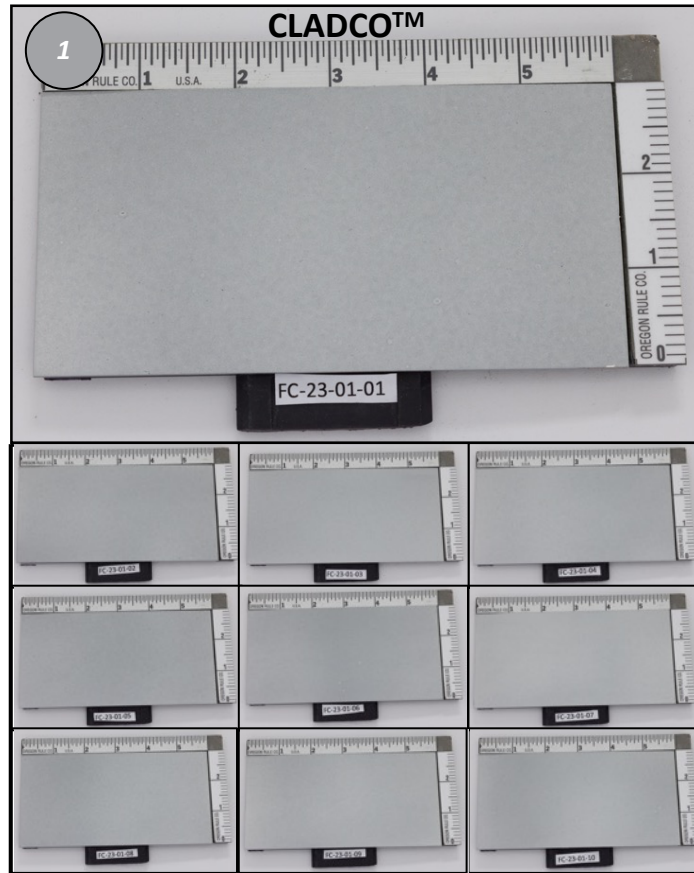
Figure 8. Intake photos of the organic/inorganic quasi-ceramic coating samples FC-23-01-XX provided by FC. Also shown are basic attributes (approximate thickness, cure temperature, application methods, coating type, and number of components).

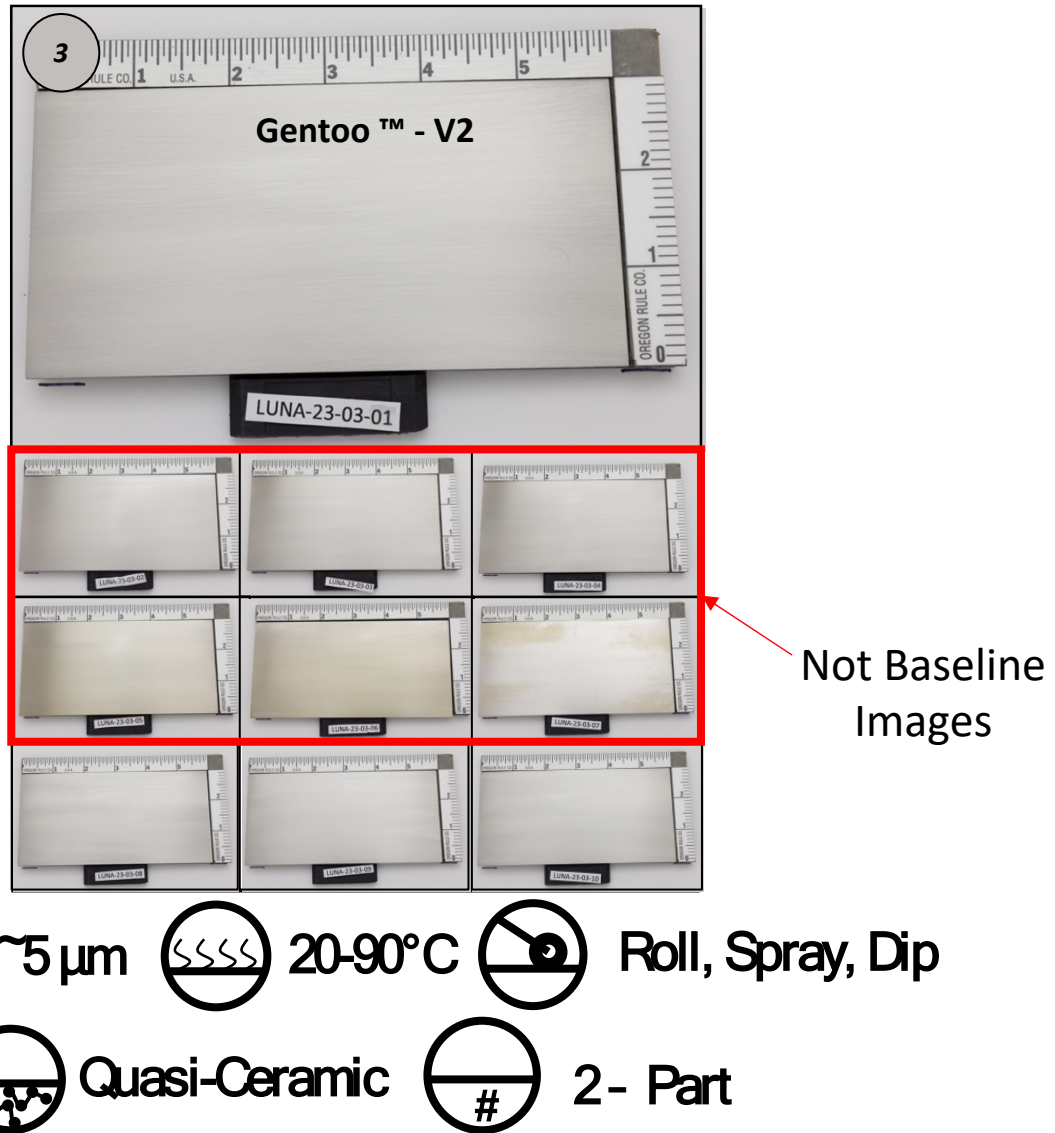
### LUNA-23-03-XX

Figure 9. Intake photos of samples of the organic/inorganic hybrid ceramic coating, LUNA-23-03-XX, provided by LUNA. Also shown are basic attributes (approximate thickness, cure temperature, application methods, coating type, and number of components). *\*Note: These samples were not received in time for baseline photos to be taken, therefore some of the images shown have been exposed to radiation.*

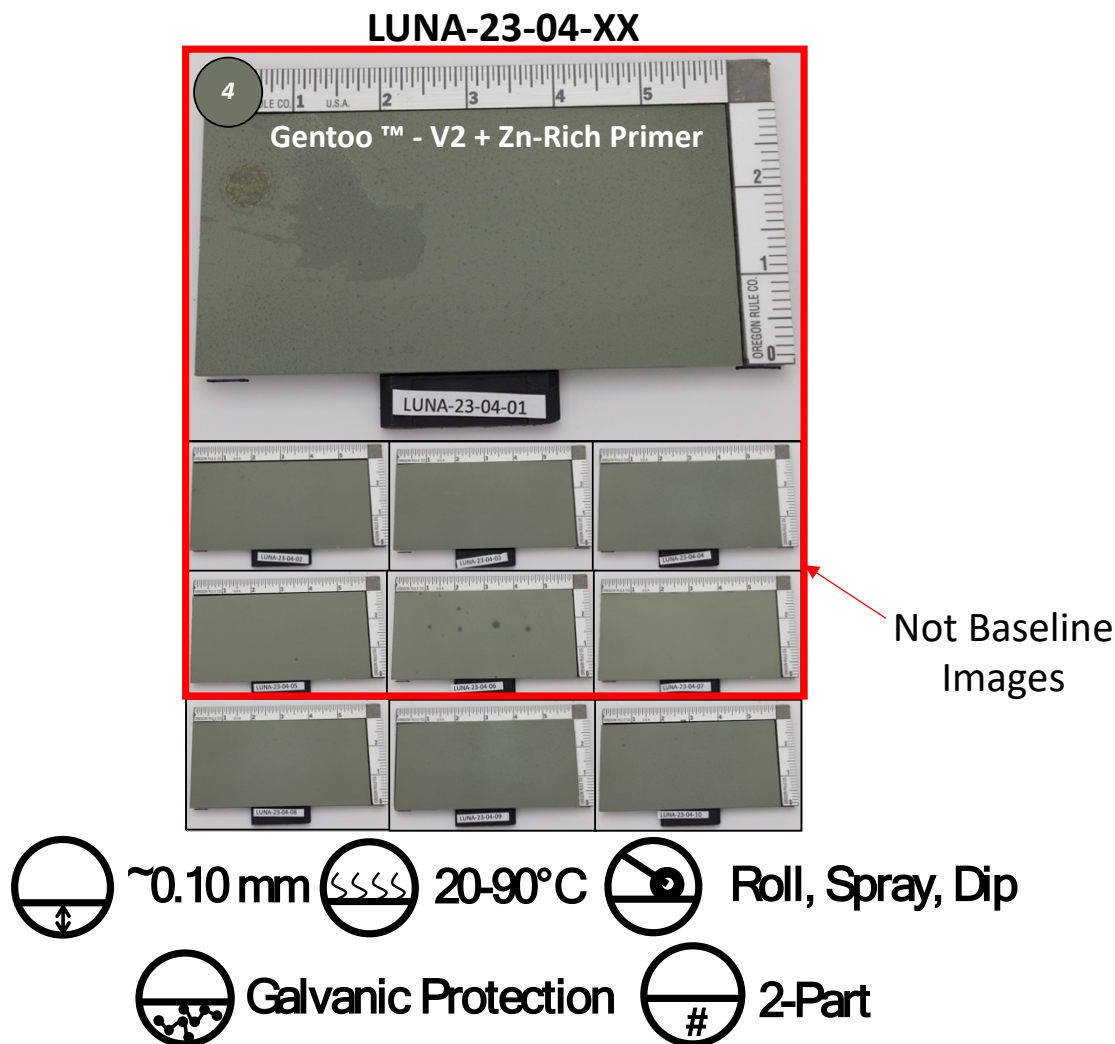
**Figure 10.** Intake photos of samples of the organic/inorganic hybrid ceramic coating on top of a Zn-rich primer, LUNA-23-04-XX, provided by LUNA. Also shown are basic attributes (approximate thickness, cure temperature, application methods, coating type, and number of components).

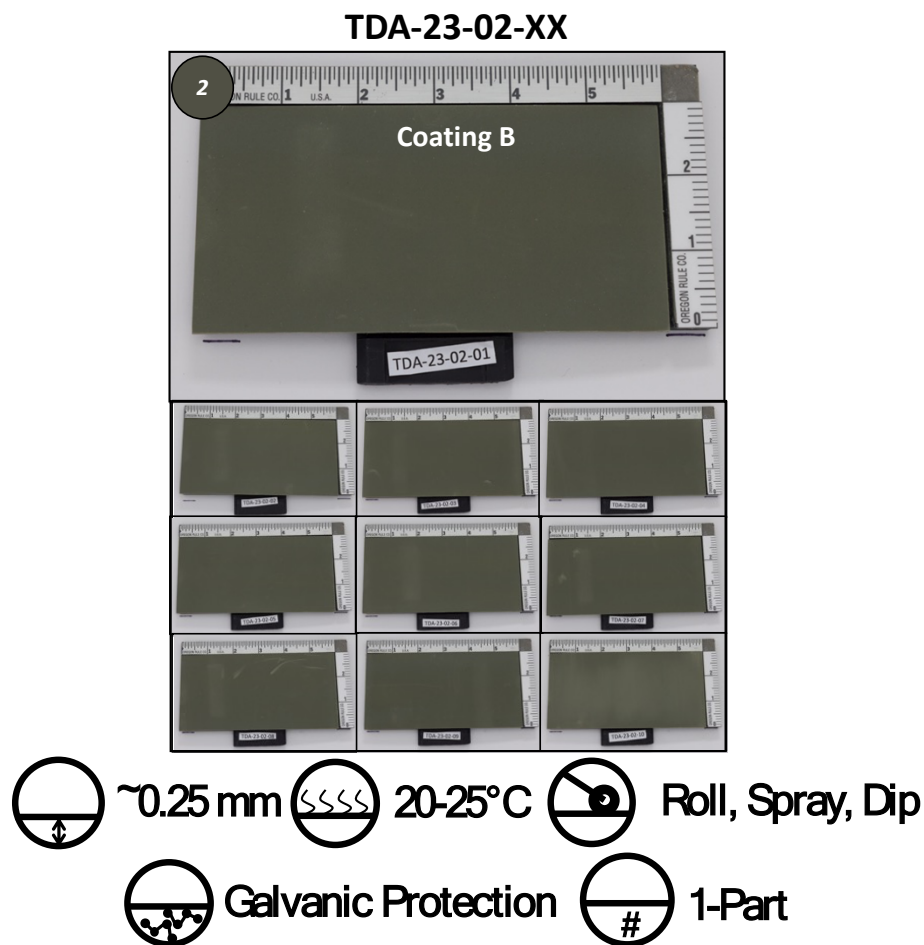
**Figure 11. Intake photos of modified Sherwin-Williams Zn-Clad II with TDA corrosion inhibitor package, TDA-23-02-XX, provided by TDA in FY23. Also shown are basic attributes (approximate thickness, cure temperature, application methods, coating type, and number of components).**

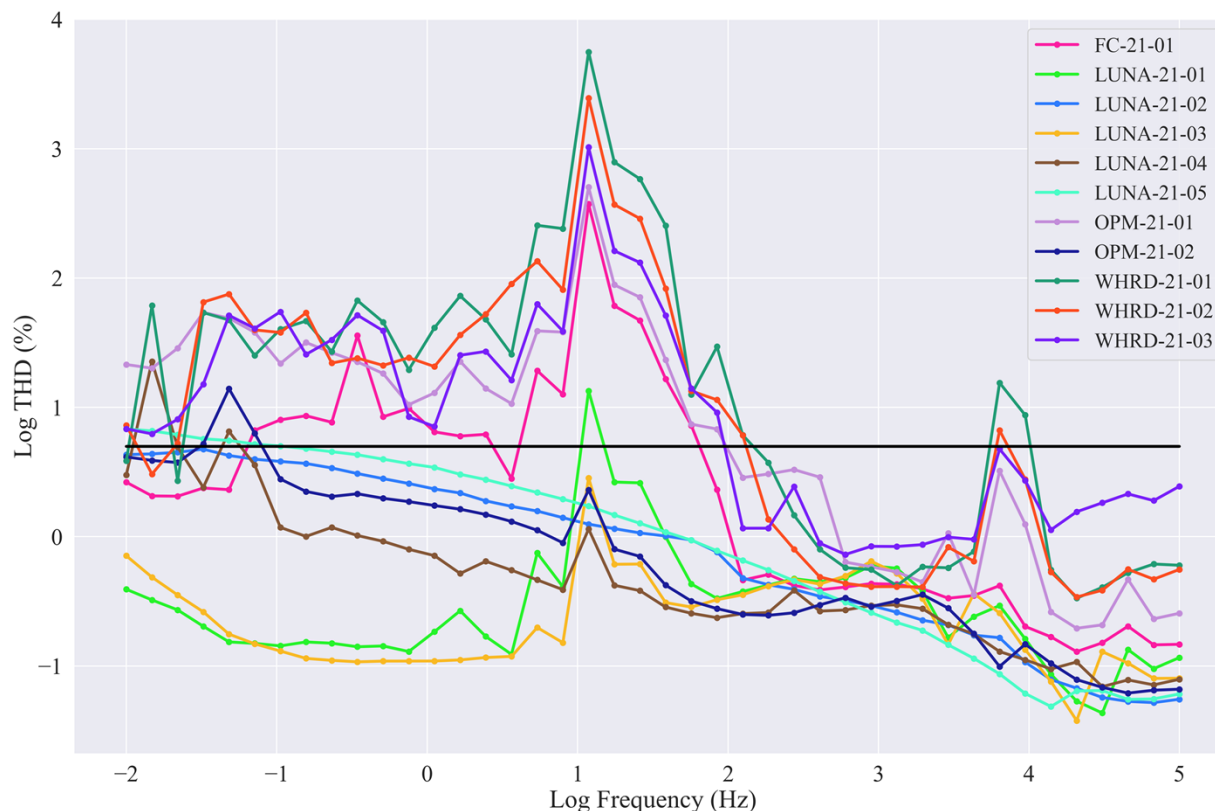
**Figure 13. Logarithm of mean total harmonic distortion (%) of the current response signal observed for baseline coatings as a function of the logarithm of the AC perturbation voltage frequency (Hz). The black horizontal line represents a 5% threshold for nonlinearity. The trends presented for baseline coatings persisted for 30-day and 90-day exposed coatings.**

LUNA-21-03 was able to remain below the 5% threshold over all frequencies. The observed THD differences between coatings are likely due to varying electrochemical kinetics as well as variance in electrical insulation, which is largely influenced by coating thickness.

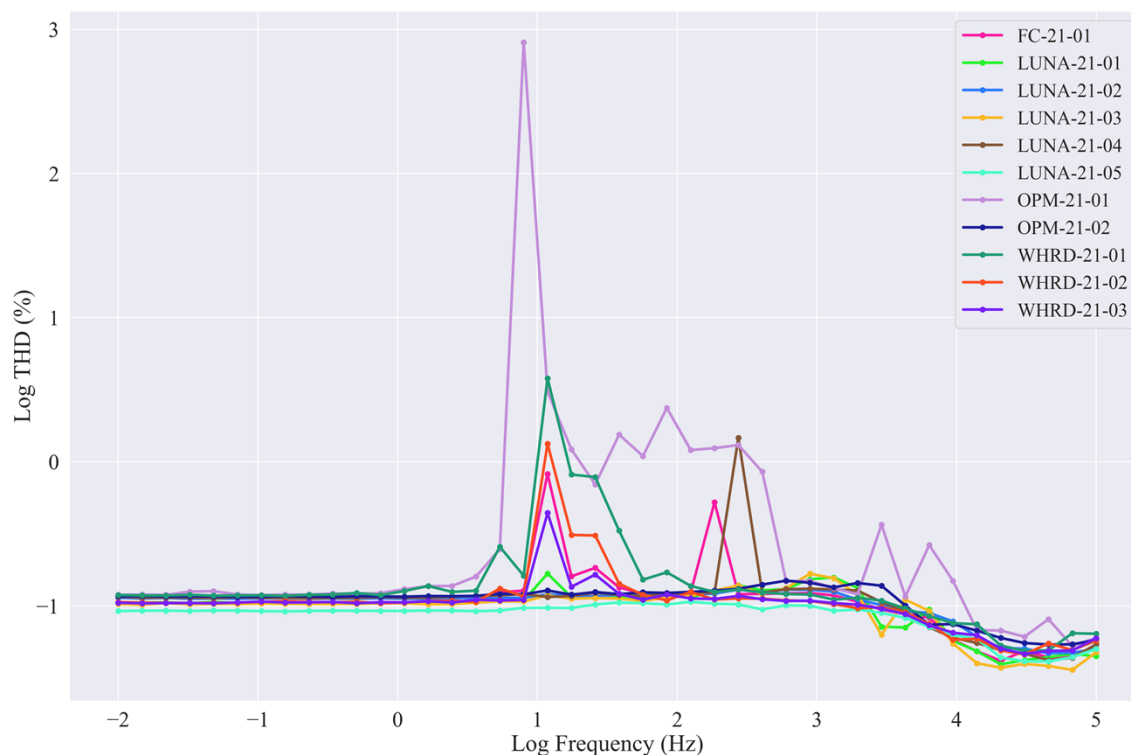
**Figure 14. Logarithm of mean total harmonic distortion (%) of the perturbation voltage input signal observed for baseline coatings as a function of the logarithm of AC perturbation voltage frequency (Hz). The trends presented for baseline coatings persisted for 30-day and 90-day exposed coatings.**

To validate the quality of the input, we performed the same THD analysis for the input perturbation voltage signal (Figure 14). We observed large spikes in input THD for the polymeric coatings at 11.837 Hz, except for OPM-21-01 whose peak input THD was shifted slightly to 7.988 Hz. It was noted that during EIS, OPM-21-02 was cracked and therefore its electrical behavior diverged from the other polymeric coatings and exhibited characteristics similar to bare SS-304. It is unclear why input THD differs between coatings and as a function of frequency. However, there may be a few possible contributions to this behavior: potentiostat circuitry introducing distortion at particular frequencies, ambient electromagnetic fields introducing extraneous signal into the circuit, non-stationarity of the open circuit potential, or reactive processes in the coatings introducing kick-back into the input lines. Further study of this phenomenon is required to understand the cause of this behavior. In this effort, open circuit potential drift correction and employment of a faraday cage may help diagnose the source of these dependencies.

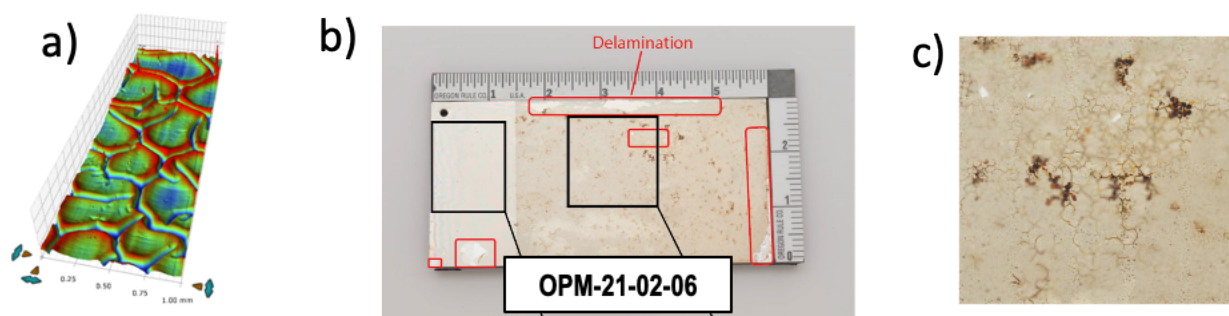
**Figure 15. a) mudcracks that formed during the curing process of OPM-21-02-XX measured by profilometry, b) visual inspection of OPM-21-02-06 after 30 days at 76%RH/40°C with 300 µg/cm<sup>2</sup> ASW showing corrosion damage and delamination, and c) a close up of the corrosion damage following atmospheric exposure.**

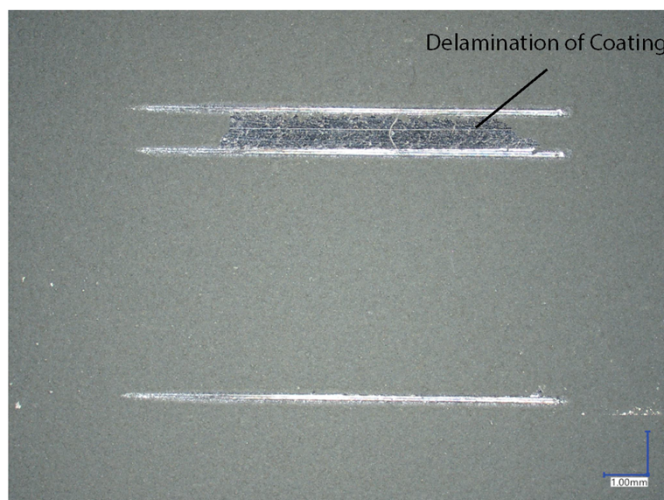
**Figure 16. Optical image of LUNA-21-05-02 (Zn-rich primer only) after scratch testing at 25N force. Adhesive failure occurred at <2N, and a subsequent scratch at a separation distance of 1 mm caused delamination of the coating between the scratches. A scratch performed using a separation distance of 5 mm did not cause delamination between scratches [1].**

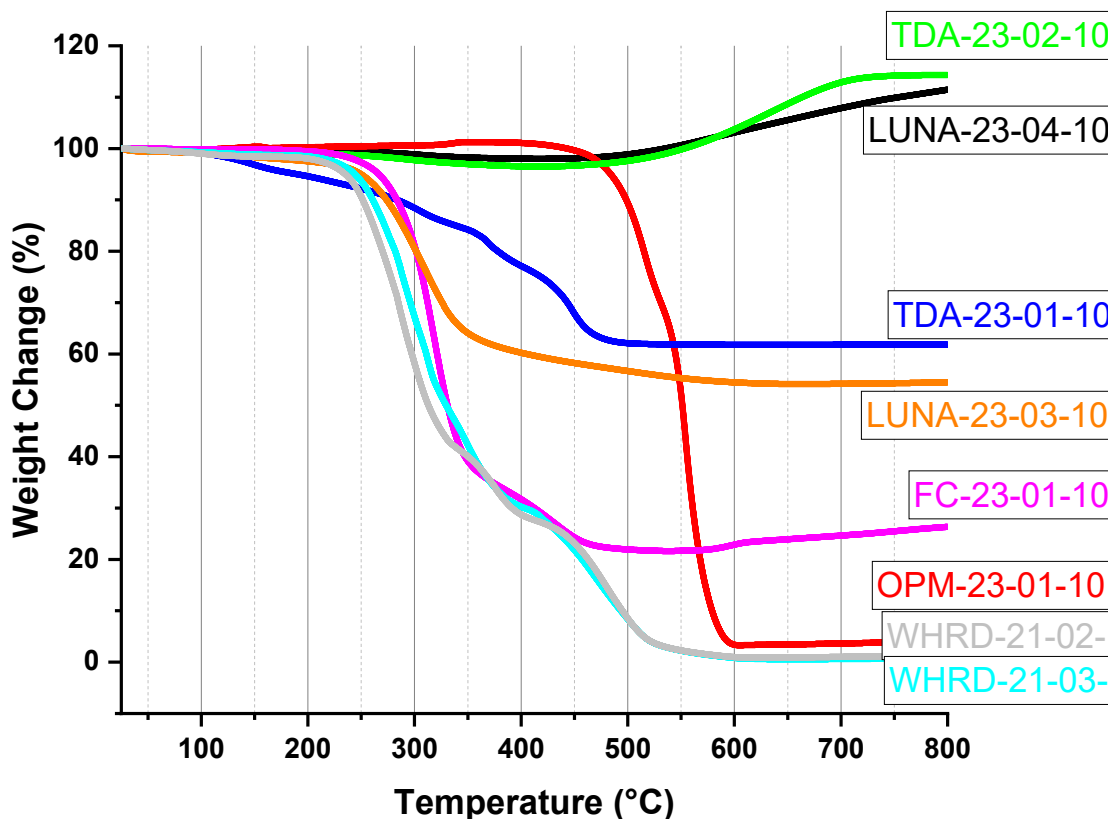
Figure 19. TGA data for all coatings expressed as % weight change. Coatings were tested to temperatures >225°C to determine onset of thermal breakdown.

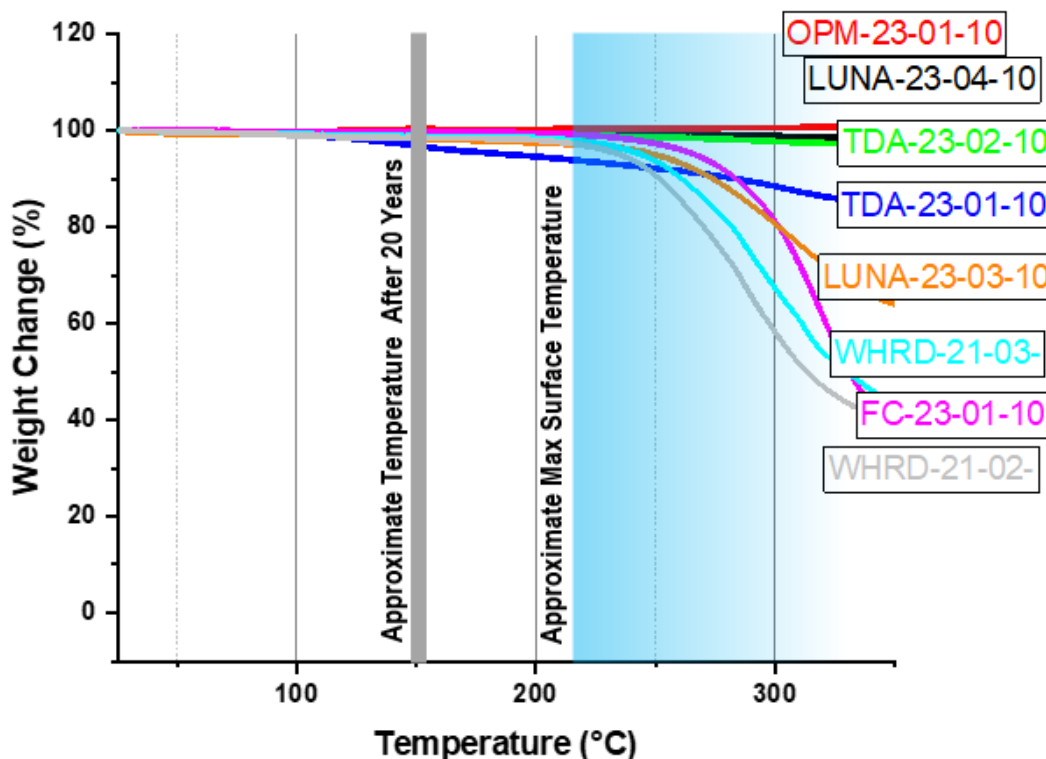
**Figure 20. TGA data on all coatings expressed as % weight change. Temperatures above 225°C were tested to determine onset of material breakdown and do not correspond to any known application condition for SNF canisters. Canister surface temperatures (shown as vertical lines) were estimated from thermal models Gilkey, Brooks [10].**

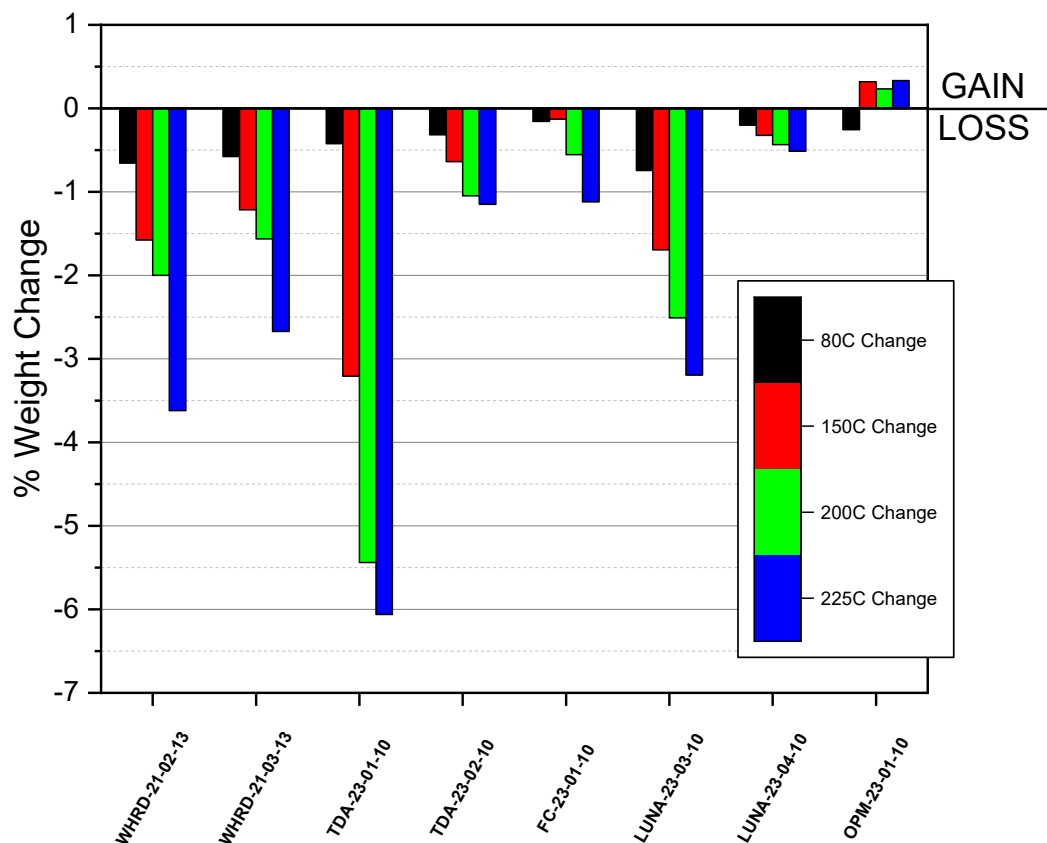
Figure 21. Weight change at 80°C, 150°C, 200°C and 225°C for all coatings.

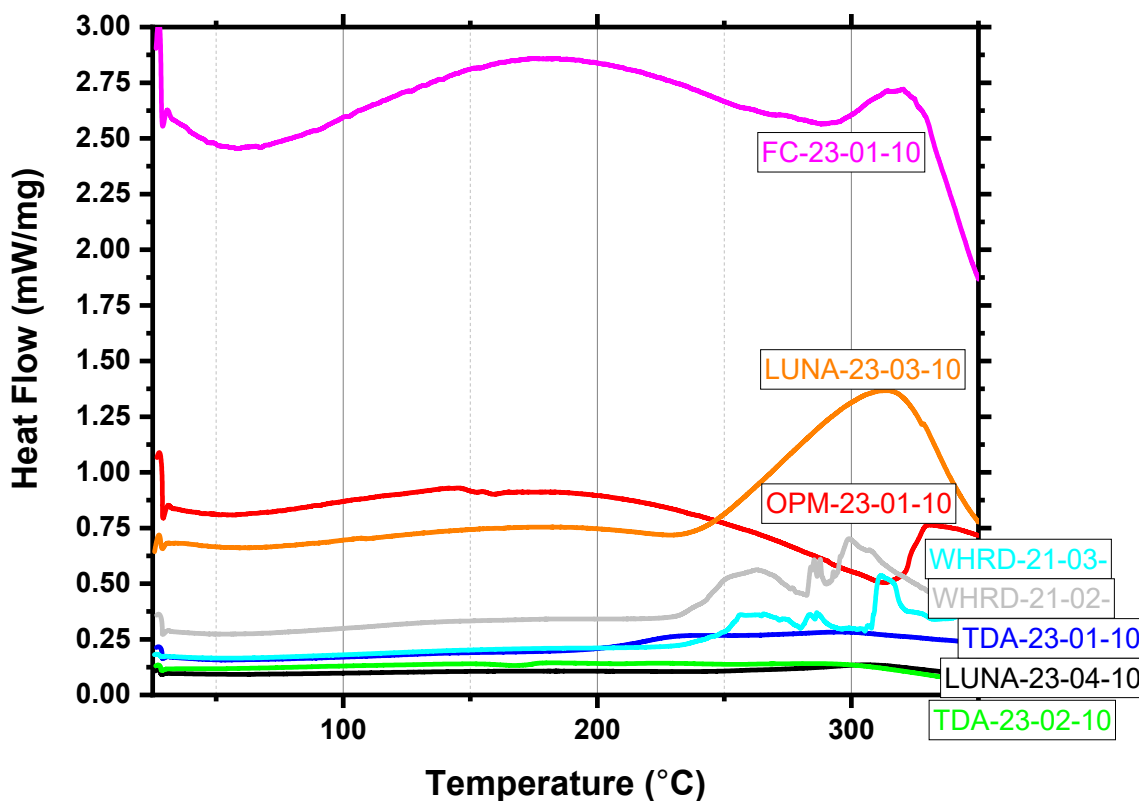
**Figure 22. Mass-normalized heat flow (W/g) data collected during Thermogravimetric experiments. Samples were tested past 225°C to determine onset of phase changes or other thermodynamic events.**

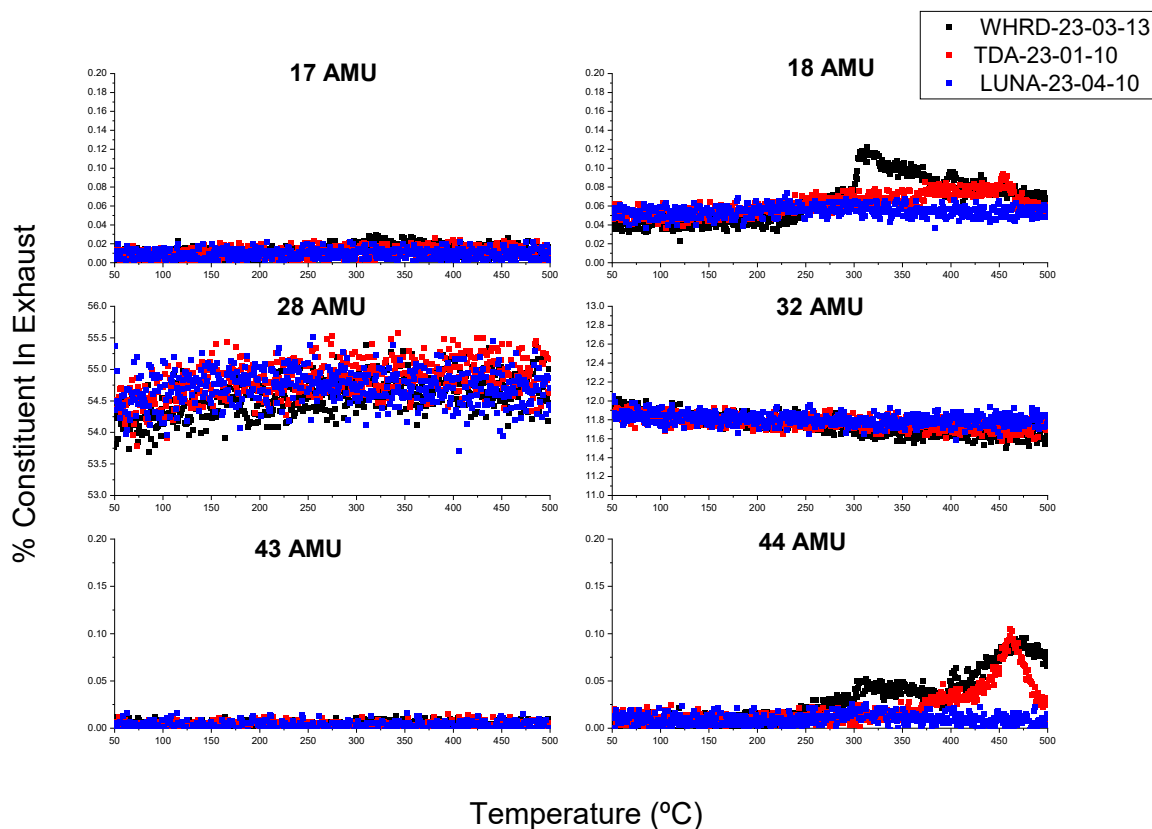
Figure 23. Residual Gas Analysis of exhaust stream during heating in TGA of various species with different atomic weights (in AMU).

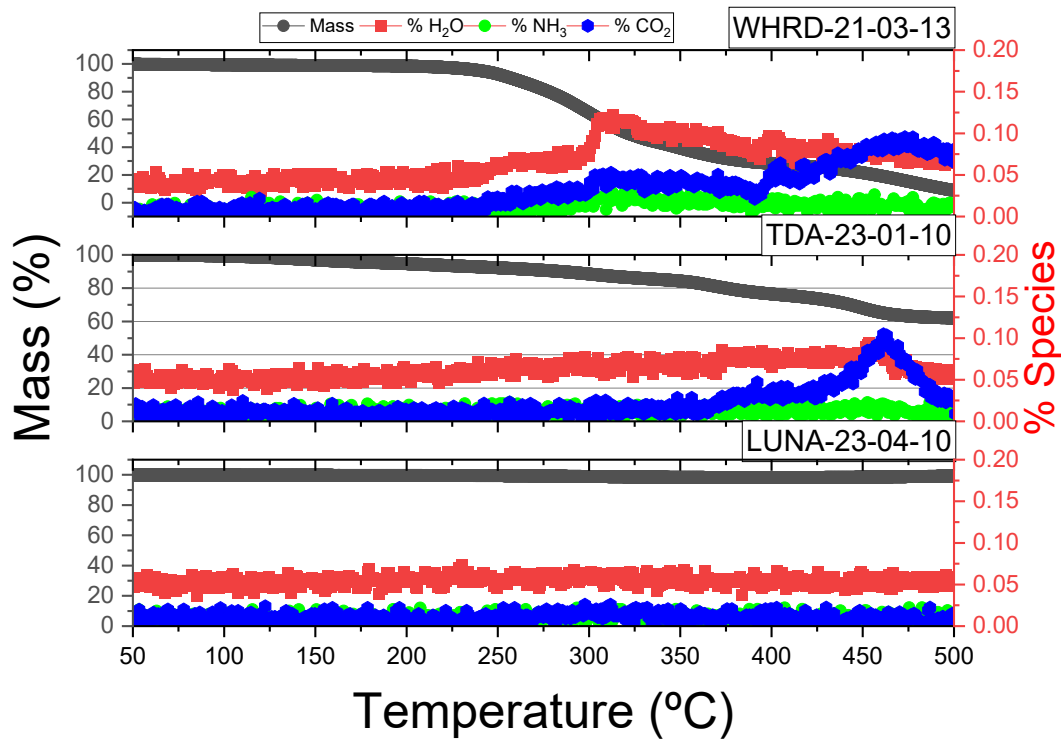
Figure 24. Thermogravimetric mass % plotted with % species detected in the exhaust by residual gas analysis. Listed gas species are most probable detected species [65].

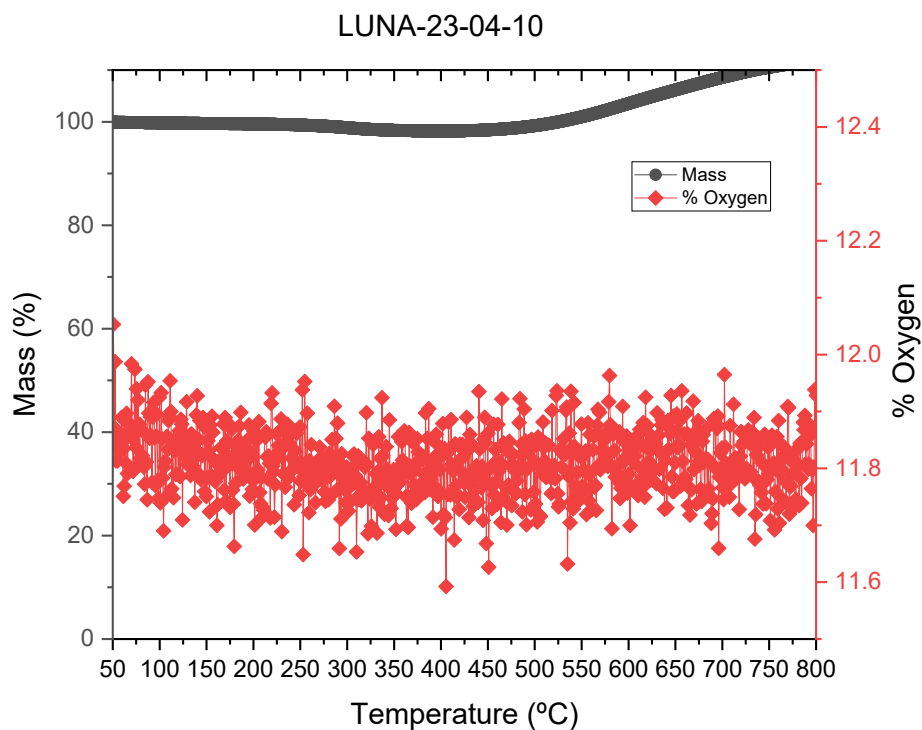
**Figure 25. TGA mass % plotted with % oxygen detected in the exhaust by RGA for LUNA-23-04-10. Compressed air was used as a cover gas for the TGA measurement which has an oxygen concentration of 20.5% but since the RGA was not calibrated for high concentrations this data should be regarded as relative concentration only.**

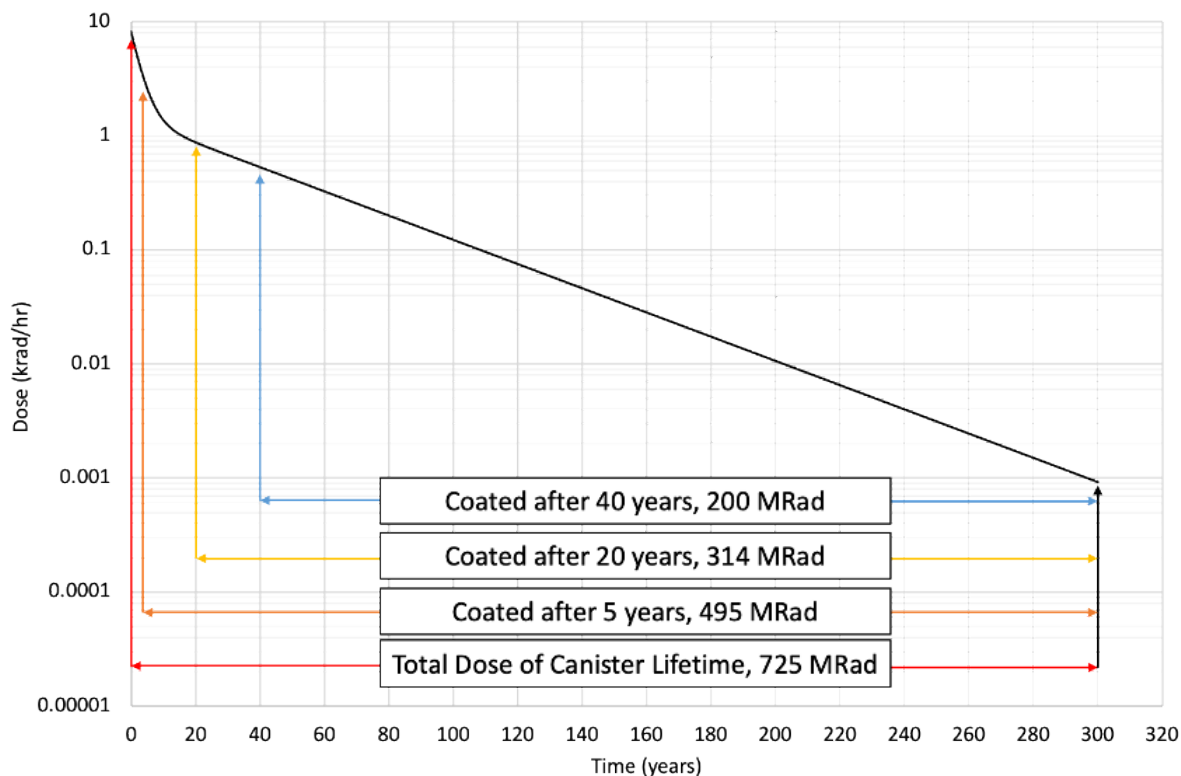
**Figure 26. Estimated dose rate at a canister surface assuming 45-48 GWd/MTU (4% <sup>235</sup>U) burnup over a period of 300 years [66]. Test intervals were chosen based on realistic inspection intervals (such as the first inspection performed after 20 years of storage).**

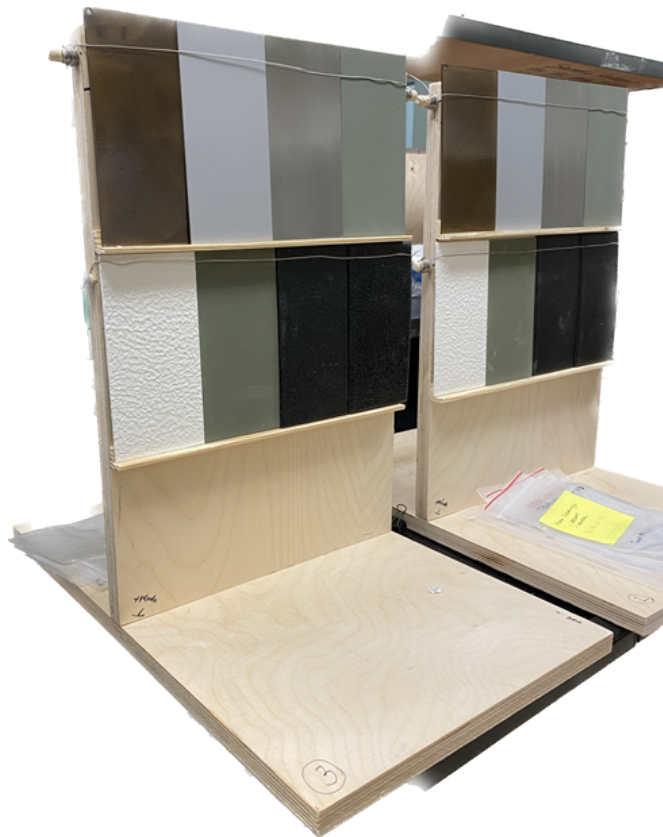
**Figure 27. Wooden fixtures used to hold coating specimens in front of the linear  $^{60}\text{Co}$  array at Sandia's Gamma Irradiation Facility. Thin gauge 304 stainless steel wire was used to prevent the specimens from falling into the containment pool and to hold the specimens flat against the fixture during exposure. Samples were wrapped in foil to prevent abrasion against the wire (not shown).**

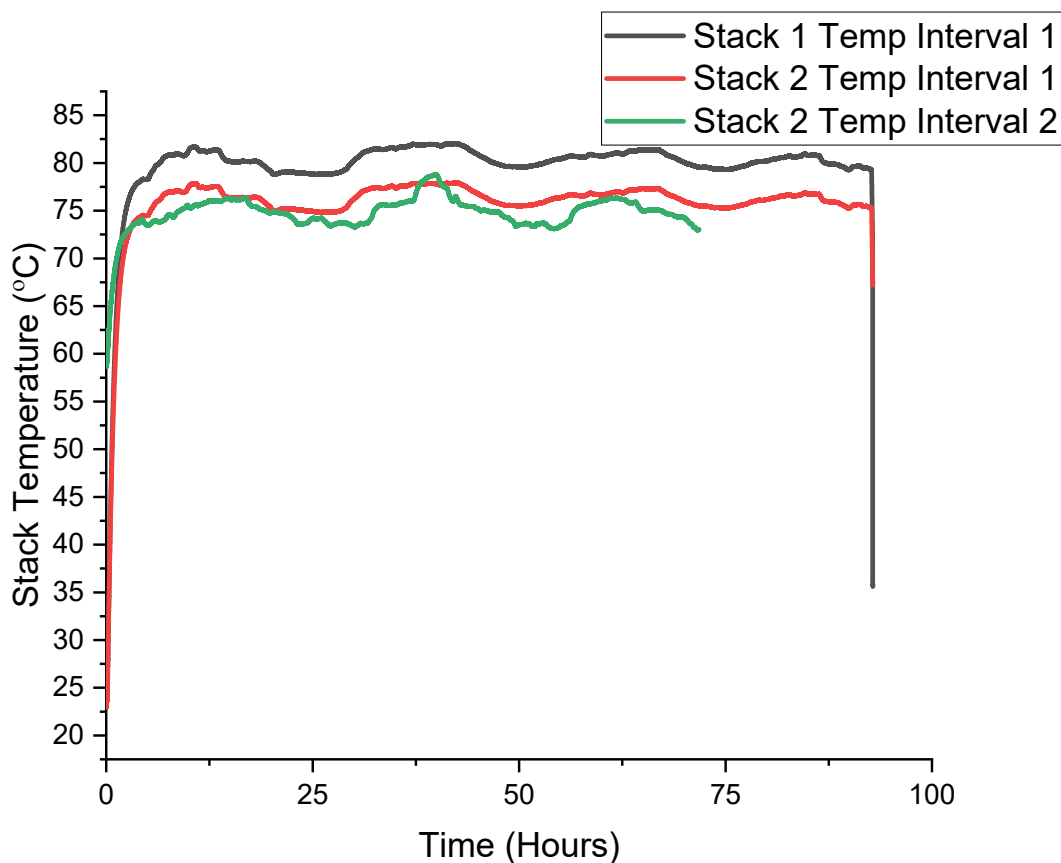
**Figure 29. Stack temperature during exposure in the GIF shutter Array (dose rate 1054 rad/s). Stack 1 was removed after 93 hours (achieved 350 Mrad). Stack 2 (735 Mrad) was replaced and self-heated to the same temperature.**

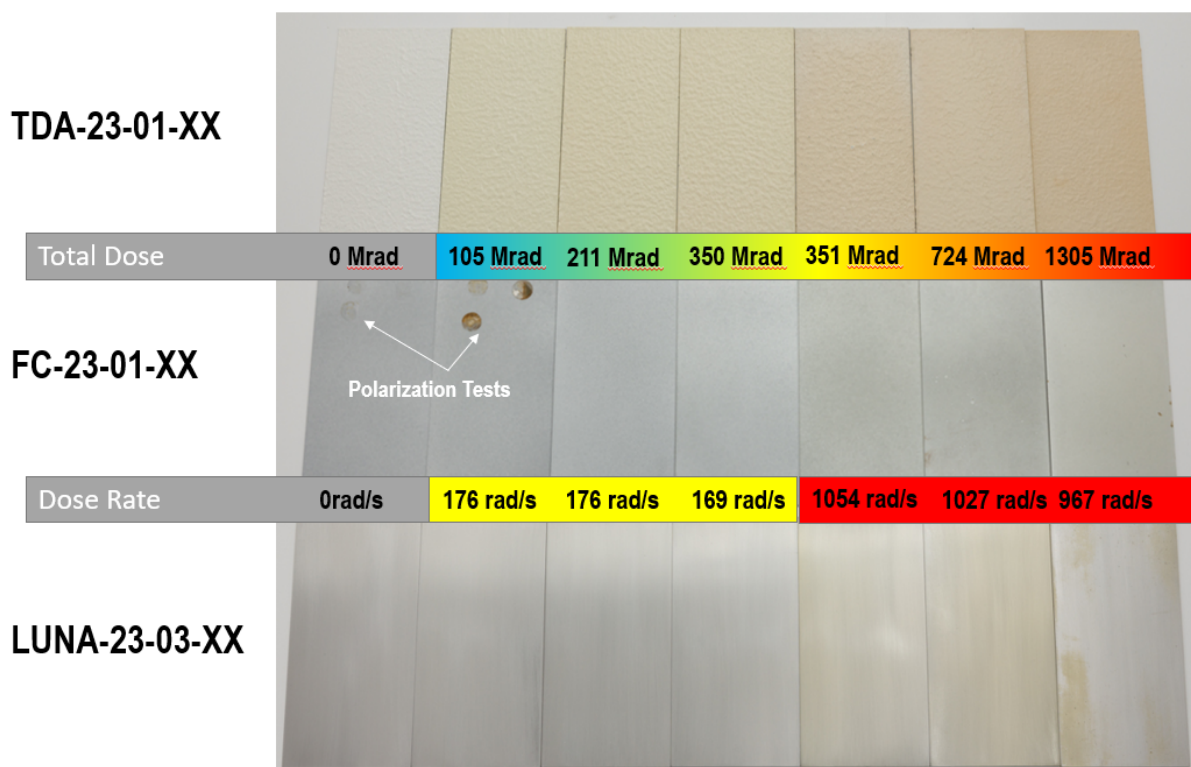
**Figure 30. Color comparison of coatings after exposure to increasing (left to right) doses of gamma radiation. These coupons exhibited the most obvious color changes, yellowing with increasing exposure.**

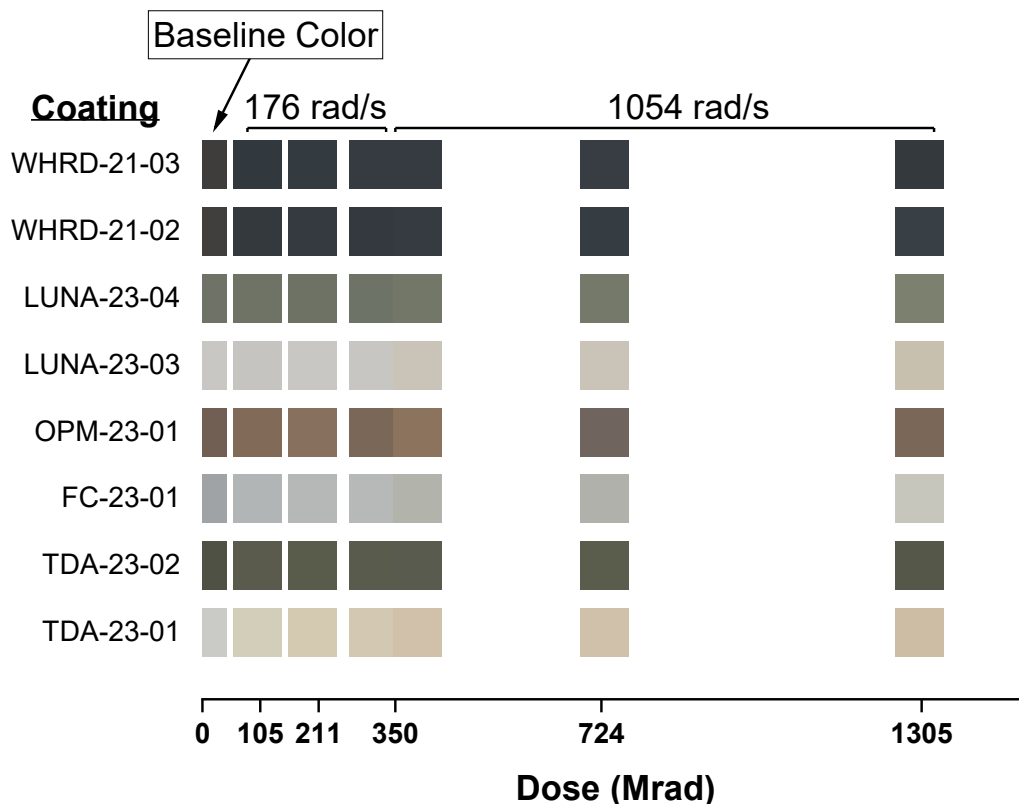
**Figure 31. Colorimetric representation of baseline and gamma irradiated samples. Some coatings had high variability in baseline color while others exhibited yellowing with increasing dose.**
