# ***FY23 Status: Corrosion-Resistant Coatings on Spent Nuclear Fuel Canisters to Mitigate and Repair Potential Stress Corrosion Cracking***

## **Spent Fuel and Waste Disposition**

*August 10, 2023  
M3SF-23SN010207052  
SAND2023-09205R*

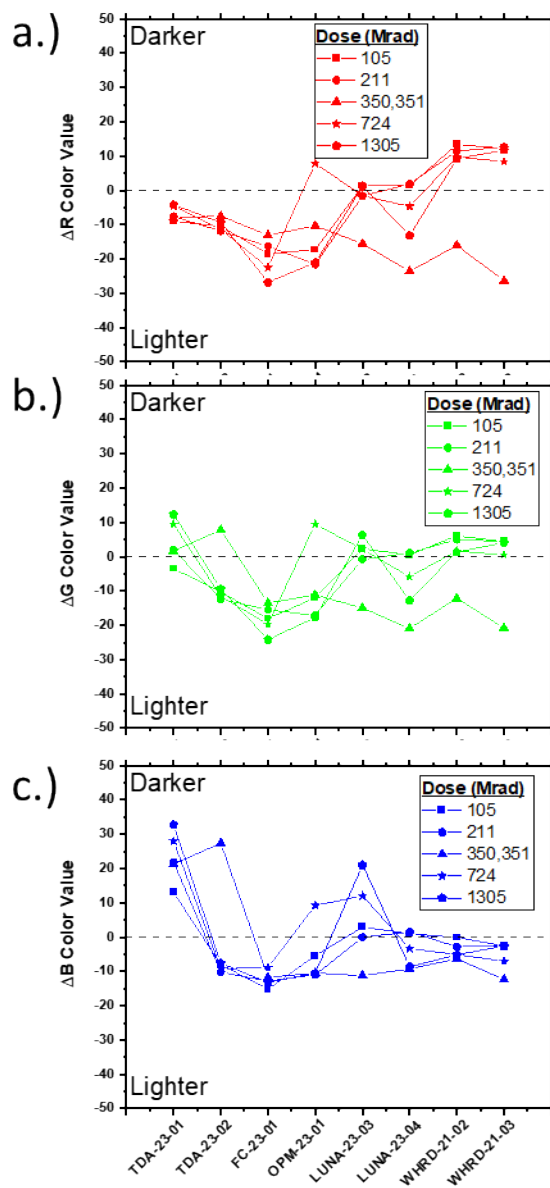
Figure 32. Colorimetric analysis of Red (a), Green (b), and Blue (c) color channels relative to baseline values.

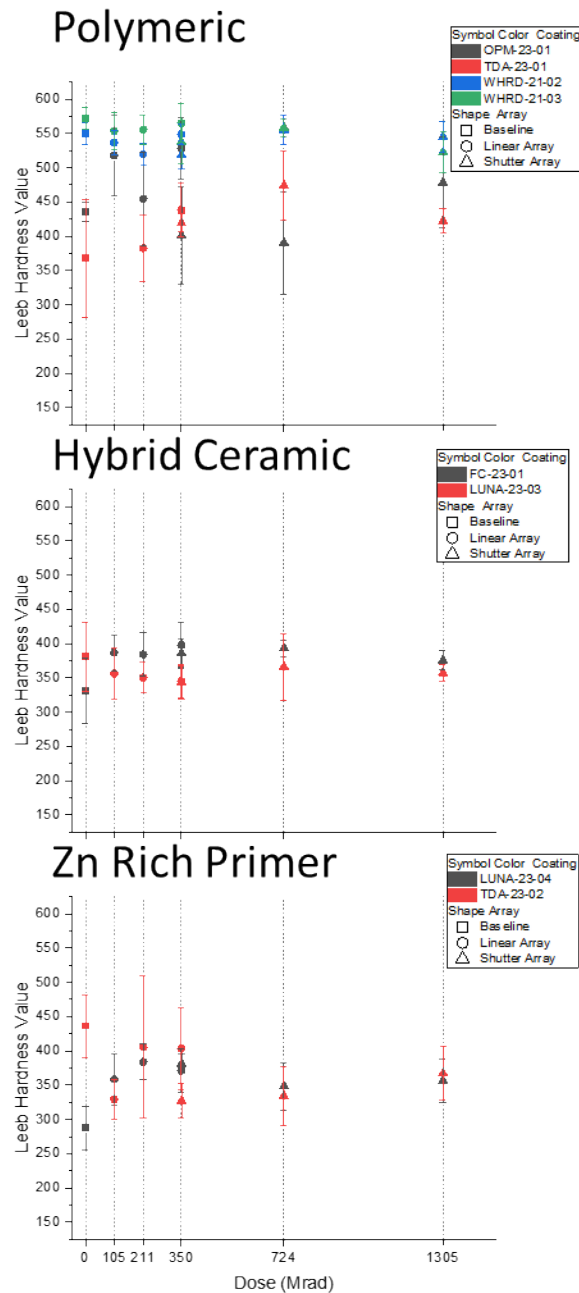
**Figure 33 Leeb hardness values for all coatings before and after exposure to gamma radiation. LUNA-23-04 comprises LUNA-23-03 coated on top of a zinc rich primer underlayer.**

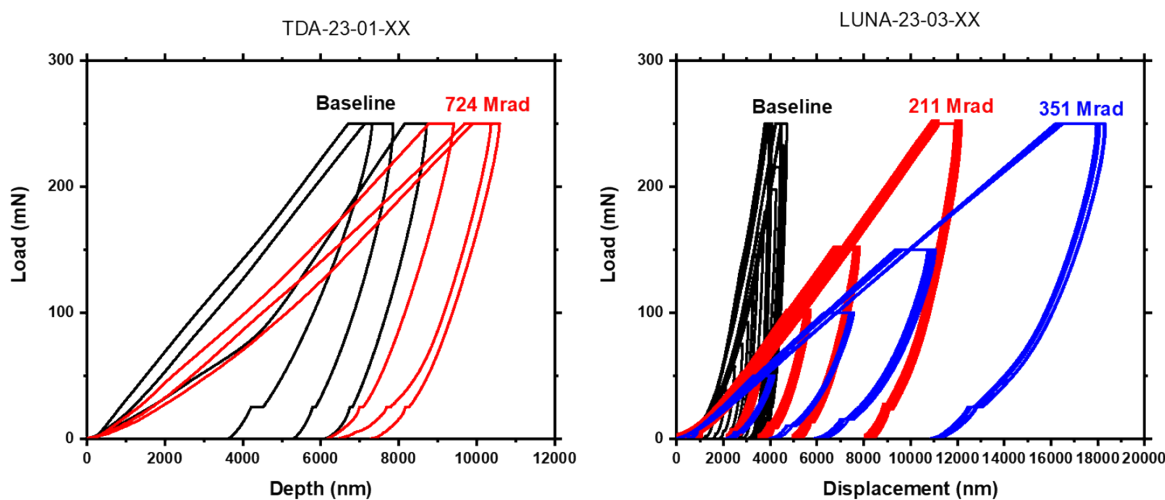
**Figure 34. Nanoindentation data from two coatings exposed to gamma radiation. Samples generally exhibited softening with increasing dose.**

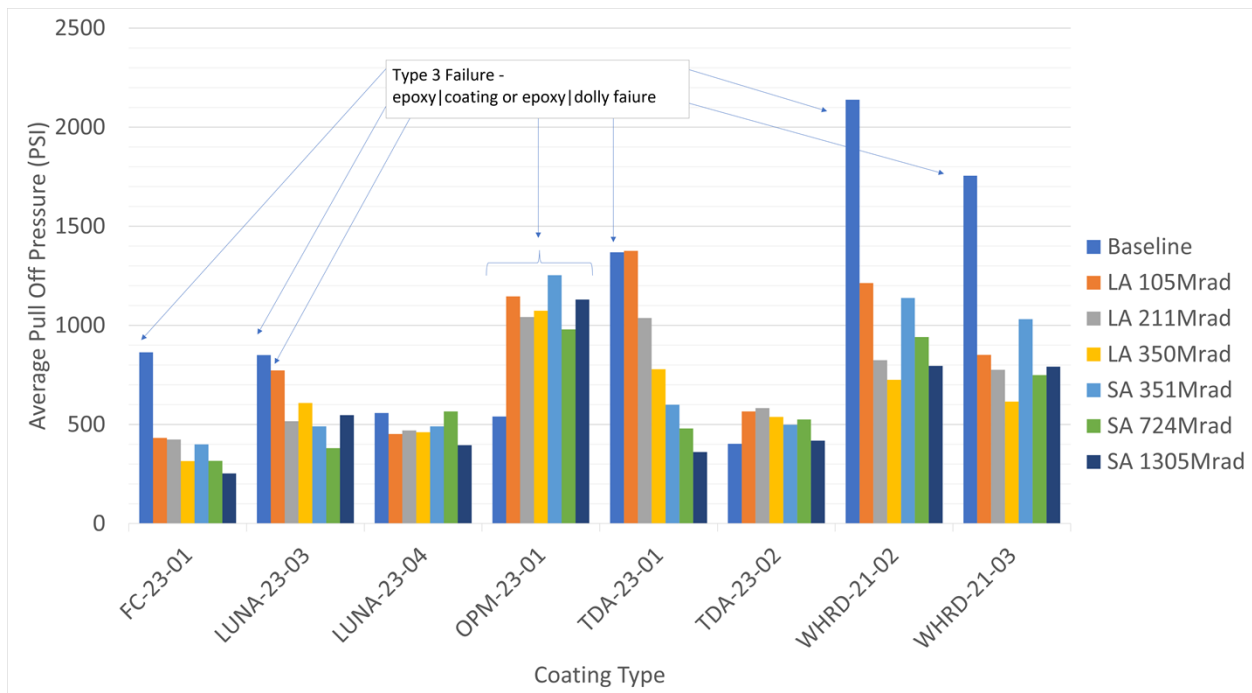
**Figure 35. Average pull off pressure (psi) as a function of coating type with clustered columns of total radiation exposure (Mrad).**

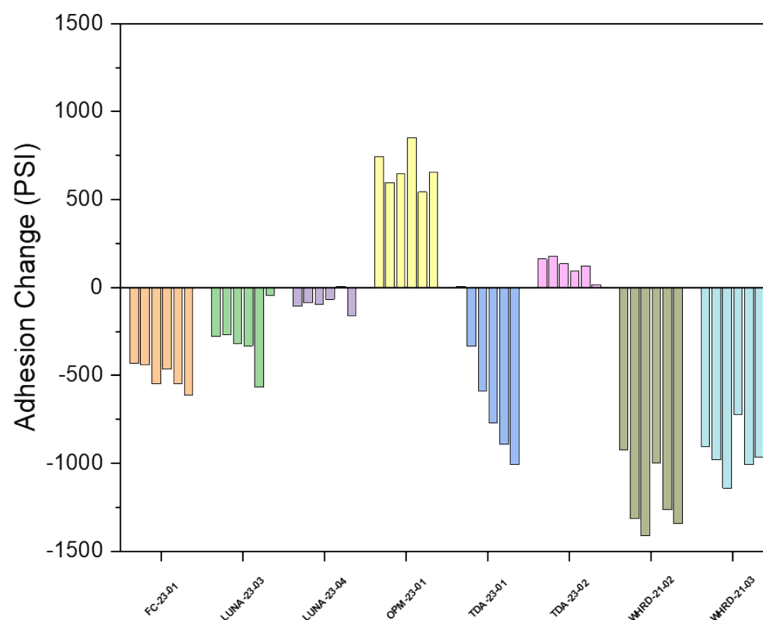
**Figure 36. Adhesion value change for each coating with respect to baseline, unirradiated coatings. Each sample group is organized by increasing dose (left to right). High positive change in adhesion for OPM-23-01 represents an increase in surficial bond between adhesion test dolly and coating surface but does not represent an increase in actual adhesion strength.**

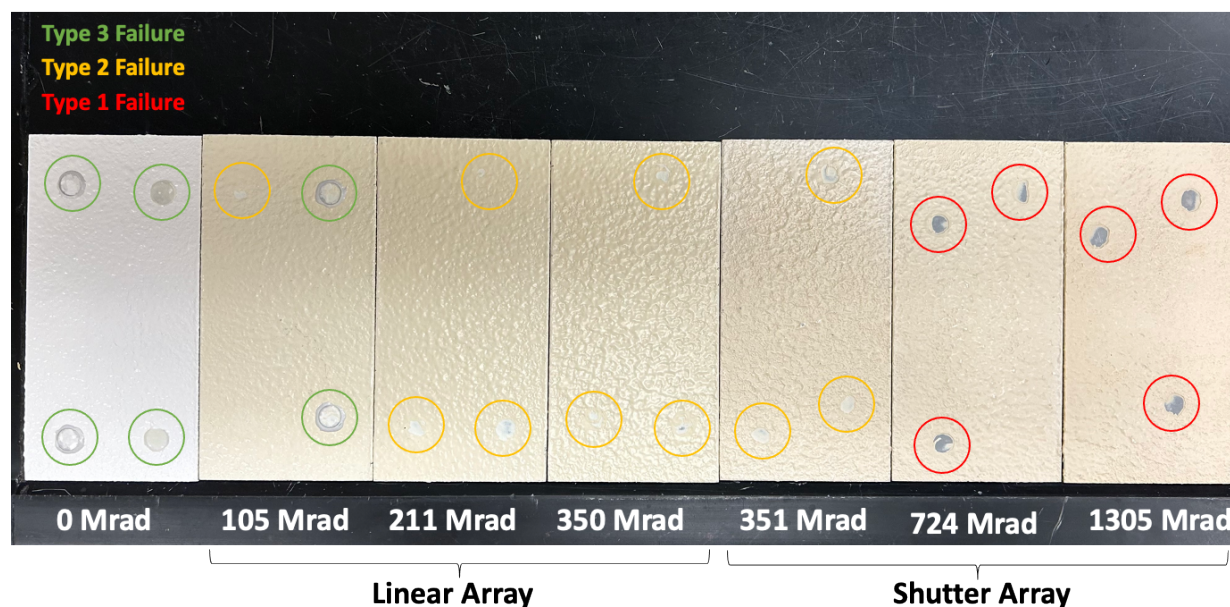
**Figure 37. Photo showing the type of failure observed during the adhesion tests for TDA-23-01-XX as a function of radiation.**

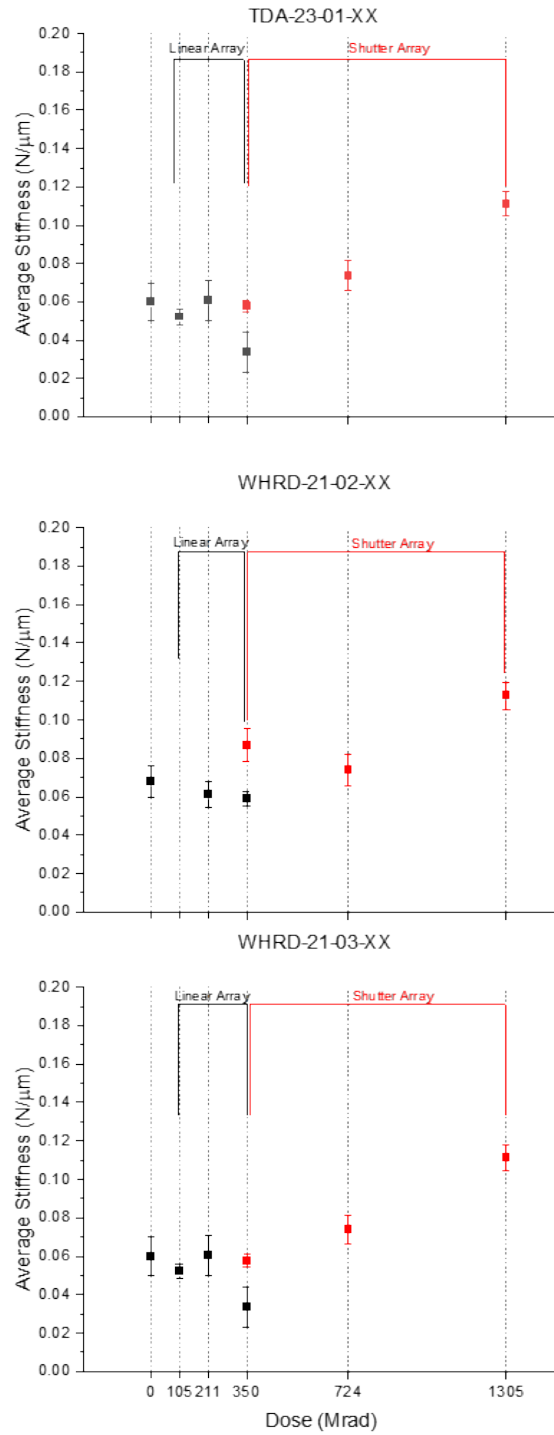
**Figure 40 Stiffness vs gamma radiation dose derived from scratch testing data for three polymeric coatings.**

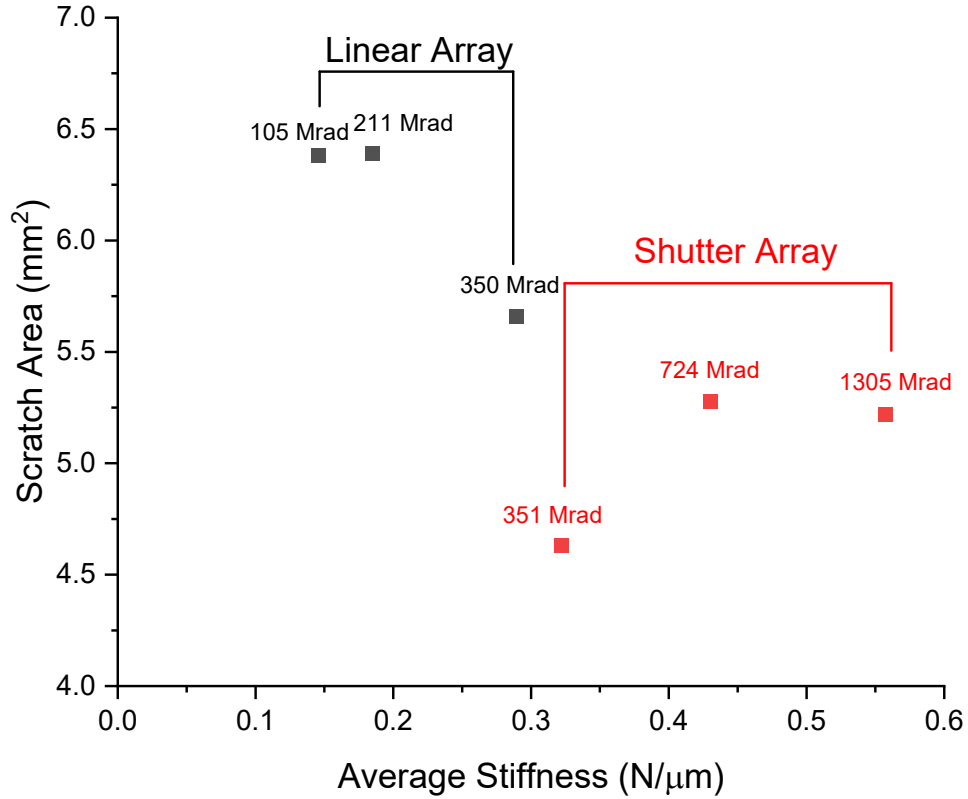
Figure 41 Scratch area vs average stiffness for TDA-23-01-XX. Scratch area was measured from image data. Decreased scratch area represents an increase in material stiffness.

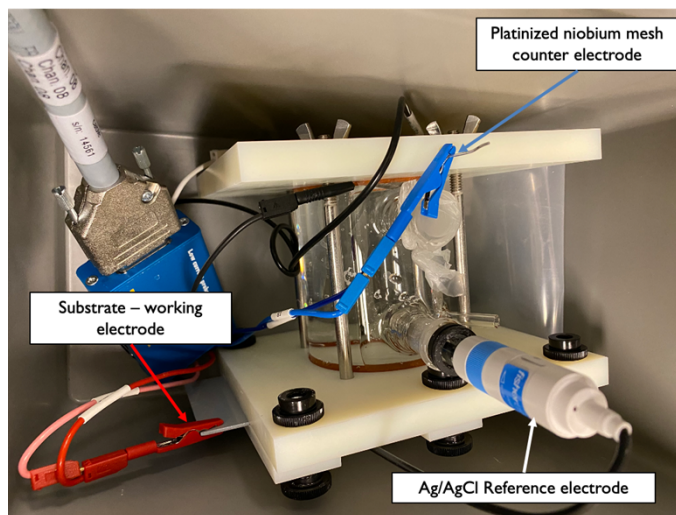
Figure 42. Three-electrode electrochemical cell for electrochemical measurements

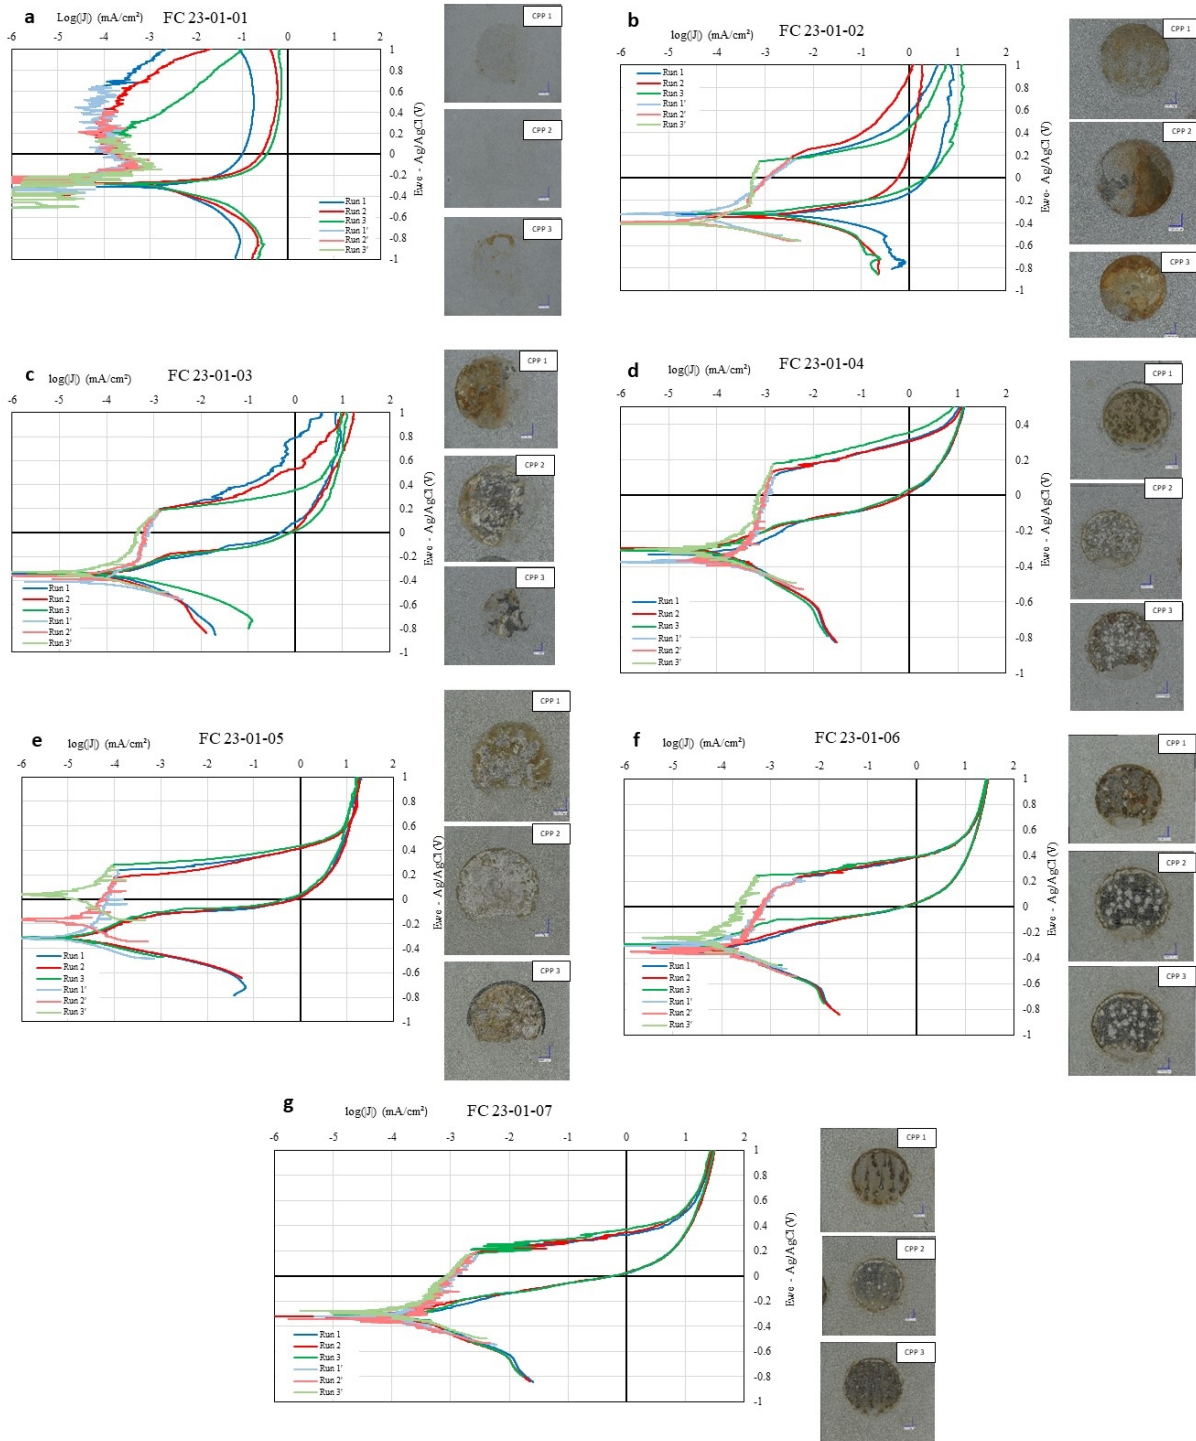
**Figure 43. Polarization scans of FC-23-01-XX following gamma irradiation to a) 0 Mrad, b) 105 Mrad-LA, c) 211 Mrad-LA, d) 350 Mrad-LA, e) 351 Mrad-SA, f) 724 Mrad-SA, and g) 1305 Mrad-SASA**

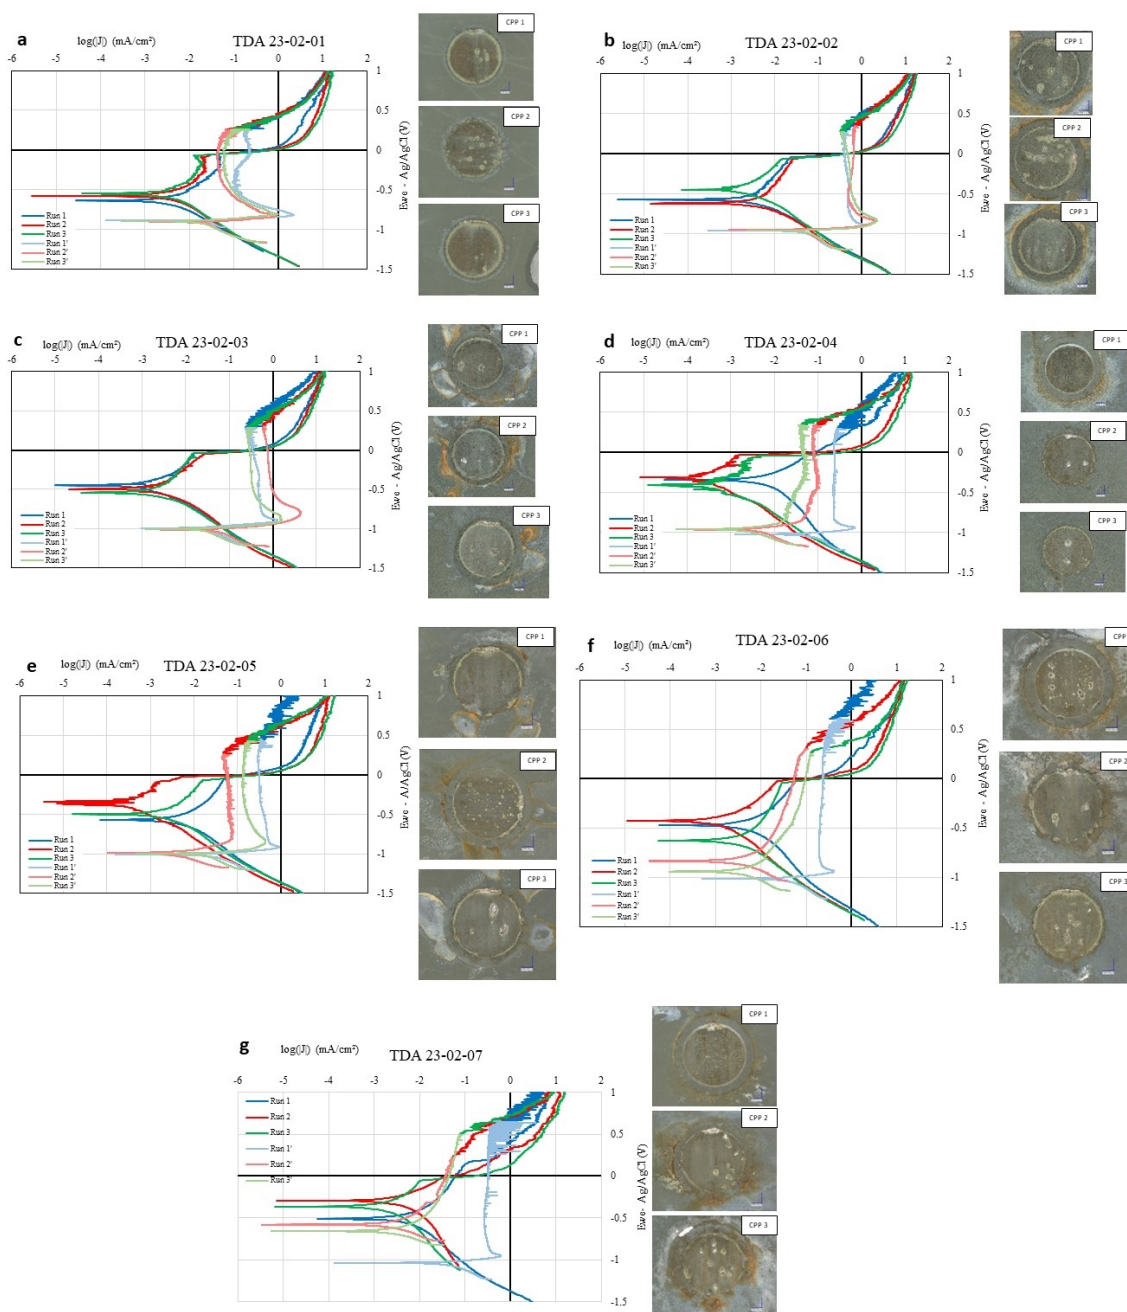
**Figure 46. Polarization scans of TDA-23-02-XX following gamma irradiation to a) 0 Mrad, b) 105 Mrad-LA, c) 211 Mrad -LA, c) 350 Mrad- LA, e) 351 Mrad -SA, f) 724 Mrad -SA, and g) 1305 Mrad-SA.**
