Sandia
National
Laboratories

Panel Session II. Connector Failures Field and Lab Findings: Macro-level Forensics

EPRI Wind and Solar O&M Innovation Workshop

July 17, 2024

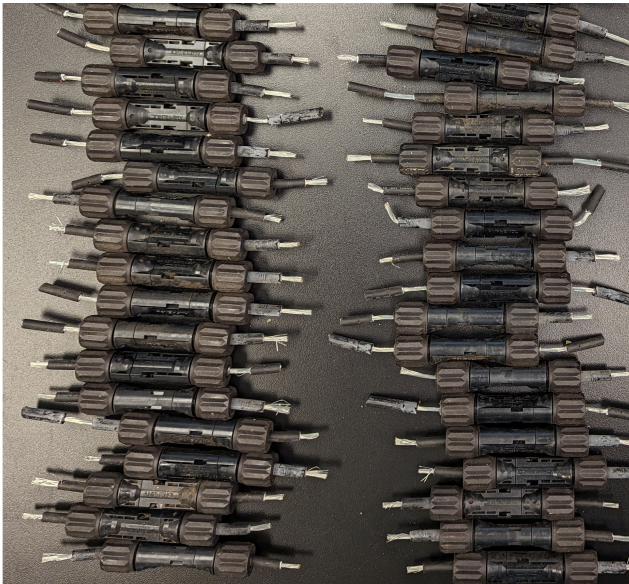
Harvested Connectors

- Direct resistance measurement
- Rarely complete set
- Destructive

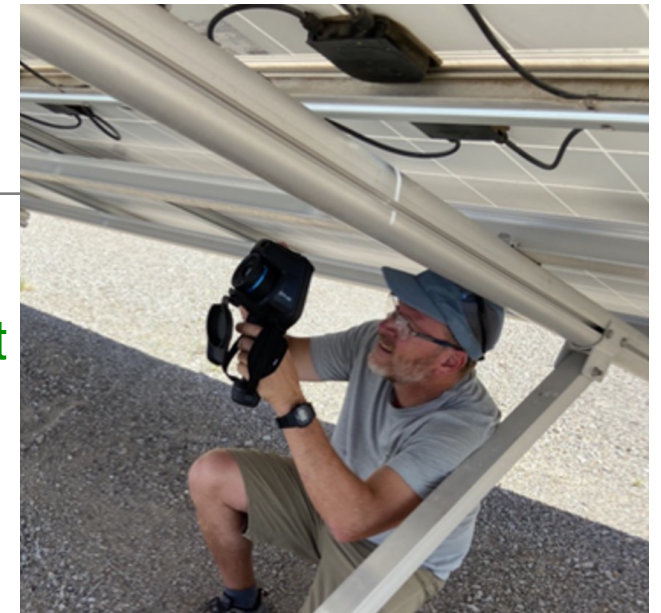
Site Inspection (thermal images)

- Fast (robotic inspection)
- Installation practices evident
- Non-destructive
- Track individual connectors
- Infer resistance from temp.

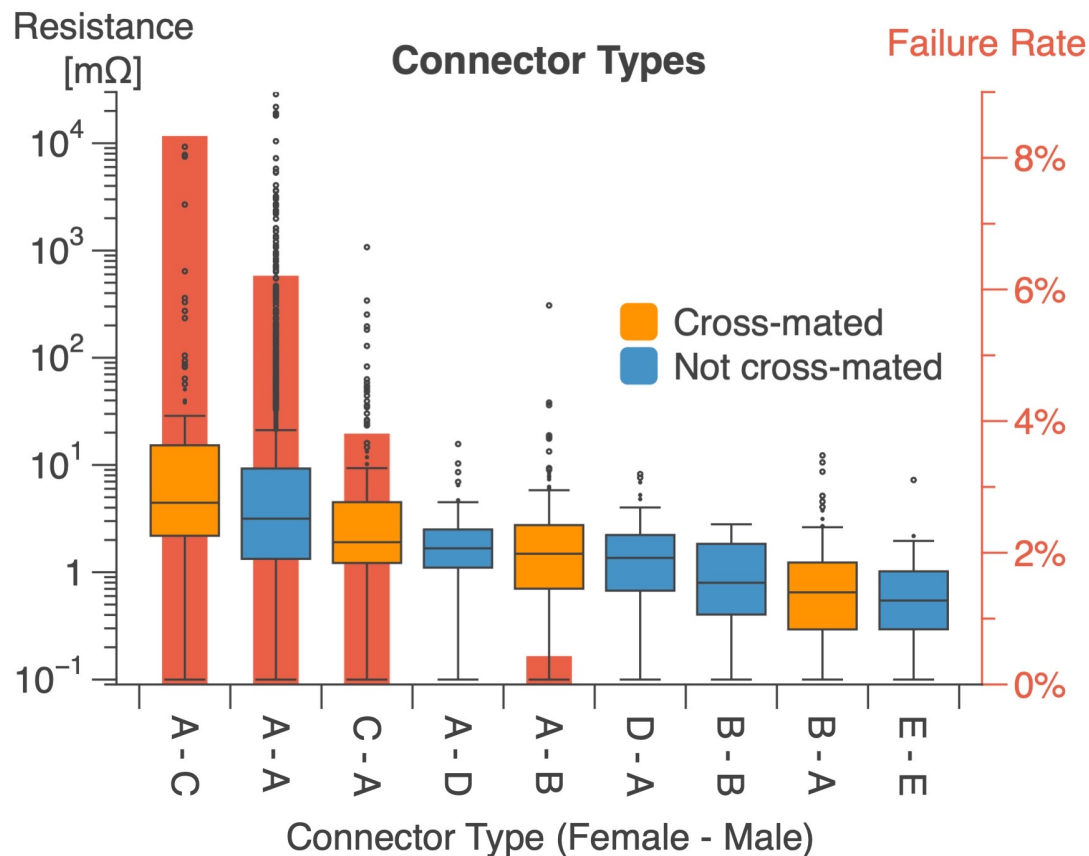
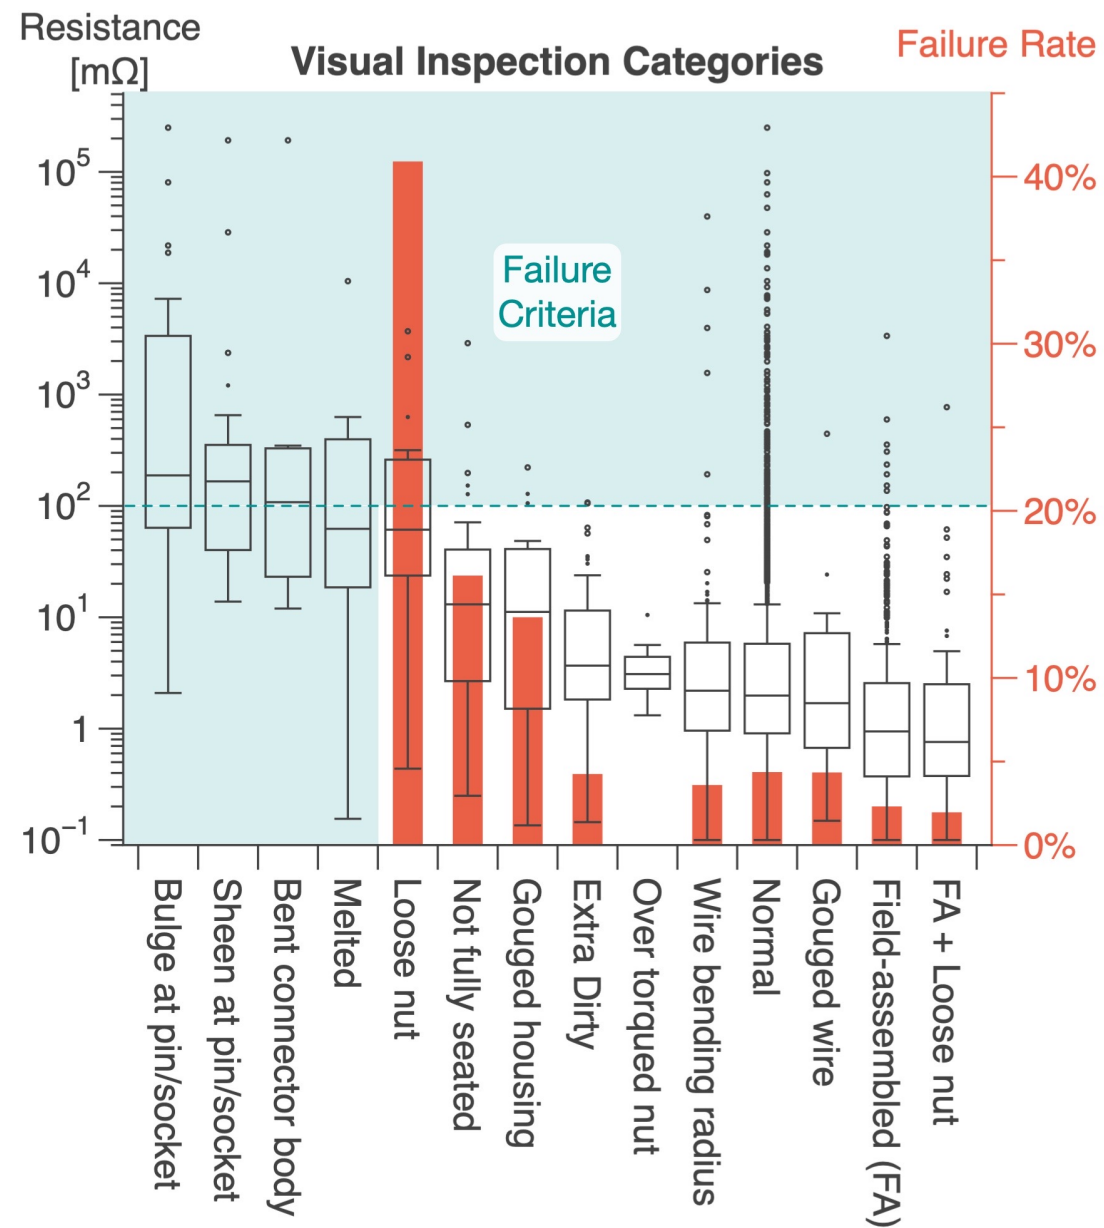
Preliminary Data: 4500 Rooftop Connectors

- Donated by residential solar installer
- 4-step rapid characterization
 - Strip wires, barcode, inspect, 4-wire resistance

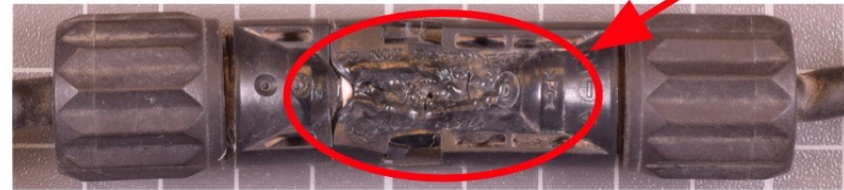
Melted Thermal events

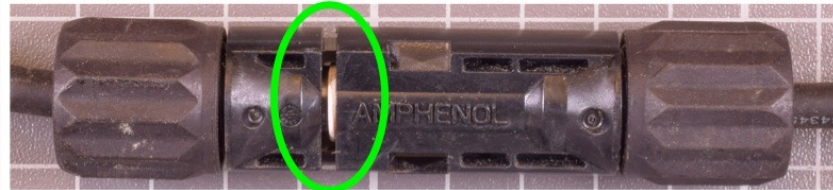
Not fully seated

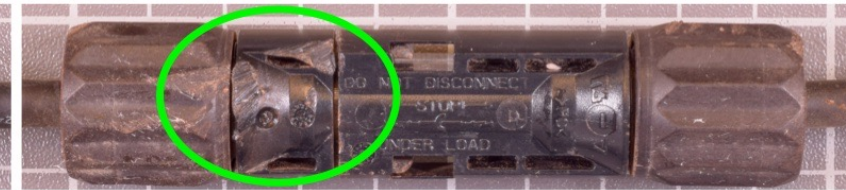
Gouged housing

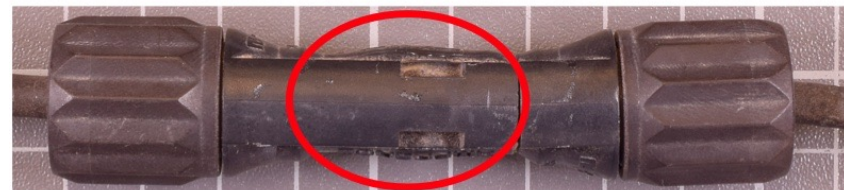
Bulge at pin/sleeve

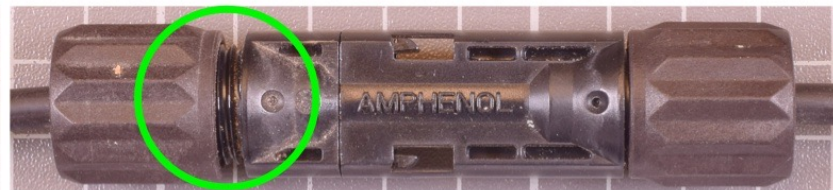
Loose nut

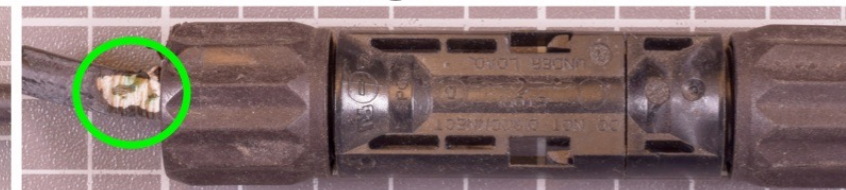
Gouged wire

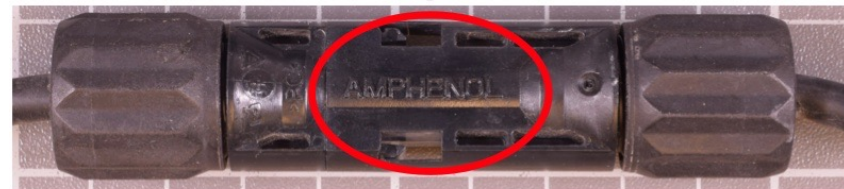
Sheen at pin/sleeve

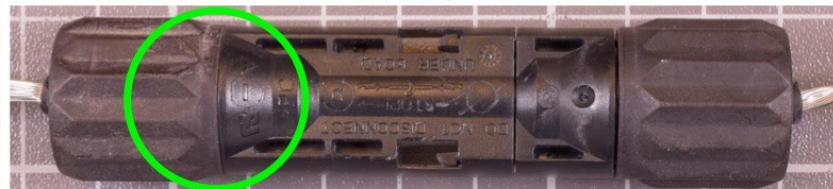
Over-torqued nut

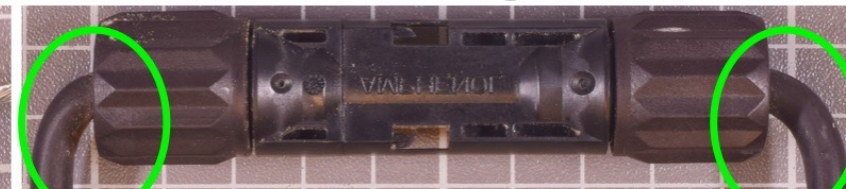
Wire bending radius

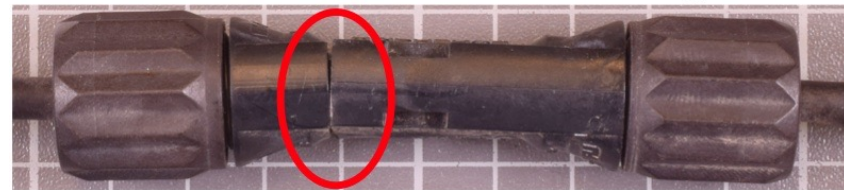
Bent connector body

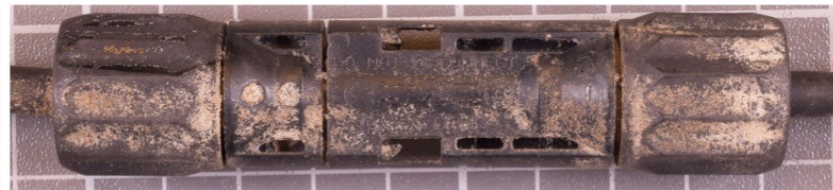
Extra dirty

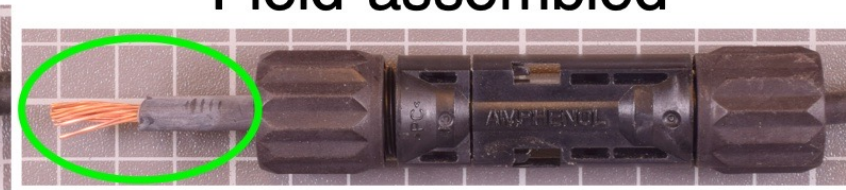
Field-assembled

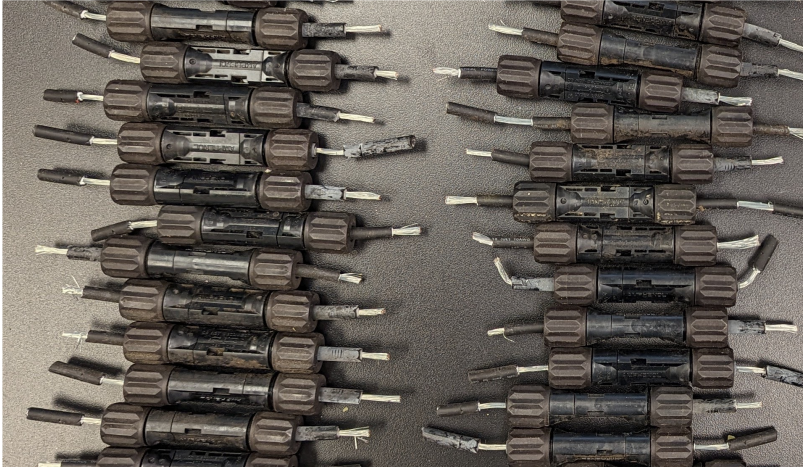
Harvested Connector Characterization

1. Strip wires
 2. Apply unique barcode to each connector
 3. Visual inspection (melting, types, etc.)
 4. 4-wire resistance measurement
- Approach designed for fast screening (not high accuracy)

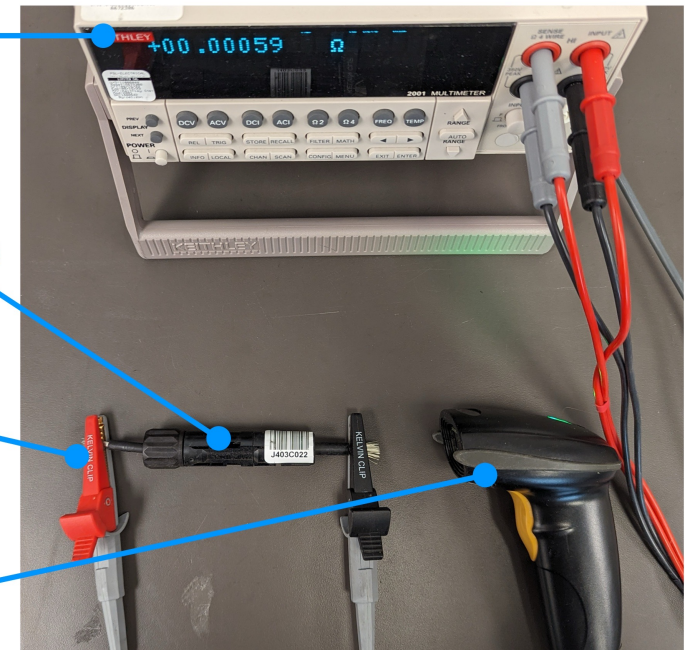
Custom Control App

Keithley Multimeter

Connector w/ Barcode

Kelvin Clips

Barcode Scanner
