# EPC Perspective

McCarthy Building Co.

# Overview

# Top 5 Warranty and Quality Topics '23

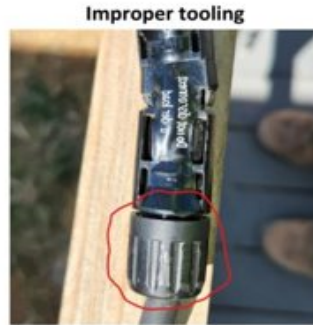
Evidence of improper tooling used for torquing

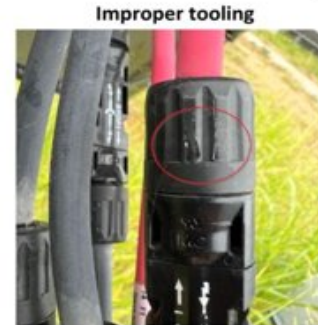
Pliers/ Channel Locks marks

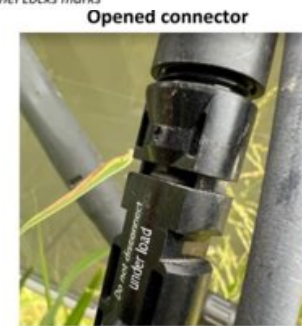
Open connector, not fully engaged.

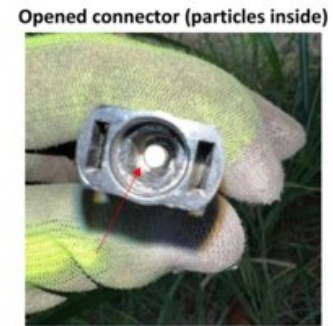
Visible debris or foreign particle inside connector body

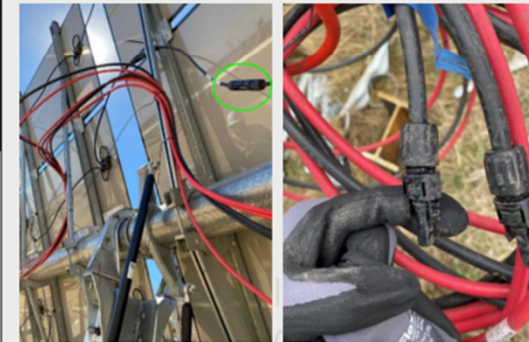
Figure 1

- UV light can degrade the connector and increase the temperature. The recommendation is to locate all connectors behind the panel and out of direct UV exposure. See correct connector location circled in green in figure 1.

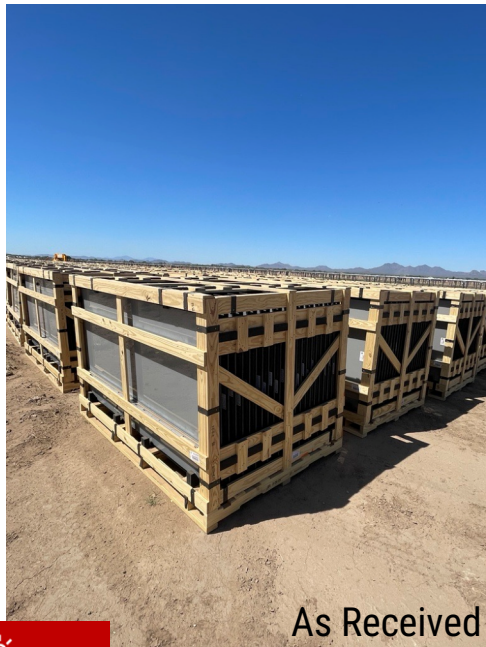
As Received

- Concerted efforts to cap all end-of-row connectors.

- Module manufacturer education.
  - Module manufacturers are providing modules with no connector caps. This further increases connector challenges in the field.
