SANDIA REPORT

SAND2013-1185

Preliminary Photovoltaic Arc-Fault Prognostic Tests using Sacrificial Fiber Optic Cabling

Jay Johnson, Kenneth D. Blemel, and Francis Peter

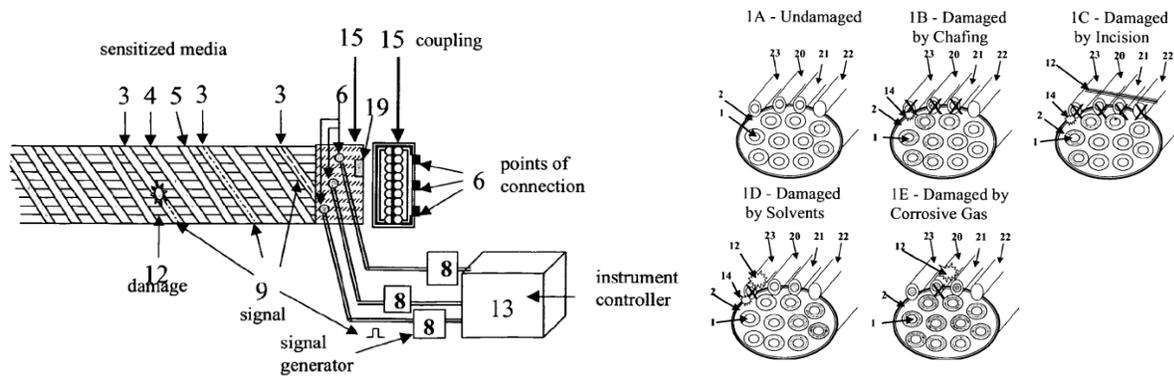
Figure 1. Method for detecting damage to conduit or electrical systems [5].

Management Sciences' use of polymeric fiber optics to determine damage to conduits originated with internal research and development and is described in four patents [6-9]. Initial development was to detect incipient or real damage to electrical conductors in electrical cables caused by chemicals, chafing, abrasion, and/or hot spots. It was believed that this technology could also be applied to photovoltaic systems in order to detect problems to the electrical circuitry. In the event of hot spots, which are believed to precede arc-faults, the polymeric fiber optic would melt and cause the system to shut down. In the event of physical wear or trauma, the fiber optic cable would be broken and the light signal would not reach the photodetector. The principle behind the photonic emitter/detector pair and the wear mechanisms is shown in Figure 1.

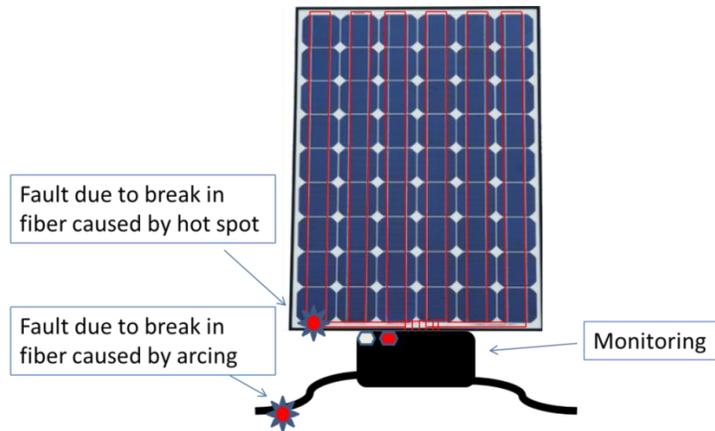
Figure 2. Arc-fault detector design for multi-cell modules. Red lines indicate the optical fiber.

Sentient Business Systems has proposed to incorporate fiber optic cables in the modules and around DC cabling. These optical paths will be connected with optical fiber connectors built into the electrical contact connectors. The polymeric fiber system can be subdivided into any number of modules and DC runs to isolate the fault when there is an alarm. One proposed layout for the module is shown in Figure 2. One potential wrapping scheme for the DC cabling is shown in Figure 3. A prototype system with a fiber optic cable is shown in Figure 4. Polycarbonate sheet may be cold bent with the minimum radius based upon a bend ratio of 100. The inexpensive, polymeric fiber optical strands can be as small as 0.1 mm in diameter which equates to a bending radius of 10 mm, so the electrical path can easily be followed using the overlaid optical fiber.

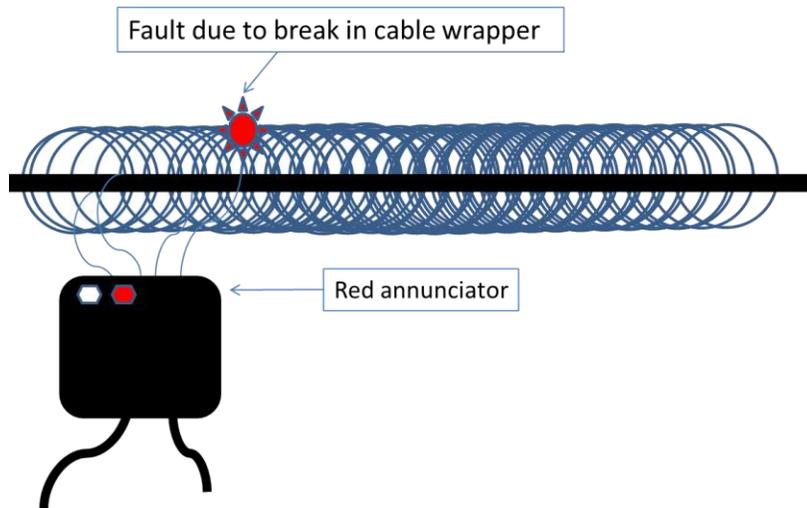
Figure 3. Fiber optic arc-fault detector deployed on a section of DC cabling.

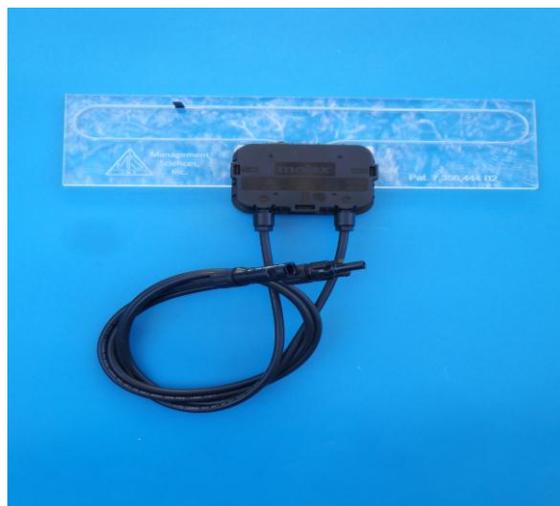
Figure 4. Prototype fiber optic arc-fault detector. The black tab can be lifted to break the fiber optic connection and a red LED will illuminate.

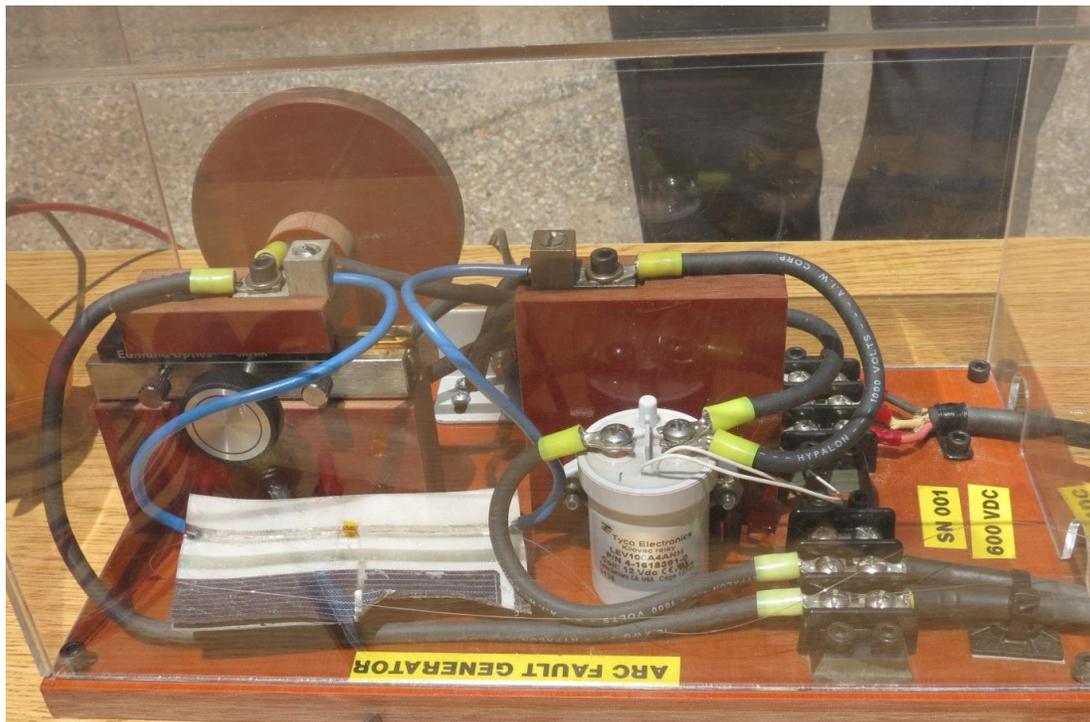
Figure 5. Series arc-fault experiment using a cut busbar sample.

A module busbar sample was extracted from a PV module and the tempered front-side glass and EVA encapsulant were removed to allow connectors to be soldered to the ends. The middle of the busbar was cut with a razor blade and a single steel wool fiber was taped across the gap, as shown in Figure 5. The fiber optic cable was run along the top and over the gap in the busbar. The power through the busbar sample was created by two strings shorted through the sample. The arc current was ~ 7.3 A. This simulated string current was used to guarantee an arc was formed, but would not be typical for most PV strings. When the arc-fault flash was generated, the high temperatures easily melted the fiber optic cable, shown in Figure 6.

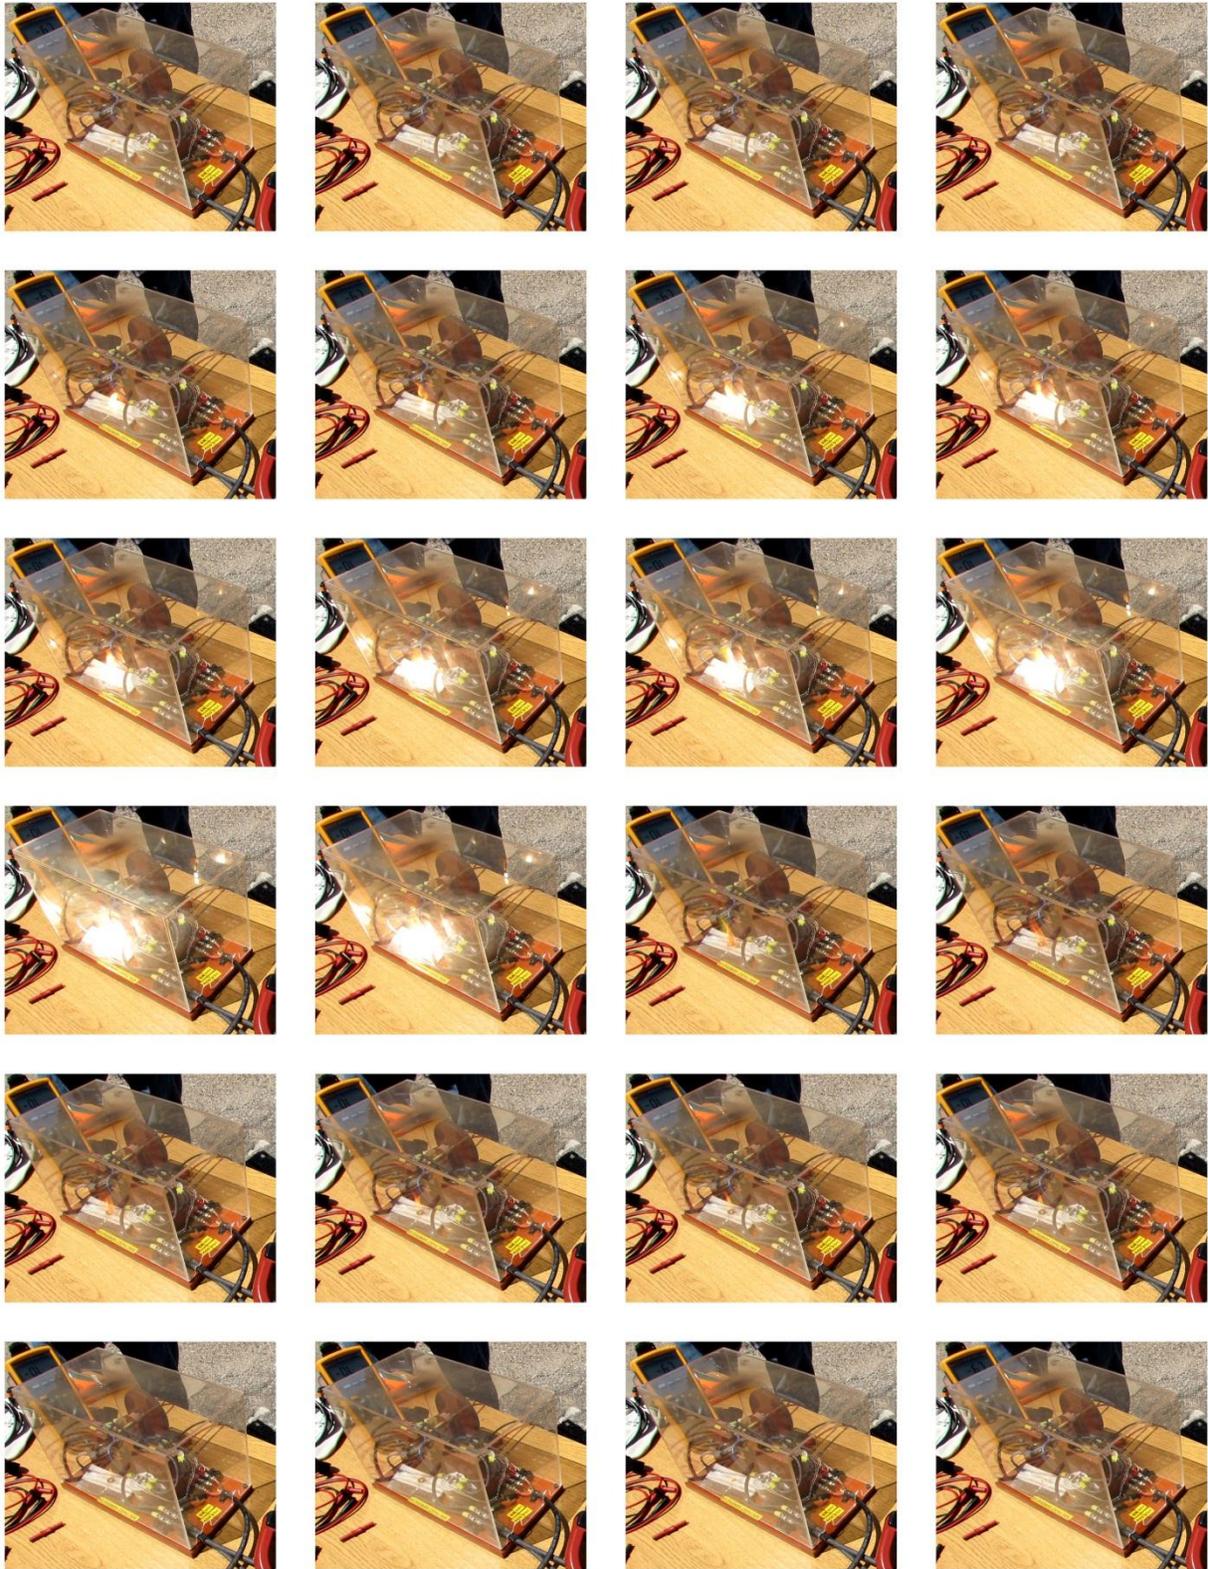
Figure 6. Simulated series arc-fault on the busbar conductor. Consecutive frames were taken from video shot at 23.98 frames/sec. Total time represented is 1.00 second.

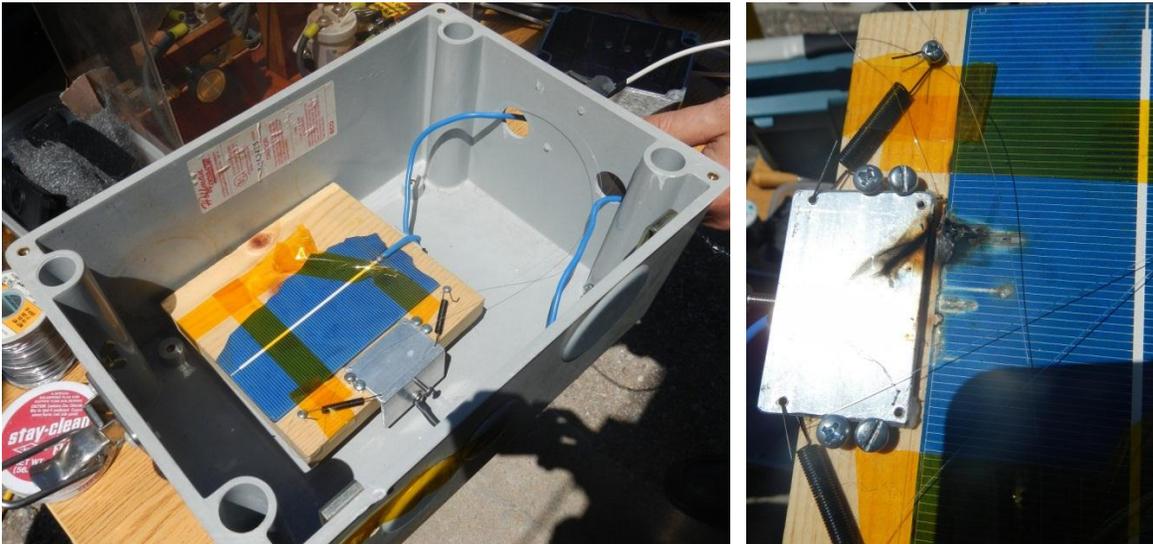
Figure 7. Arc-fault to ground setup (left) and damage caused by the arc (right).

The final arc-fault test was a type of ground-fault where an arc is generated from the PV cell to the equipment ground. A fiber optic cable was placed along the side of the cell, shown in Figure 7. If these fiber optic cables were monitored separately, the type of arc-fault could be determined. The collector ribbon was charged to V_{OC} and the frame was grounded. A piece of steel wool was placed across the cell to the frame to initiate the arc-fault. The resulting damage, illustrated in Figure 7 and Figure 9, broke the polymeric fiber connection and the fault was detected.

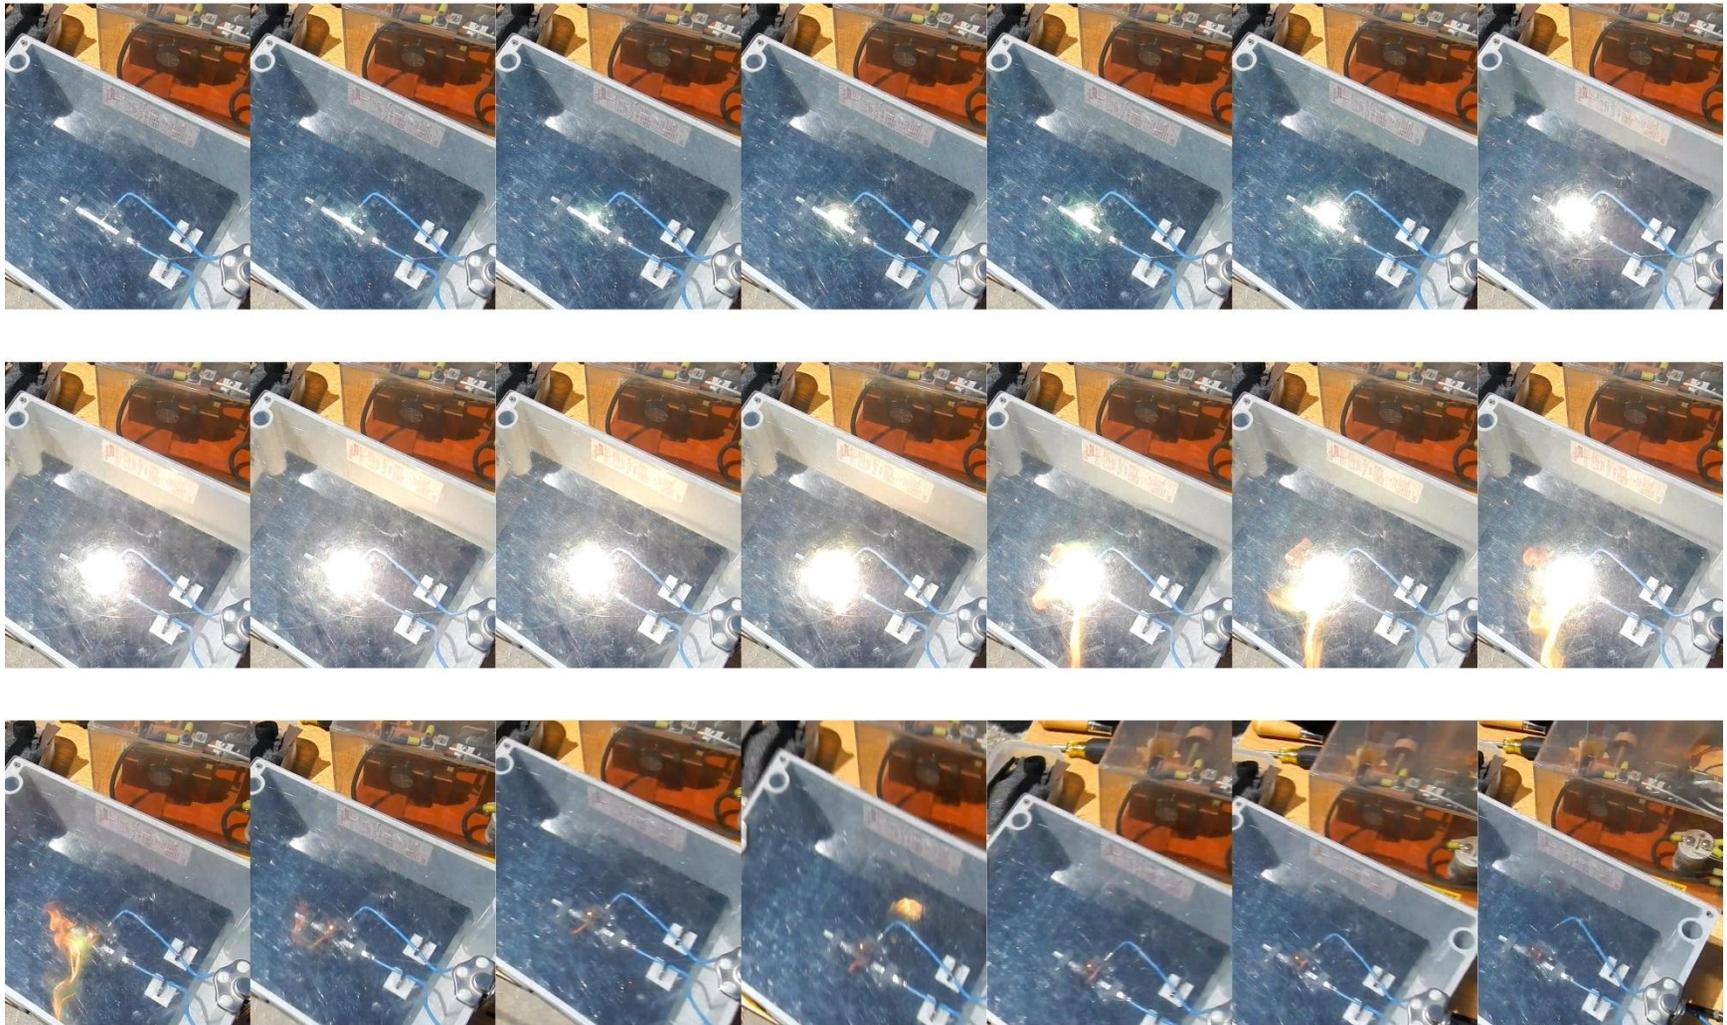
Figure 8. Simulated series arc-fault between the module busbar and collector ribbon. Consecutive frames were taken from video shot at 23.98 frames/sec. Total time represented is 0.88 seconds.

Another possible arc-fault scenario in a module is due to a poor solder connection between the busbar and the collector ribbon, which runs on the top and bottom of the cells. To simulate an arc-fault in this location, the busbar and ribbon were extracted from a PV module and mounted on a polycarbonate plate. The collector ribbon was then disconnected from the busbar to establish the arc-fault, as shown in Figure 8. Again in this case two strings in parallel powered the arc fault, so the current is greater than would be typically seen in a series fault. In this simulation, the polymeric fiber cable was vaporized and the detector no longer saw the light signal.

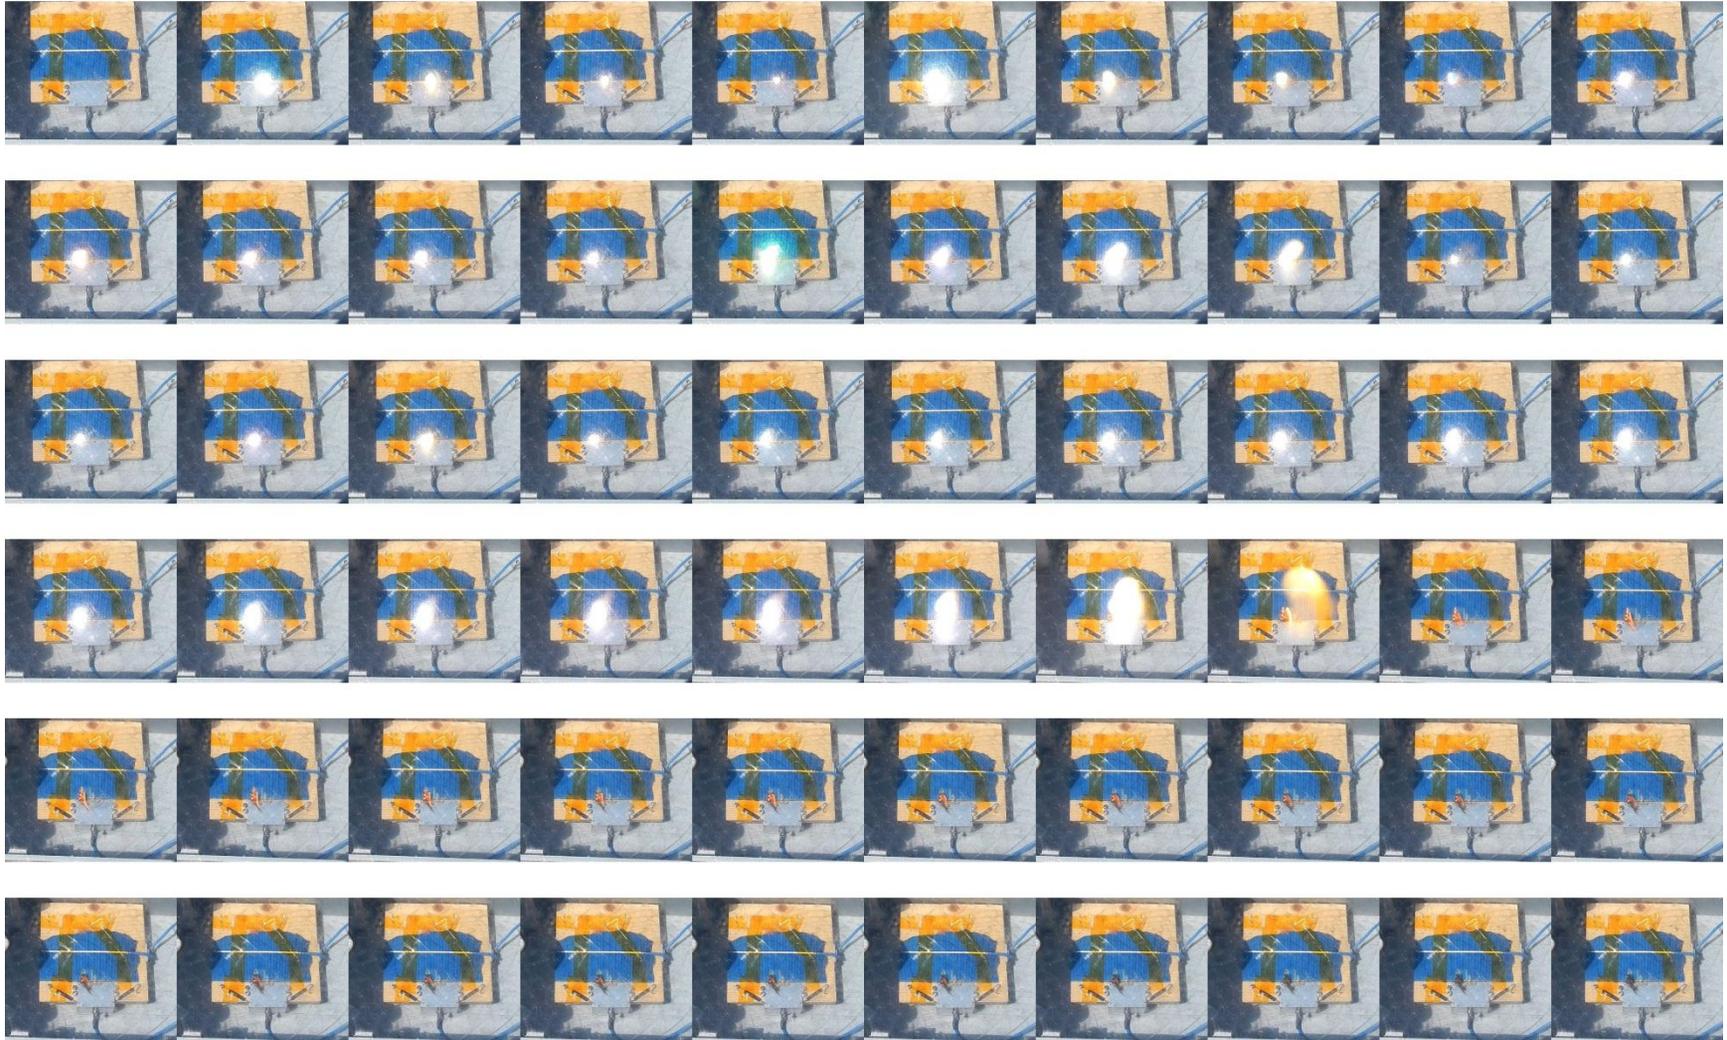
Figure 9. Simulated arc-fault from a PV cell to the frame. Consecutive frames were taken from video shot at 29.97 frames/sec. Total time represented is 2.00 seconds.

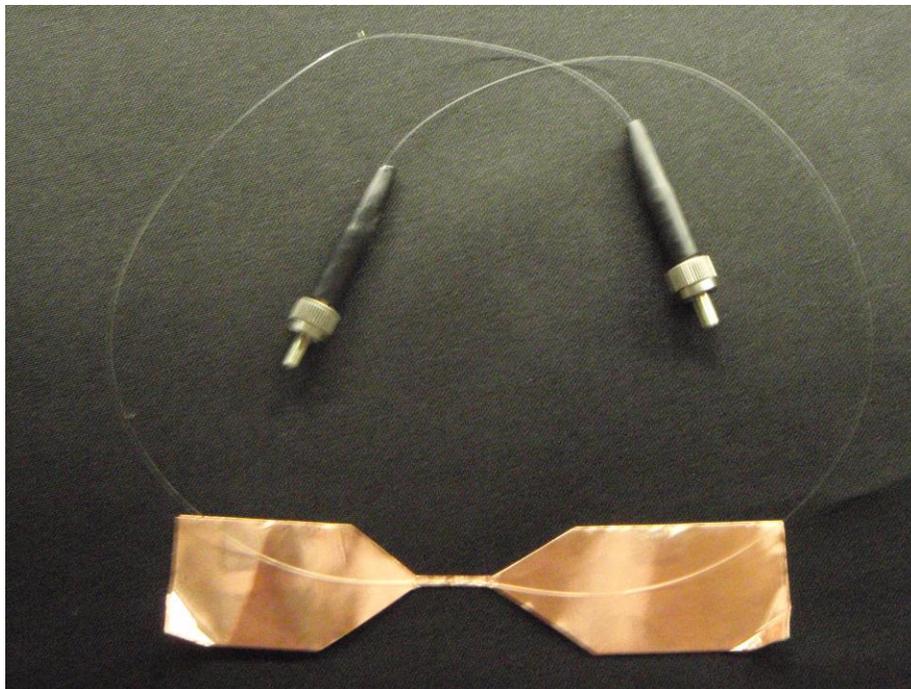
Figure 10. Resistive test fiber setup.

Sentient Systems prepared a simple test case using a copper strip (see Figure 10) to create a resistive section of the copper with the polymeric fiber laid over this resistive section. Wires were soldered to each end of the copper foil and the test coupon was mounted to a wood block for testing. 6 A current was passed through the test section and the light transmission through the polymeric fiber was measured using the photodetector. After approximately 3 minutes, the amount of light transmitted by the fiber dropped off substantially and the test was terminated. The resulting damage to the polymeric fiber is shown in Figure 11. This latent fault was detected substantially before the fault could deteriorate into a full “arc fault” condition. Determining the fiber optic melt temperature and the optical transmission alarm threshold are areas of future study.

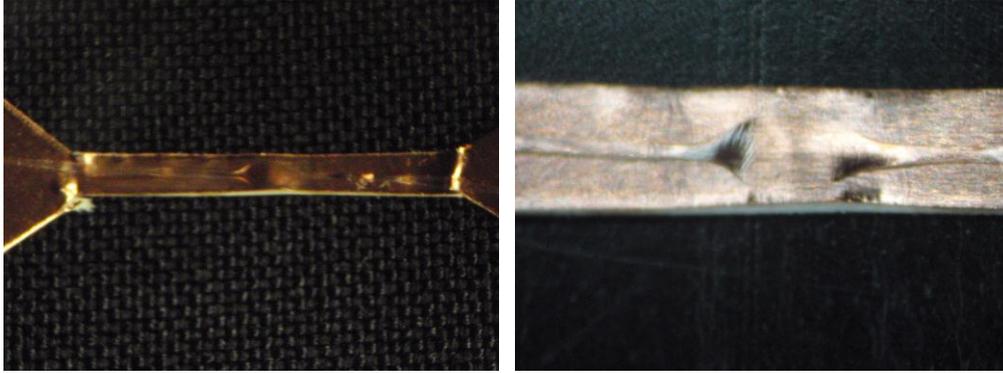
Figure 11. Fiber damage from “hot spot” test.
