PV Connector Reliability

Part II: Forensics Analysis of Failed Connectors

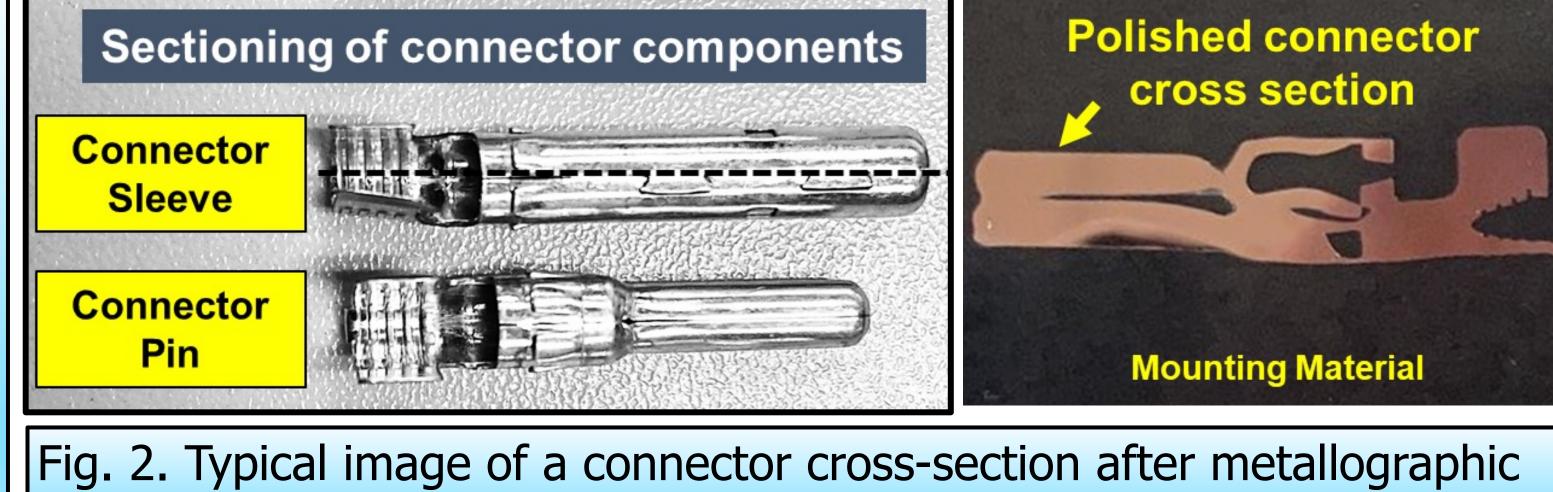
• Methodology: Metallic pin and sleeve components are prepared using standard metallurgical preparation procedures. Fig. 2 shows connector components and sectioning scheme (*left image*) and an example of polished cross section of metallic connector components (*right image*).
