# Bladena

## Solutions for cracks.

Presenter: Andrei Buliga M.Sc. Structural Engineer

29.08.18

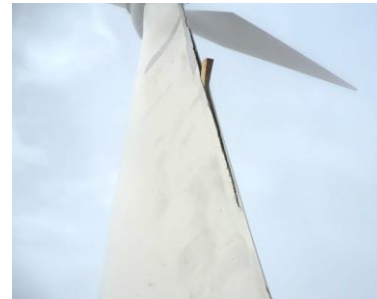
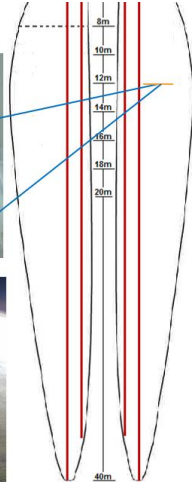
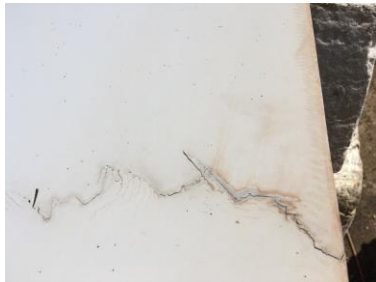
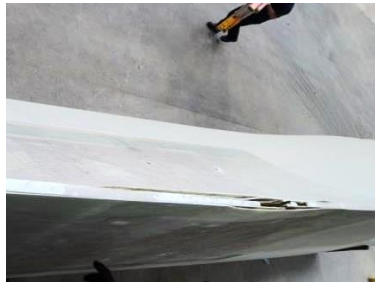
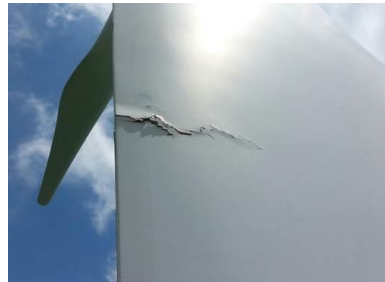
| No. | Damage type | Root-Cause |
| 1 | Transverse cracks | Out-of-plane bending of panels on top of skin debonded areas. |
| 2 | Peeling in bondlines | Breathing and Cross-Sectional Shear Distortion (CSSD). |
| 3 | Corner failures | Cross-Sectional Shear Distortion. |
| 4 | Transition zone | Out-of-plane bending of panels in the transition zone. |
| 5 | Cracks in the mid-span area | Insufficient buckling capacity in the trailing edge often caused by edgewise vibration |

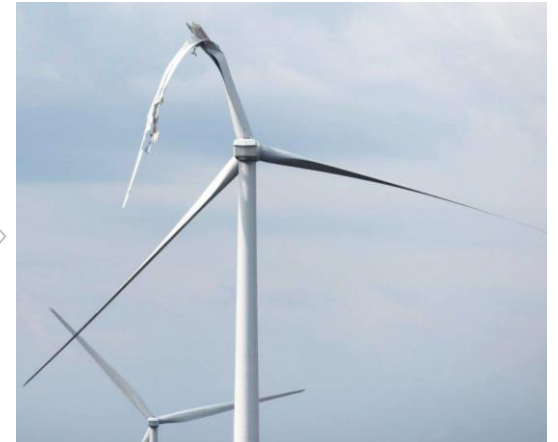
- Damages observed in the field are sometimes monitored by WTOs and not repaired until they reach a certain size (high risk).
- It is a risky approach, as the surface does not always indicate the “true” risk. In many cases the damage grows fast and the risk for failure is higher than anticipated.

Rapid  
development

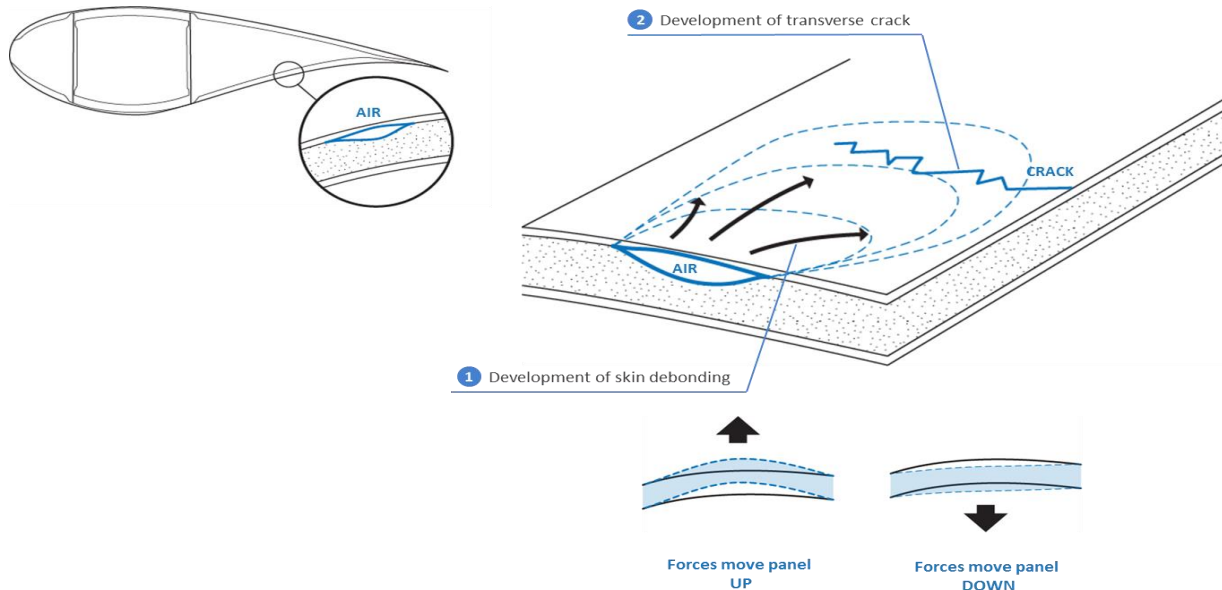
## Conclusion:

- In most cases, damages start under the visible part of blades and develop towards the surface.
- When damages are visible, an extensive zone underneath is already altered.

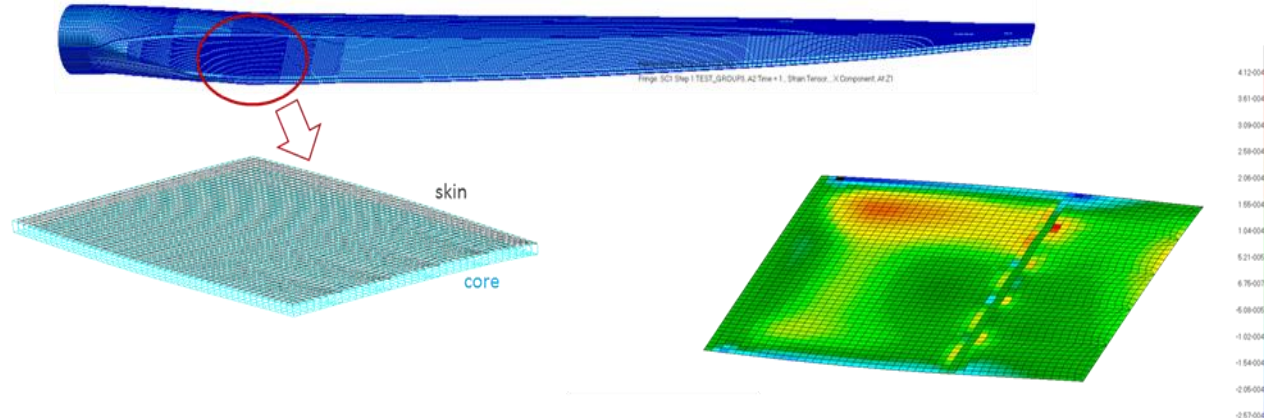
## Conclusions:

- The strain level shifts, depending if only delamination occurred or a transverse crack was developed on top of the delamination.
- The delamination zone will have a non-ideal strain distribution and strain hot spots will appear. In these areas the material strength can be exceeded and cracks will develop.
- The developed cracks will cause a change of the deformation pattern and a new strain distribution will occur.

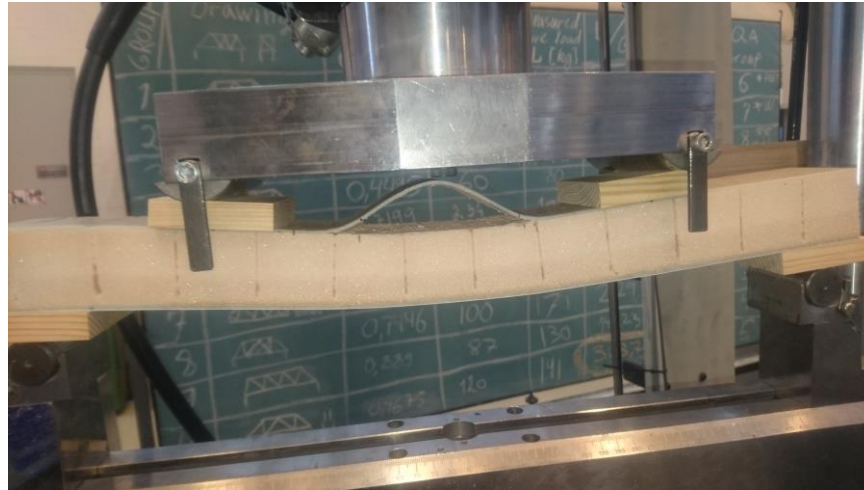
- The preliminary results validate the hypothesis:

*The bending of the panels will introduce crack growth for a panel with an initial sandwich core debond*
