Investigation of Installation Practices: Field Observations

Sandia-EPRI Connector Reliability Workshop

Site Visits: Utility, Commercial, Small R&D

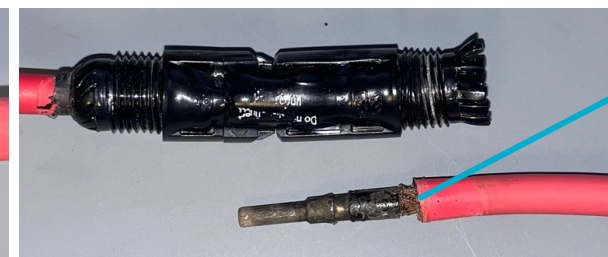
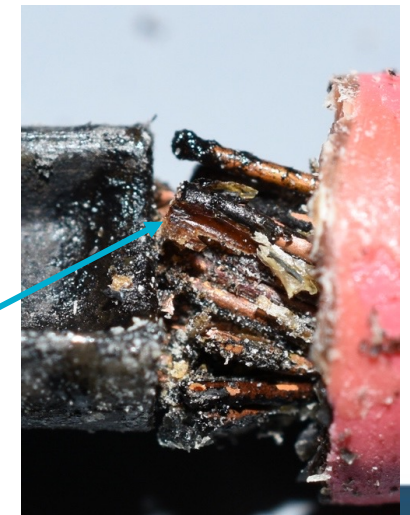
Module Replacements/Cable Management

- Field-made jumper to accommodate a module replacement
- Cable routing left connectors laying in trays where they could be submerged
 - connectors are IP68, but....only if they're assembled correctly
- Electrical arc to racking
