# Connector Failures: Field and Lab Findings

**Connector Reliability Across the US Solar Sector**

**SETO CPS Agreement # Sandia 38531 and NREL 39035**

07/17/2024

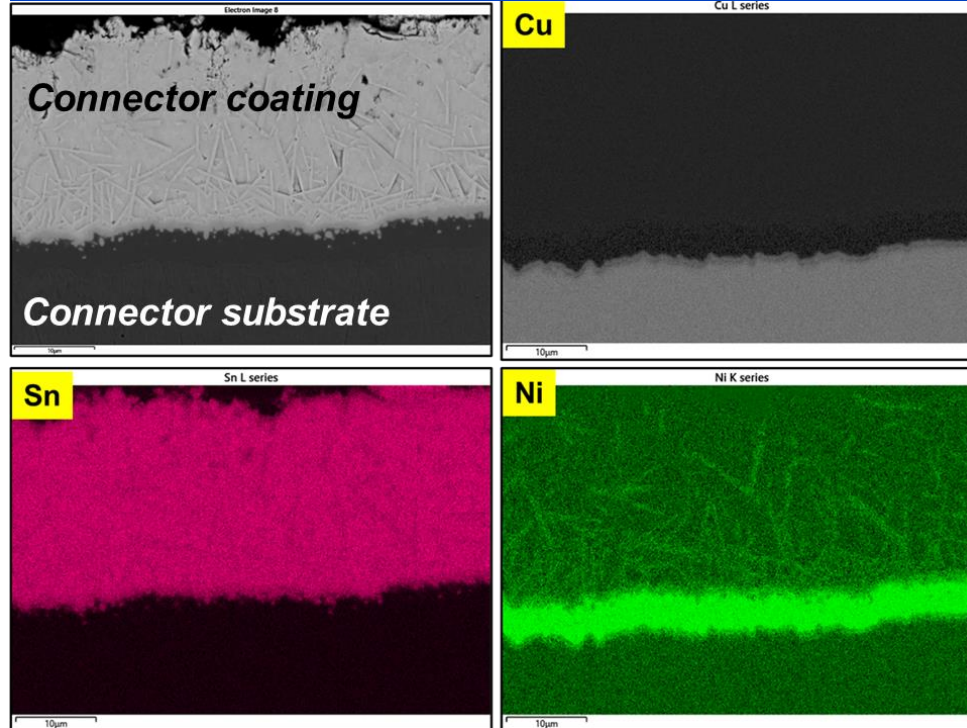
Typical coating structure shows a layered morphology with Tin (Sn) outer and Nickel (Ni) intermediate layer

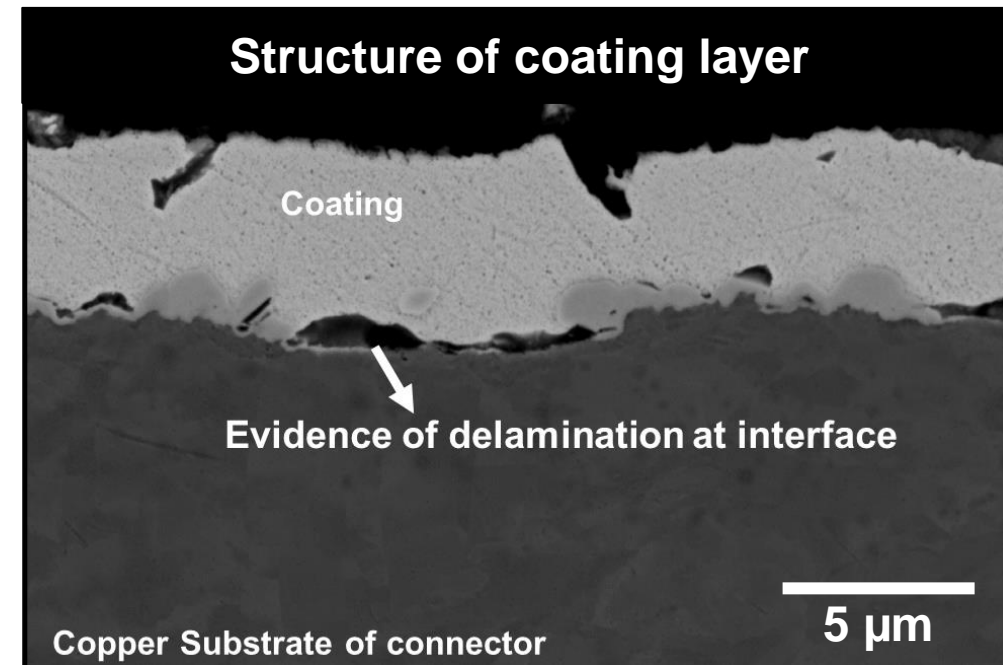
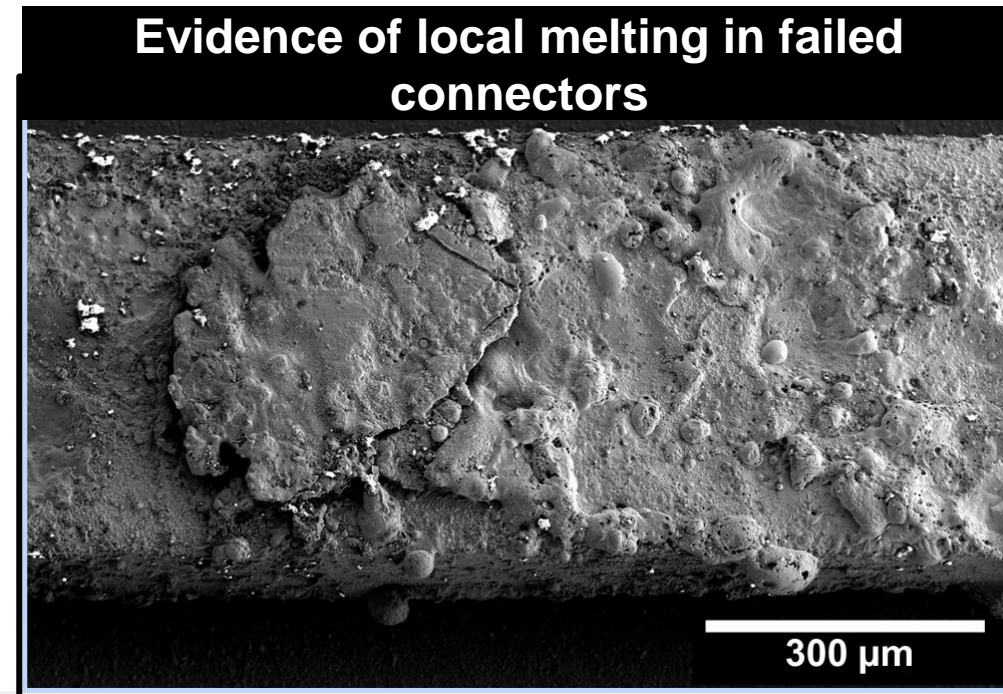
- Significant structural variations in the protective coating layers of off-the-shelf metallic connectors
  - Connectors with different manufacturers had differences in the Tin (Sn) protective coating indicating differences in manufacturing practices
  - Some connectors showed relatively poor coating adherence behavior
- Failing connectors from the field showed
  - Indications of coating degradation
  - oxidation and local melting indicating local arcing events that significantly increase temperatures

**Findings suggest that understanding manufacturing practice of coating and its degradation in service are likely important to explain cause for some connector failures in the field**
