EXTERNALLY BONDED FBG STRAIN SENSORS FOR STRUCTURAL HEALTH MONITORING OF MARINE HYDROKINETIC STRUCTURES

ABSTRACT

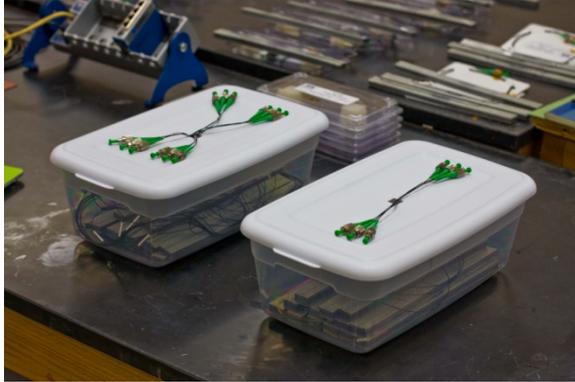
FIGURE 2: COUPONS IN SOAK TUBS

The set of coupons to be soaked in salt water were placed tubs with the FBG connects passed through a hole in the lid and out of the water, as shown in Figure 2. ASTM standard D570 was used to simulate a marine environment and the tubs were placed in a furnace for five months at 50° to assist salt-water diffusion. This is within the operating range of both sensors [22, 23]. Mass and wavelength measurements were taken for every coupon before and after the soaking process. These measurements were also tracked for a set of representative coupons during the first month to determine the amount of water absorbed by the composite matrix and its effect on material strain.
